# PRE-DEMOLITION HAZARDOUS BUILDING MATERIALS SURVEY

Town of Yorktown  
Catherine Street Pump Station  
Garden Lane and Old Crompond Road  
Yorktown, New York 10598

November 28, 2018

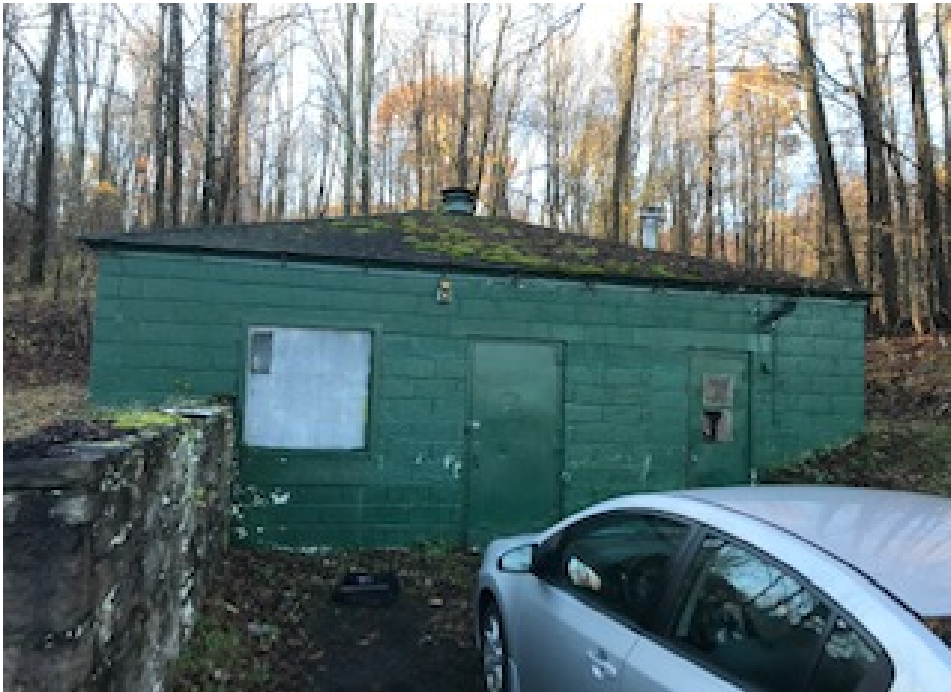
**Photograph: 1**

**Description:**  
Exterior - Pump Station

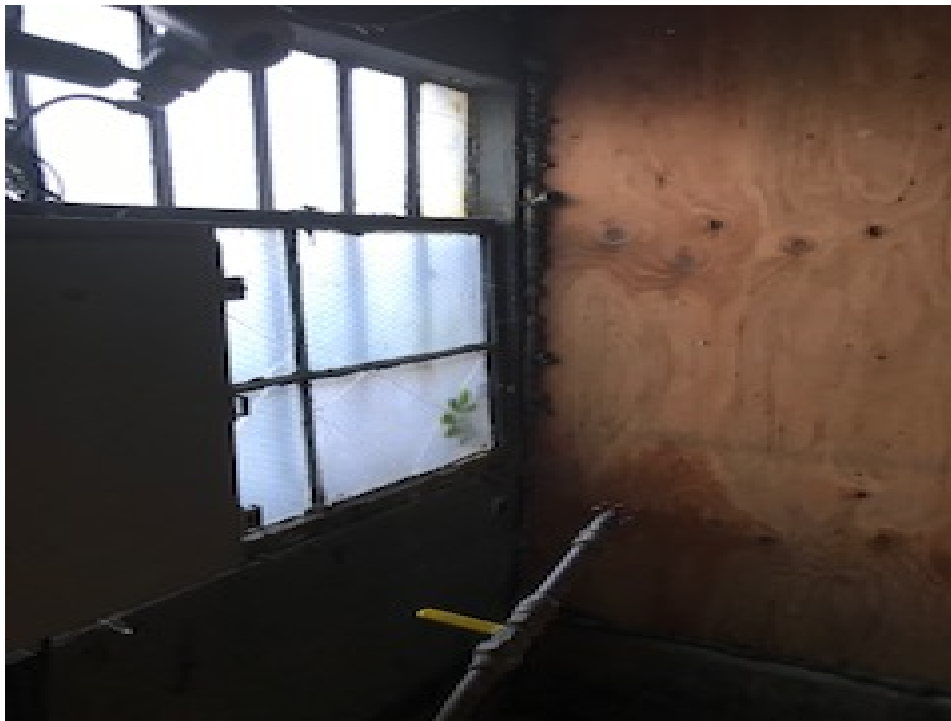
**Photograph: 2**

| HA No. | Material Description | Material Location | Sample Number | Condition | Friability | Asbestos Content | Estimated Quantity | Unit | Notes |
|---|---|---|---|---|---|---|---|---|--|
| HA-1 | Interior Window Glazing | Interior - North Window | 1A, 1B | Damaged | Non-Friable | NAD | 20 | LF | |

**Description:**  
(HA-1) (PCB-3): Interior  
Window Glazing

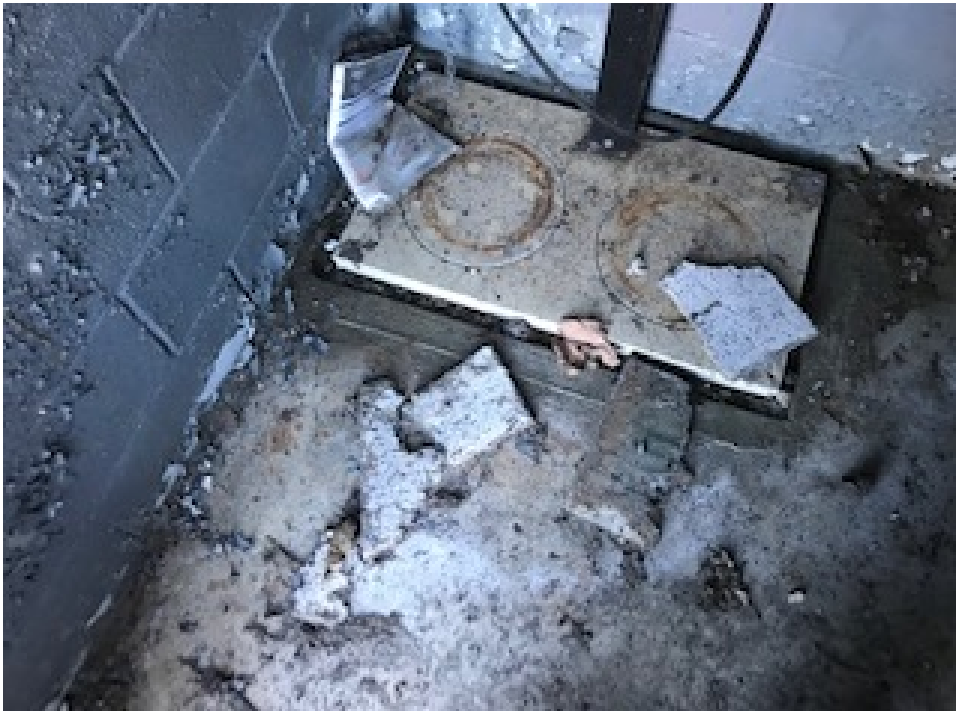
**Photograph: 7**

| HA No. | Material Description | Material Location | Sample Number | Condition | Friability | Asbestos Content | Estimated Quantity | Unit | Notes |
|---|---|---|---|---|---|---|---|---|--|
| HA-6 | Fissured Ceiling Tile | Interior - Weight Scale Room | 6A, 6B | Damaged | Friable | NAD | 2 | SF | Debris located on floor. |

HA-6: Fissured Ceiling  
Tile  
LP-4: Gray Paint on  
Concrete Wall

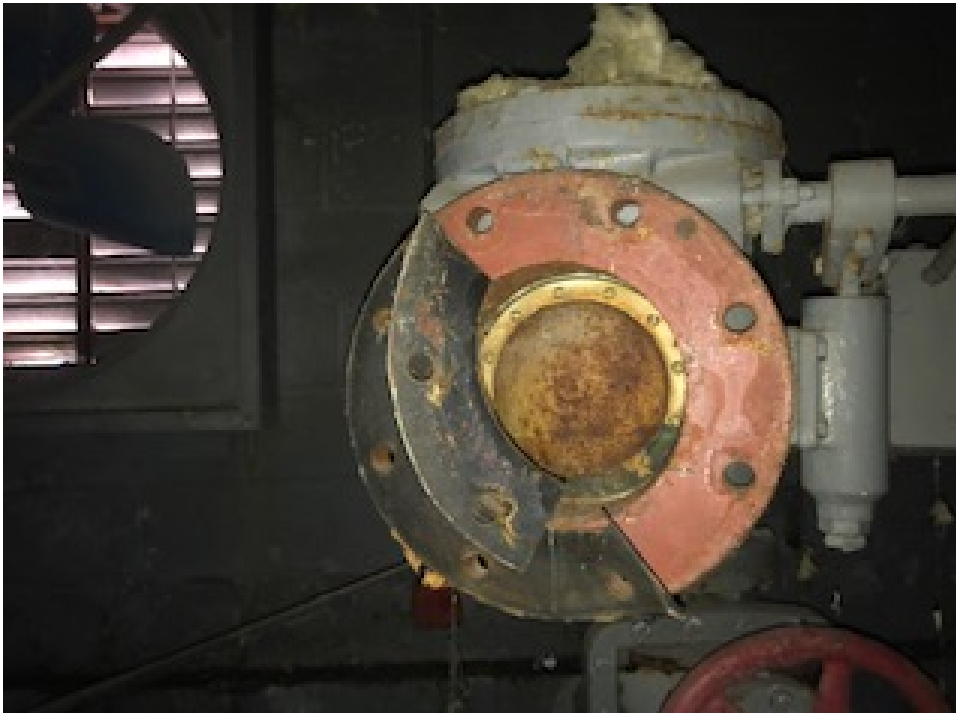
**Photograph: 9**

**Description:**  
HA-10: Valve Gasket

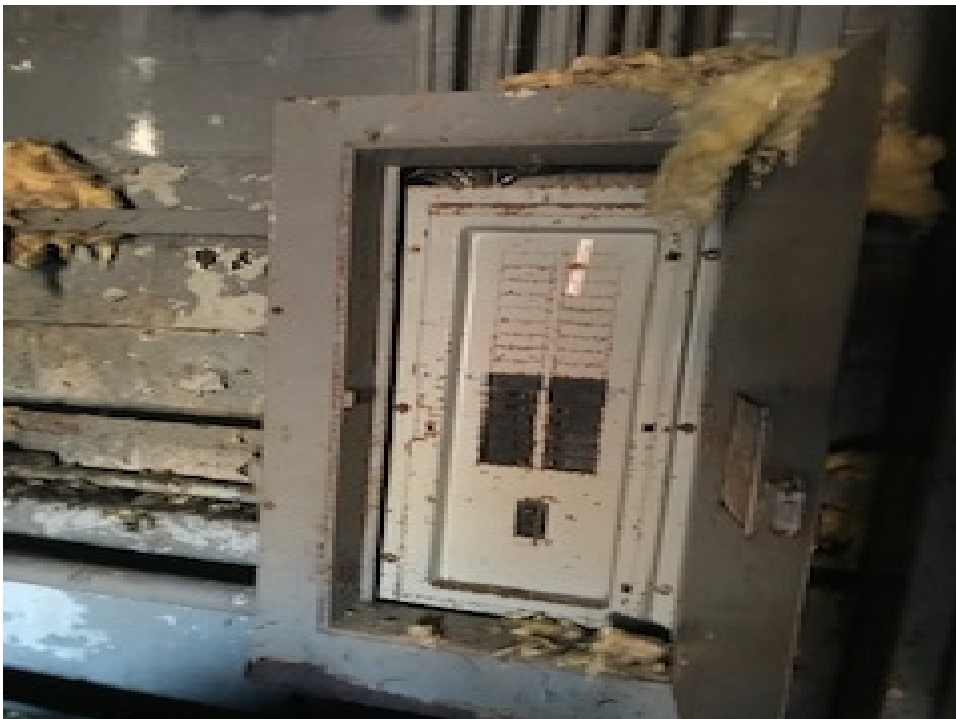
**Photograph: 10**

- HA-11: Electrical Components/Wire Wrap

**Description:**  
HA-11: Electrical  
Components/Wire  
Wrap (Assumed ACM)

ACMs identified at the site that may be disturbed during demolition activities, must be removed by a licensed asbestos abatement contractor utilizing industry standard work procedures in accordance with all federal, state, and local regulations governing asbestos.

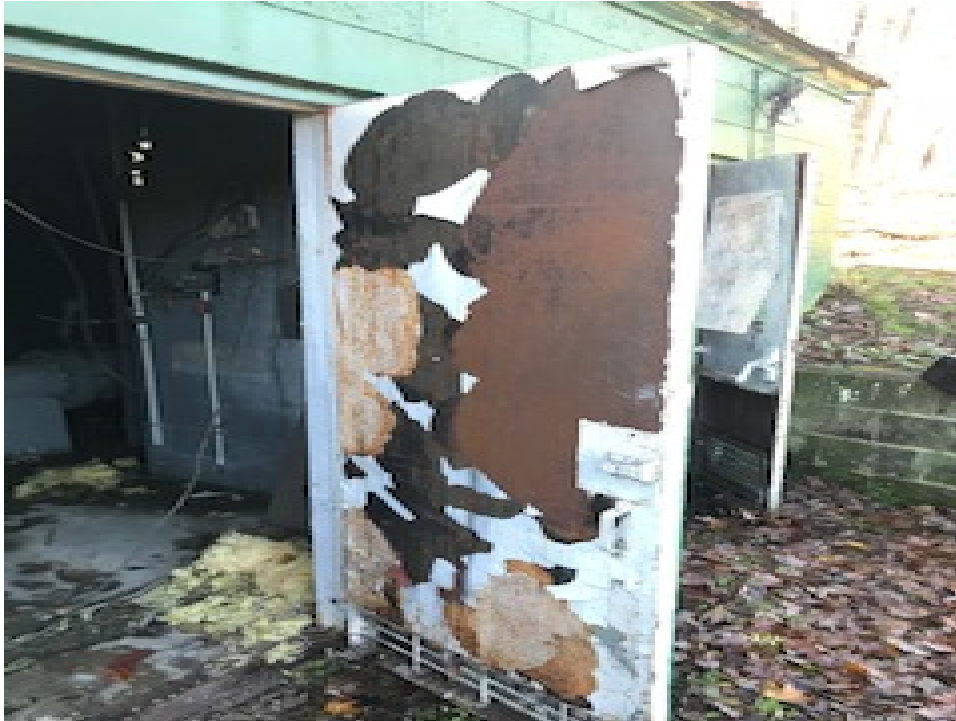
**Photograph: 11**

- LP-2: Green Paint with Metal Door - Exterior
- LP-3: White/Red Paint with Metal Door - Interior
- LP-4: Gray Paint on Concrete Wall - Interior
- LP-5: Gray Paint with Pipes/Pumps/Valves - Interior

**Description:**  
LP-3: White/Red paint  
on Metal Door

Arcadis recommends that the general contractor and any sub-trades be advised of the presence of lead-based paint/lead-containing paint and their requirements for compliance with the OSHA Lead in Construction standard (Title 29 CFR, Part 1962.62). Compliance with OSHA is required for any detectable levels of lead in painted surfaces.
