Public Informational Hearing Response

Parking Lot Expansion GHP Strang, LLC

2649-2651 Strang Blvd

CONSTRUCTION INSPECTION REPORT	
Date: 08-11-2021 Day: S M T V W Th F S Property Owner: GHP Strang LLC, Mike Cinicolo Property Address: 2649-2651 Strang Blvd Property SBL: Email: mcinicolo@ghpoffice.com Contractor: Innovative Environmental Services Inc Phone: 914-449-6608 Email:	Permit #:
The state of the s	
At the request of the Planning Board, as discussed at the 8/9/21 Public Informational Hearing, this office conducted an inspection of recent site activities related to excavation and soil stockpiling. At the time of the inspection, the contractor was excavating and exposing the existing 20,000 gal underground storage tank (fuel oil) proposed to be removed. It was reported by the owner that the removal is being conducted under a current Building Permit. In addition, demolition activities were taking place within the lower level of the existing building, also in accordance with current Building Permits. A temporary construction access road had been constructed.

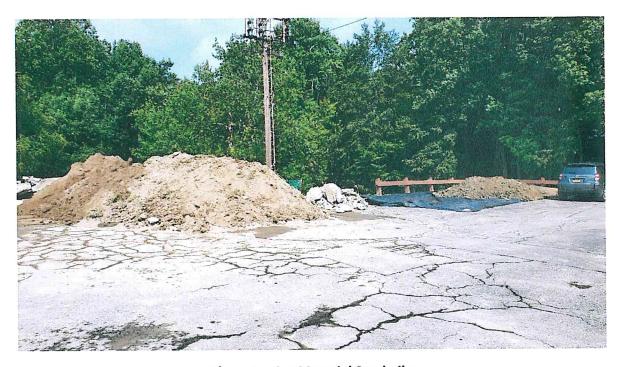
COMMENTS / REMARKS - Excavated material associated with the ongoing tank removal is being separated and temporarily stockpiled in the existing parking lot. The clean soil stockpile is covered with plastic tarps daily to prevent erosion. The contaminated soil stockpile is placed on two layers of poly-liner and then covered with plastic tarps daily to prevent erosion. The contaminated soil will be removed and disposed off site. The clean soil will be used to backfill the excavation once the tank is removed. - The internal building demolition activities continue at the lower level. The downgrade area of the temporary access road is protected by silt fence. - No erosion was observed at the time of the inspection and all controls appeared to be installed correctly. - The contractor is sweeping the parking lot daily to prevent off-site sediment transport. - No corrective actions were required at the time of the inspection.

Photo 1 – Cut Material Stockpiles

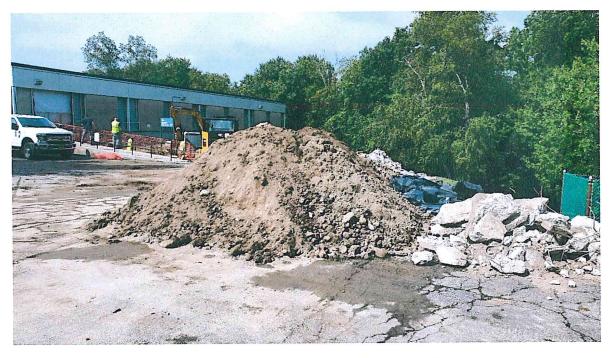
Photo 2 – Cut Material Stockpile – Clean Fill

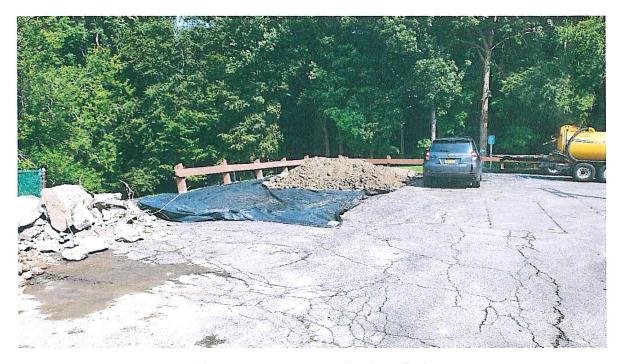
Photo 3 - Contaminated Soil Stockpile

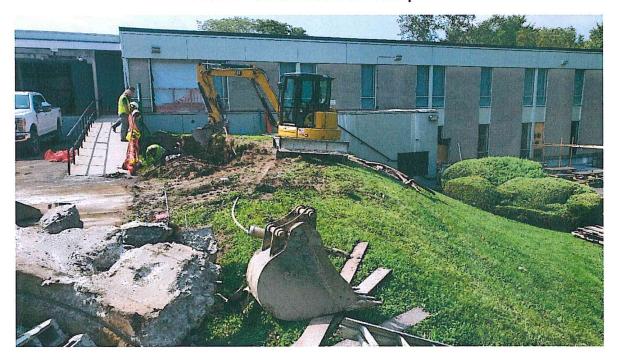
With regard to concerns for soil stockpiles, please note that the material in question is directly related to the removal of an existing 20,000 gallon underground fuel-oil storage tank. The tank removal and environmental remediation is being conducted by a Licensed Contractor under current permits from the Town. At the time of our inspection, excavated material was being stockpiled within the existing paved parking lot and is covered daily with plastic tarps to prevent erosion. The parking lot is swept daily at the end of the contractor's workday. Upon removal of the underground storage tank the clean fill is to be used for backfill material in the excavated area and any disturbed areas will be stabilized with topsoil and seed. No erosion was noted at the time of our inspection nor were any corrective actions required.

Photo 4 - Oil Tank Removal

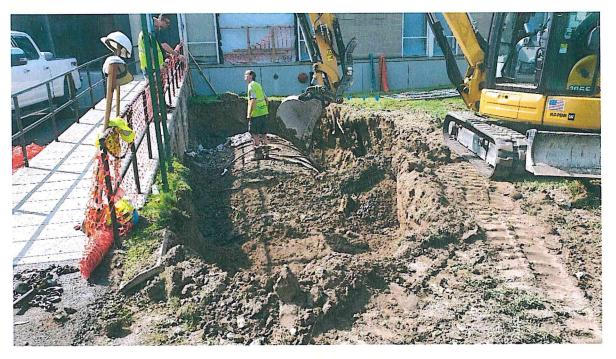
Photo 5 – 20,000 gal UST

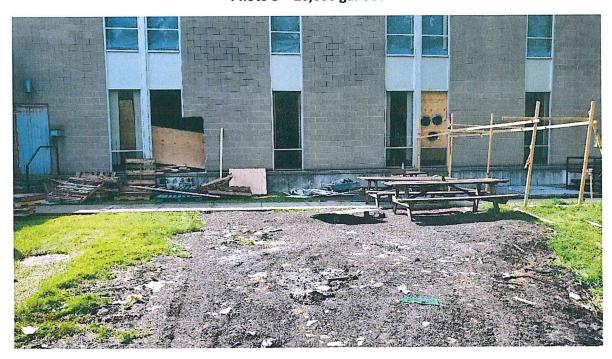
Photo 6 – Lower Level Demo

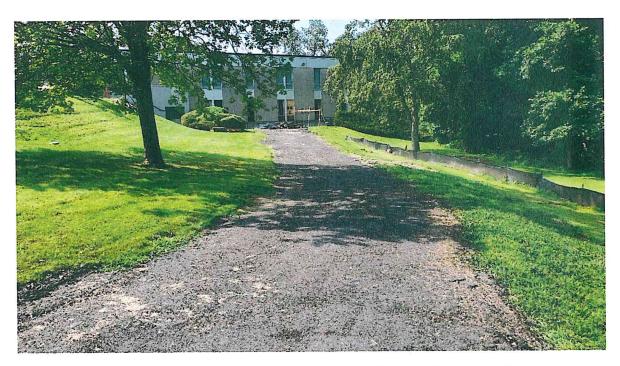
Photo 7 - Lower Level Demo and Temporary Construction Access Road

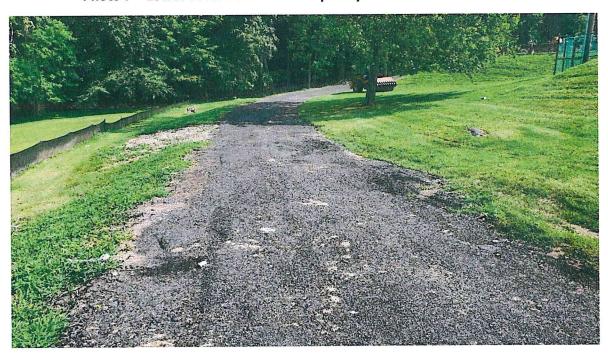
With regard to the "road" referenced by the noticed neighbor, please note that this is a temporary construction access road and is required to provide adequate access for the lower-level building demolition and renovations. A temporary construction access road has been constructed, connecting the existing upper parking lot to the lower level. The temporary access road is stable, and all downgradient areas are protected by temporary silt fence which is in good working order. No erosion was noted at the time of our inspection, nor were any corrective actions required.

Photo 8 – Temporary Construction Access Road

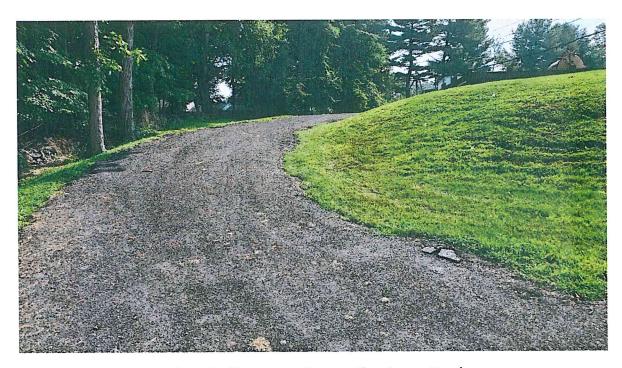
Photo 9 - Temporary Construction Access Road
