**Phase IA Archaeological and Historic Resources Assessment**  
**Costco Wholesale**  
**U.S. Route 202/N.Y. Route 35, Yorktown**  
**Westchester County, New York**

February 2012

Phase of Survey: **Phase IA Archaeological and Historic Resources Assessment**

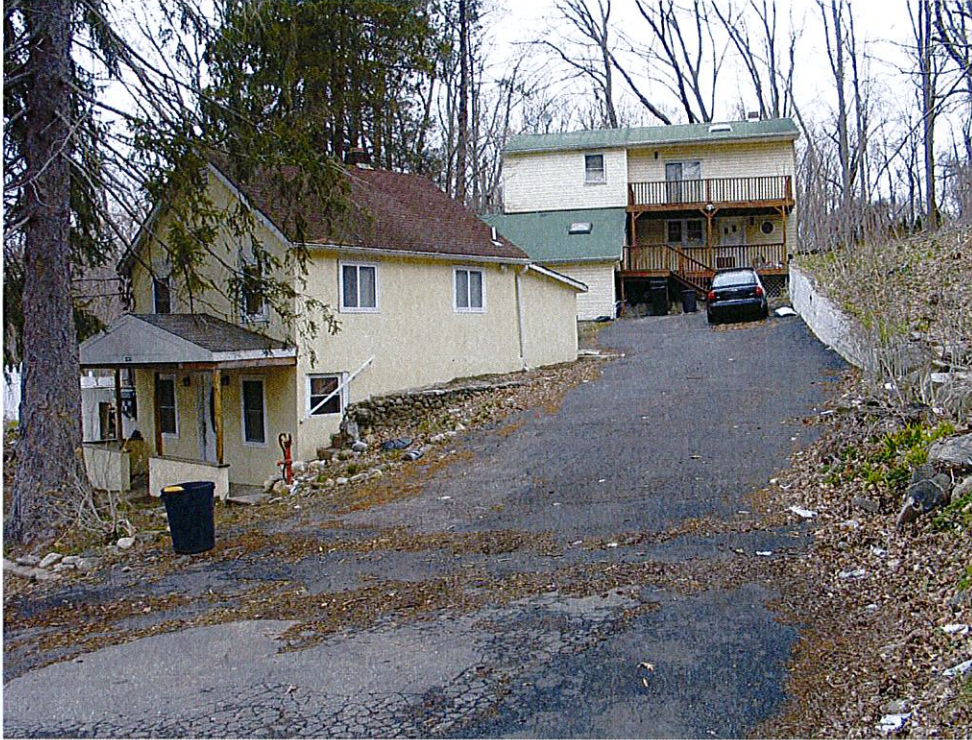
The residence further upslope from Old Crompond Road is a two story with basement frame dwelling that has been significantly modified from its original form (Photograph 1 and 5). The foundation is concrete. Town of Yorktown Department of Building records note that this house pre-dates 1932. It was expanded in 1978 and 1986.

Photograph 1: Two residences, each accessed by a common driveway, and both sharing the address of 3220 Old Crompond Road. View looking north.

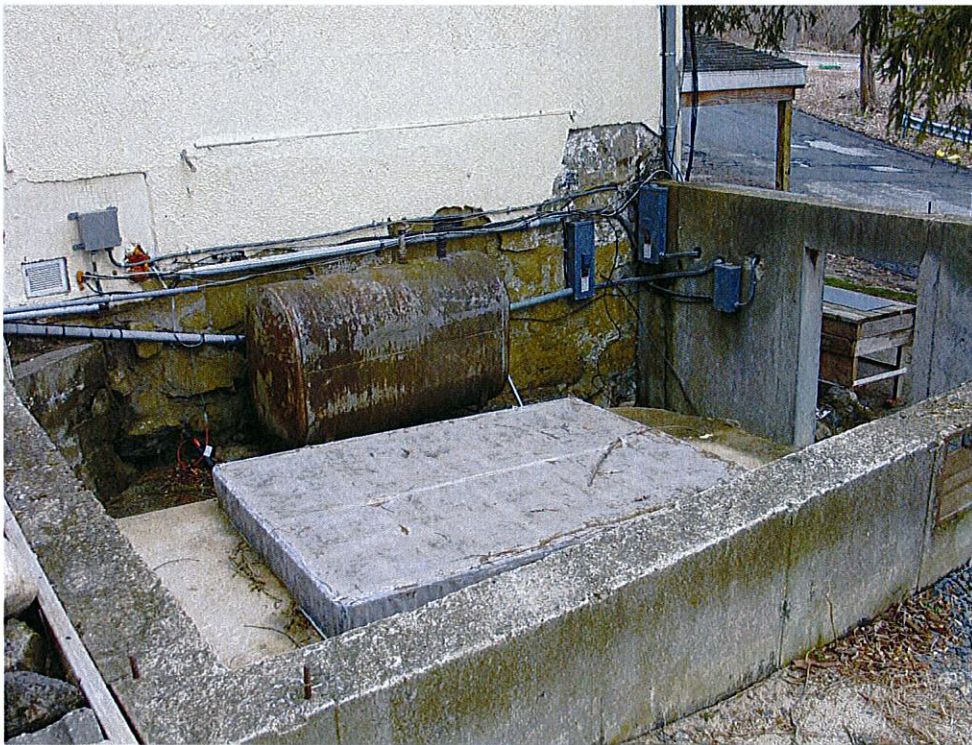
The residence directly fronting Old Crompond Road is a two story masonry building, currently covered with yellow stucco. In areas where the stucco has deteriorated, the original stone walls are visible underneath (Photograph 2). The building has a stone foundation of rough laid fieldstones, and the building is set into the hillside. There are two additions to the original building, a one-story extension off the rear, with a shed roof, and a basement level extension on the northwest side that may never have been completed, as there is a concrete block foundation, but no superstructure (Photograph 3). A fuel tank is visible along the northwest side of the structure, within the basement extension. This residence also has a subgrade well with a red pump at the southern corner, and a septic tank in the yard area just northwest of the basement extension (Photograph 4). There is a wooden privacy fence along the street front and the northwest side of the parcel, along with a dilapidated wooden shed. Town of Yorktown Department of Building records note that this house pre-dates 1932. It was expanded from its original size in 1986 and the front porch was rebuilt in 2009.

Photograph 2: Residence nearest Old Crompond Road showing exposed basement addition and stone walls under deteriorating stucco. View looking south.

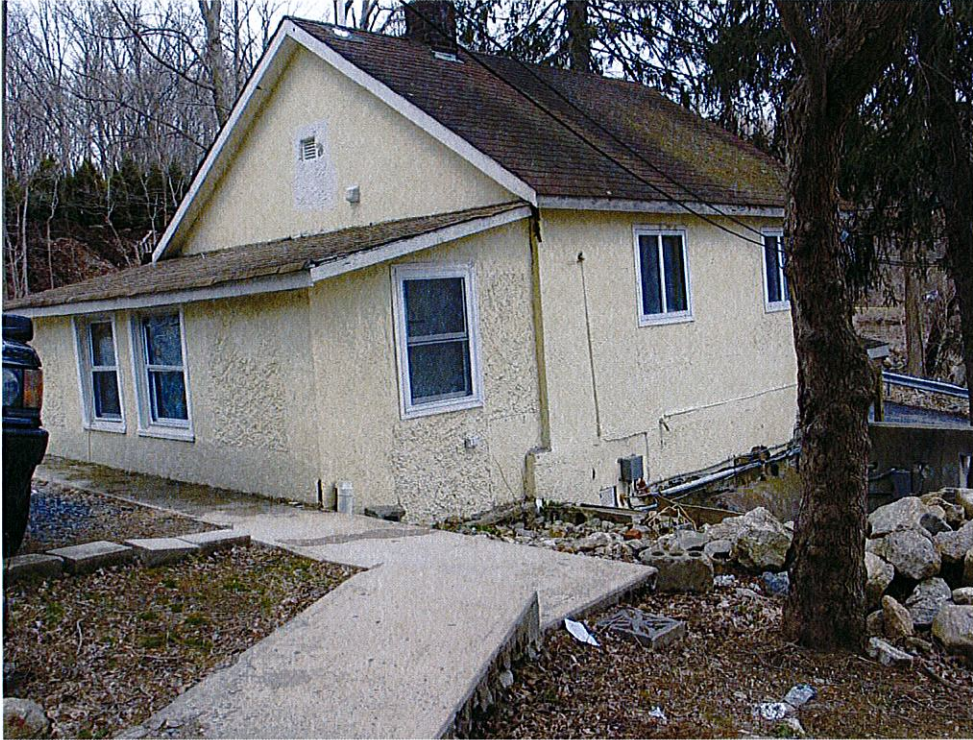
Photograph 3: Residence nearest Old Crompond Road showing one story addition off rear. View looking south.

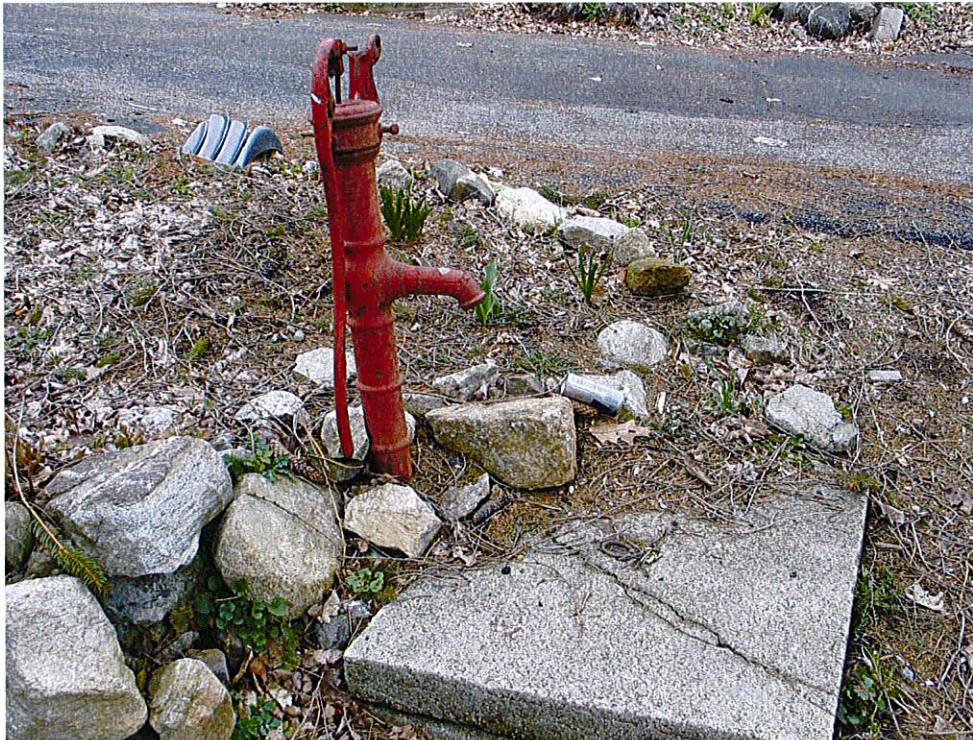
Photograph 4: Residence nearest Old Crompond Road showing location of subgrade well with a red pump.

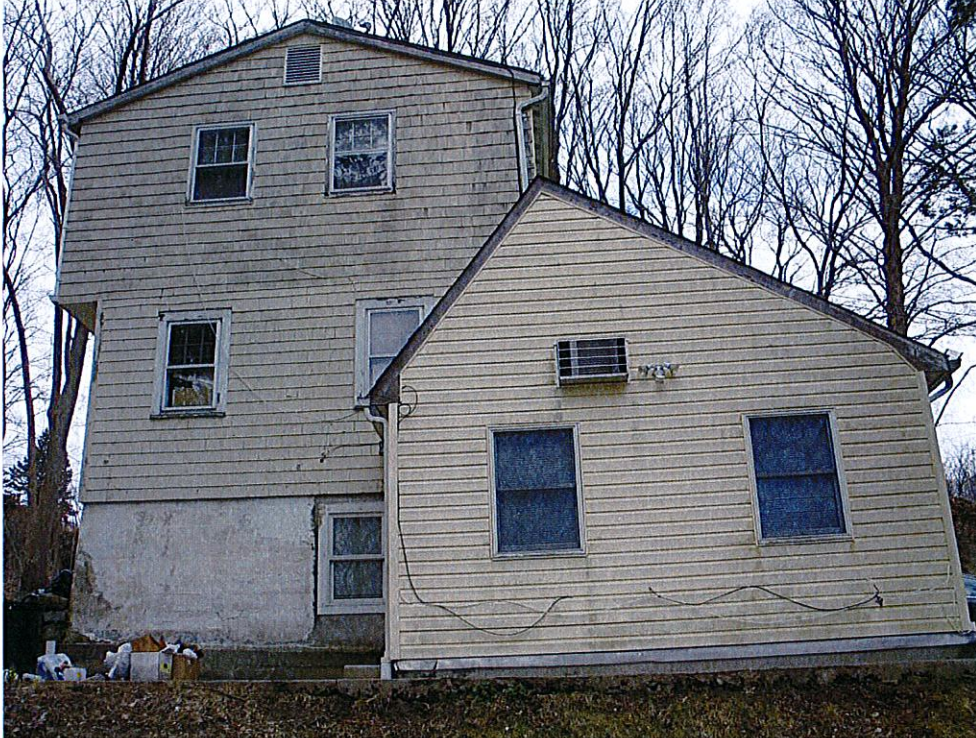
Photograph 5: Detail of residence further upslope from Old Crompond Road. View looking east.

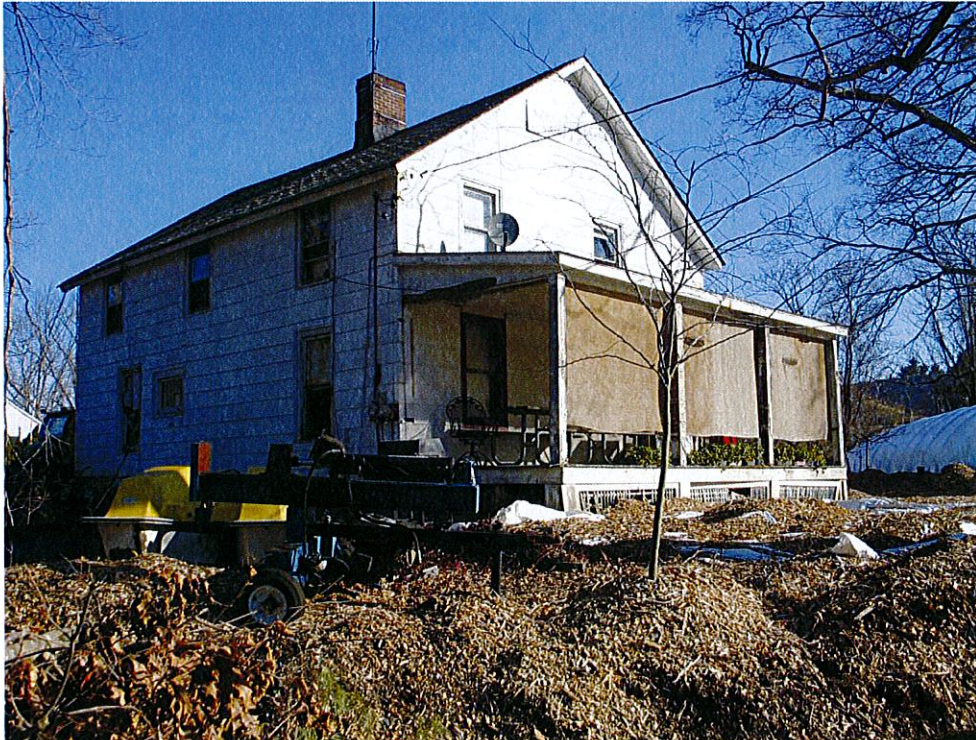
Photograph 6: Front (south) elevation of former dwelling on Zino's Nursery and Landscaping and Anthony's Power Equipment property, now retrofitted and used to repair lawn mowers. View looking northeast.

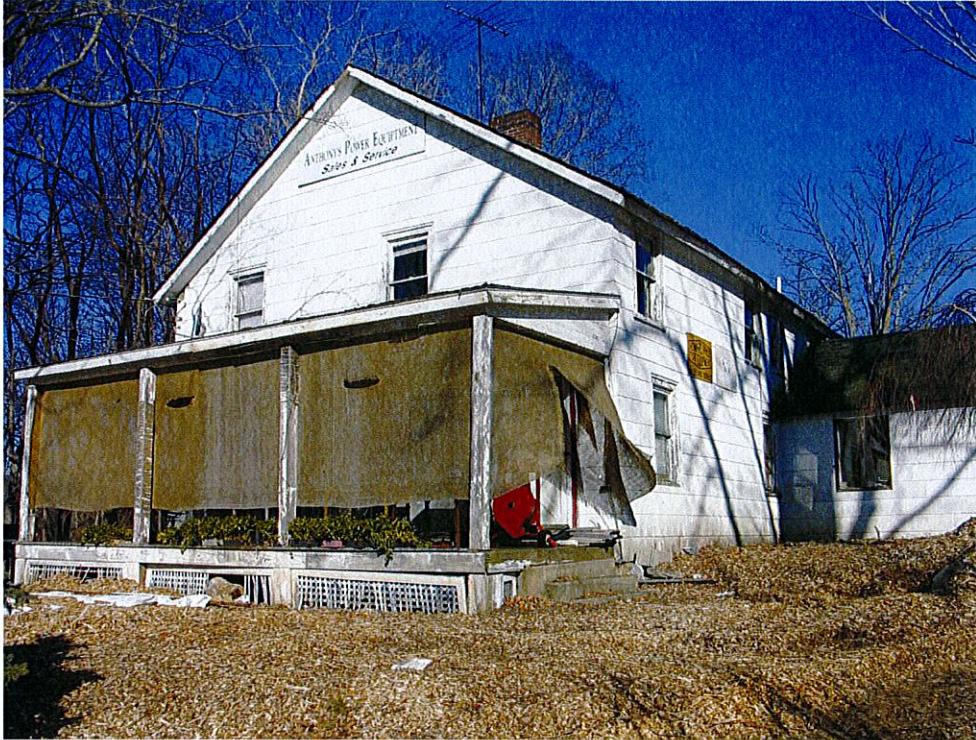
Photograph 7: Front (south) elevation of former dwelling on Zino's Nursery and Landscaping and Anthony's Power Equipment property, now retrofitted and used to repair lawn mowers. View looking northwest.

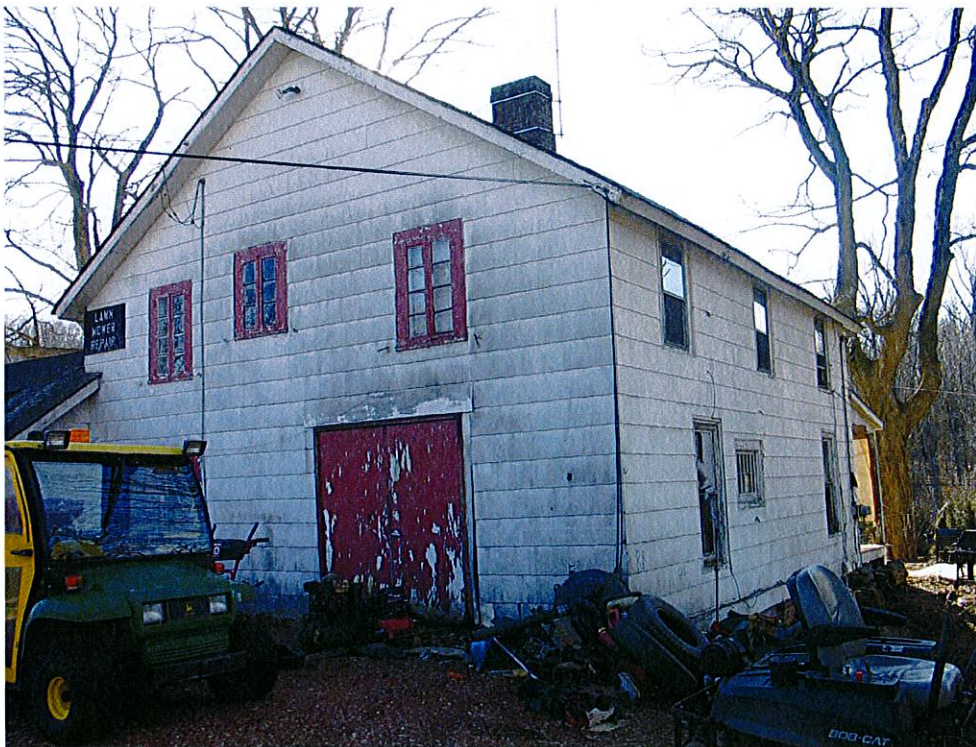
Photograph 8: Rear (north) elevation of former dwelling on Zino's Nursery and Landscaping and Anthony's Power Equipment property, now retrofitted and used to repair lawn mowers, showing wide double doors leading to workshop level. View looking southeast.

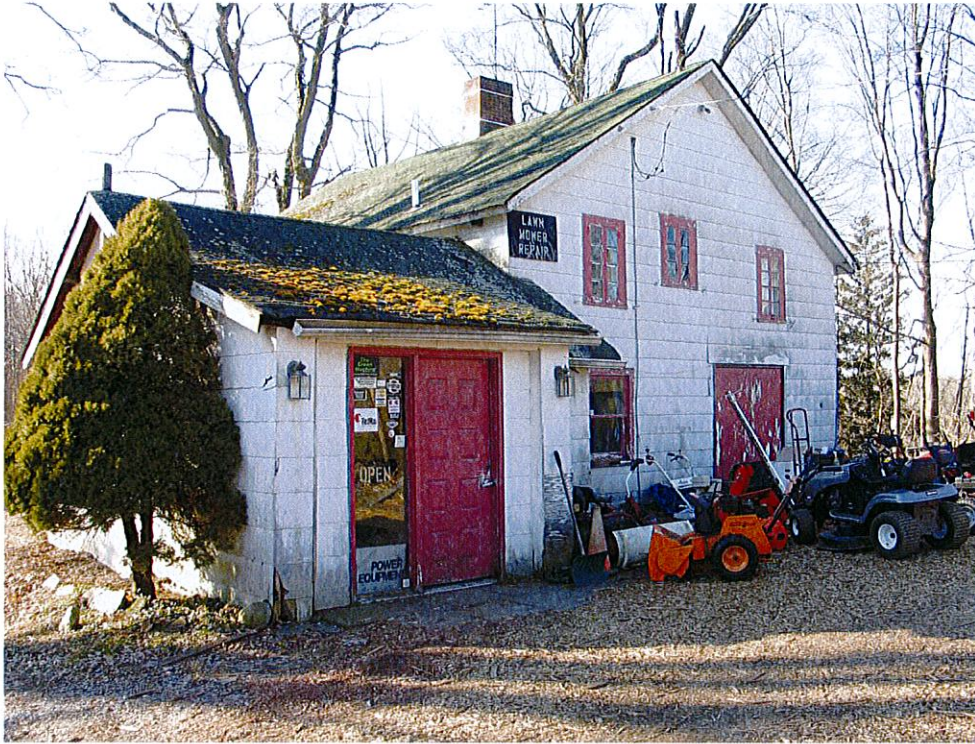
Photograph 9: Rear (north) elevation of former dwelling on Zino's Nursery and Landscaping and Anthony's Power Equipment property, now retrofitted and used to repair lawn mowers, showing office entrance on left. View looking southwest.

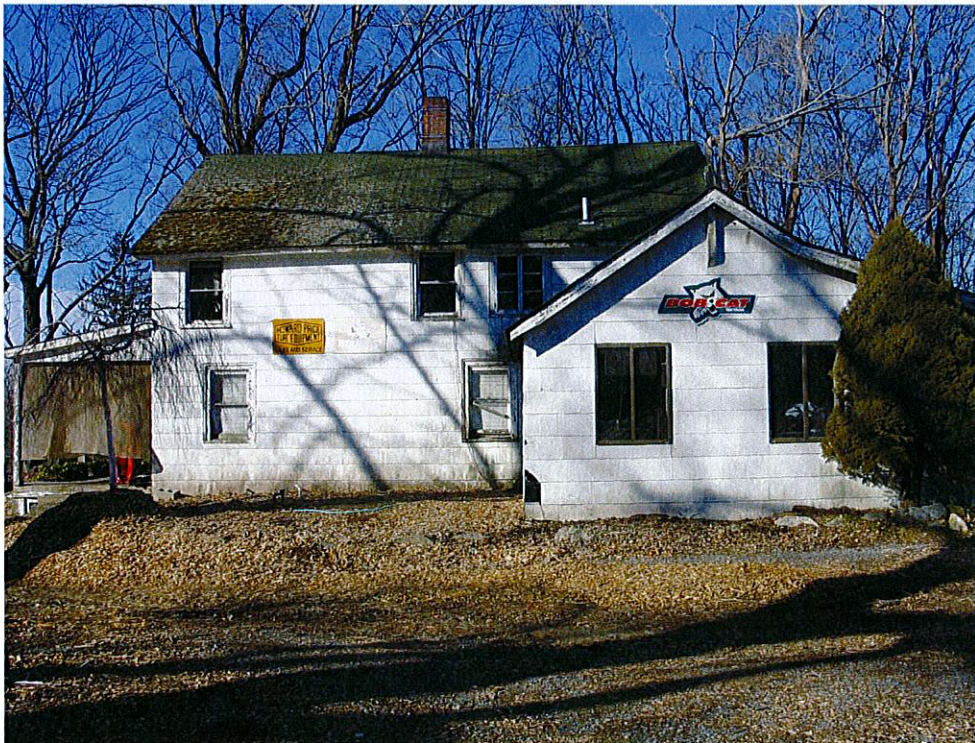
Photograph 10: Side (east) elevation of former dwelling on Zino's Nursery and Landscaping and Anthony's Power Equipment property, now retrofitted and used to repair lawn mowers, showing addition on right. View looking west.

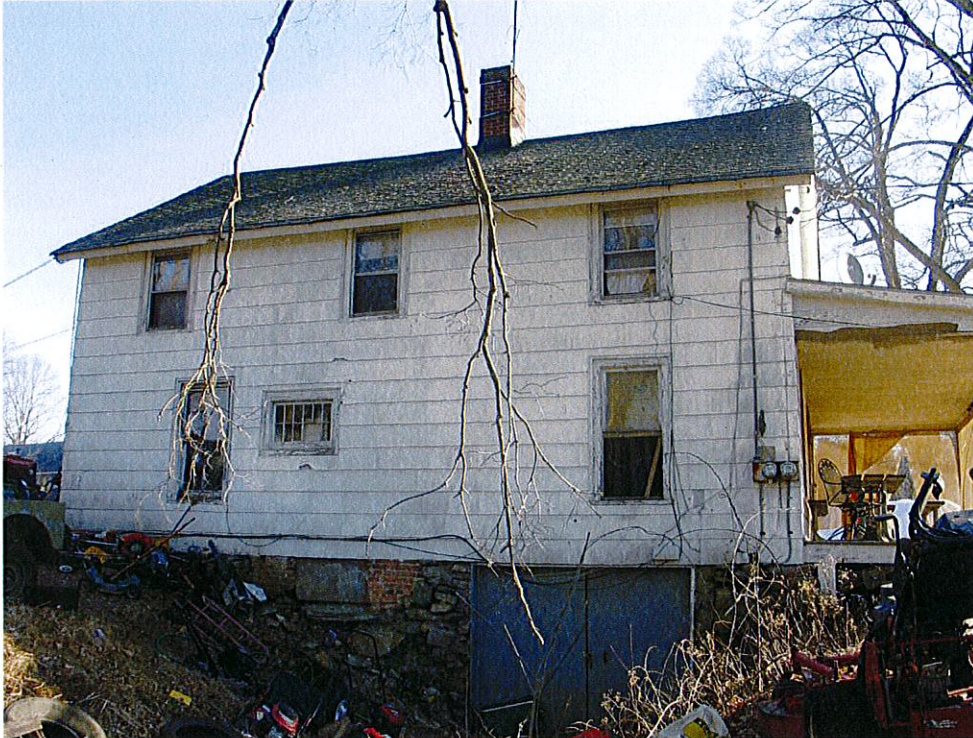
Photograph 11: Side (west) elevation of former dwelling on Zino's Nursery and Landscaping and Anthony's Power Equipment property, now retrofitted and used to repair lawn mowers, showing modified basement level. View looking east.

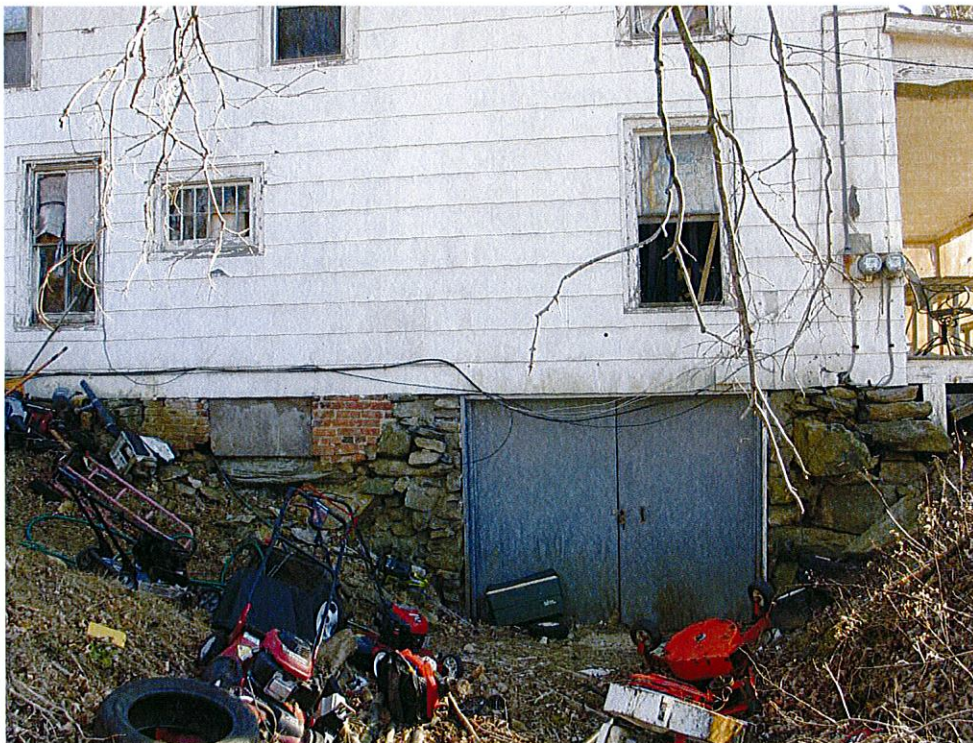
Photograph 12: Detail of side (west) elevation of former dwelling on Zino's Nursery and Landscaping and Anthony's Power Equipment property, now retrofitted and used to repair lawn mowers, showing modified basement level. View looking east.

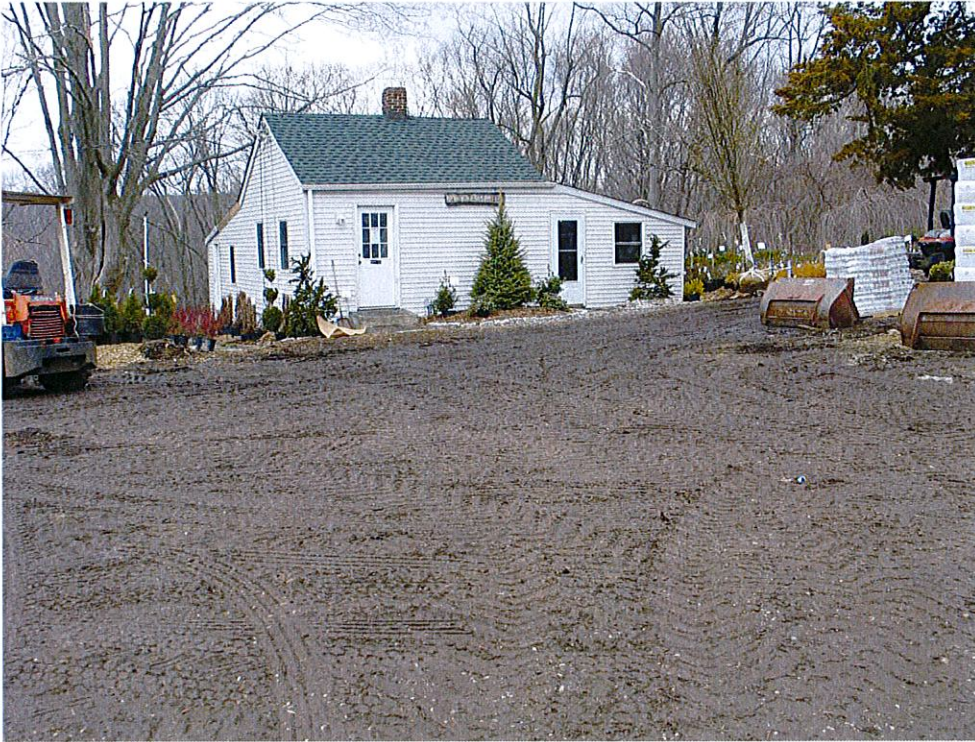
Likewise, the former workshop on the lot, now used as an office, has been very extensively modified from its original form. The foundation may be partly of stone, but is mostly obscured by vinyl siding and landscaping. A tour of the building's interior failed to illicit any additional architectural details that could help date the building, as all surfaces have been covered with drywall and other twentieth-century finishes. Mrs. Smith indicates that this building was once used by her family as an antiques shop, and had been on the property since her grandfather purchased the land.

Photograph 13: Small, one story frame building used as an office for Zino's Nursery and Landscaping. View looking northwest.

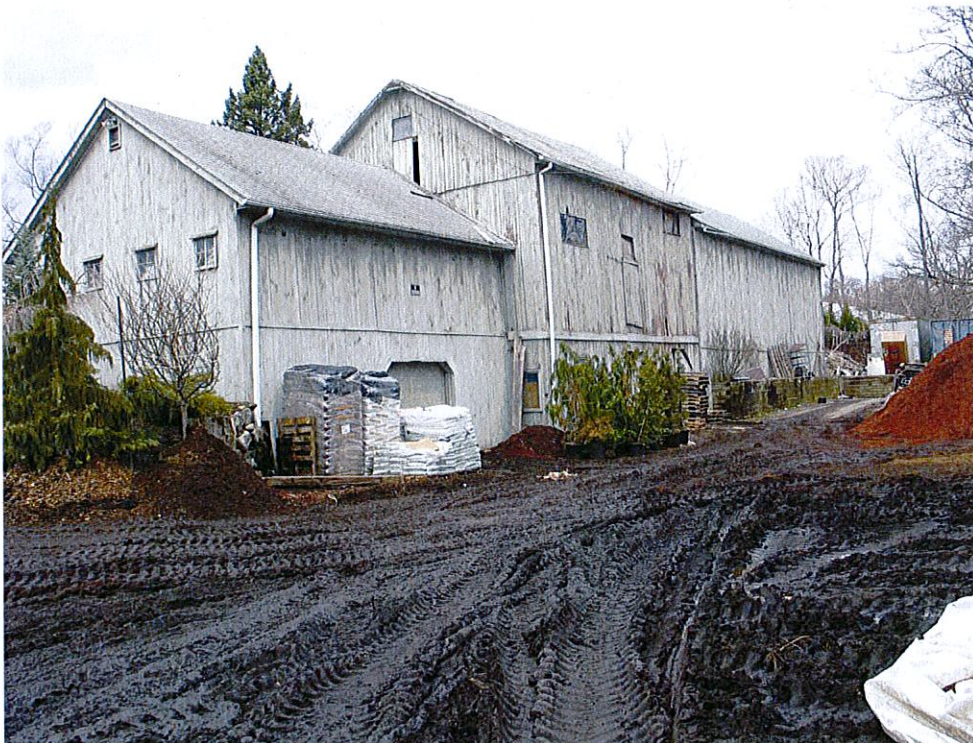
The barn on the lot may be one of the structures first shown on the 1908 map, and is definitely depicted on the 1930 map. The center section clearly is the oldest part, and has a well maintained slate roof. Mrs. Smith indicates that this section was the hay barn and housed livestock, including cows and horses. The southern part probably dates to the early to mid-twentieth century. Mrs. Smith indicates that it was once used as a carriage house. Finally, as noted in Town of Yorktown Department of Building records, the northern portion of the structure dates to 1988. That year, the existing barn was reconstructed as well.

Photograph 14: Southeastern elevation of two story frame barn, comprised of three distinct sections. View looking northwest.

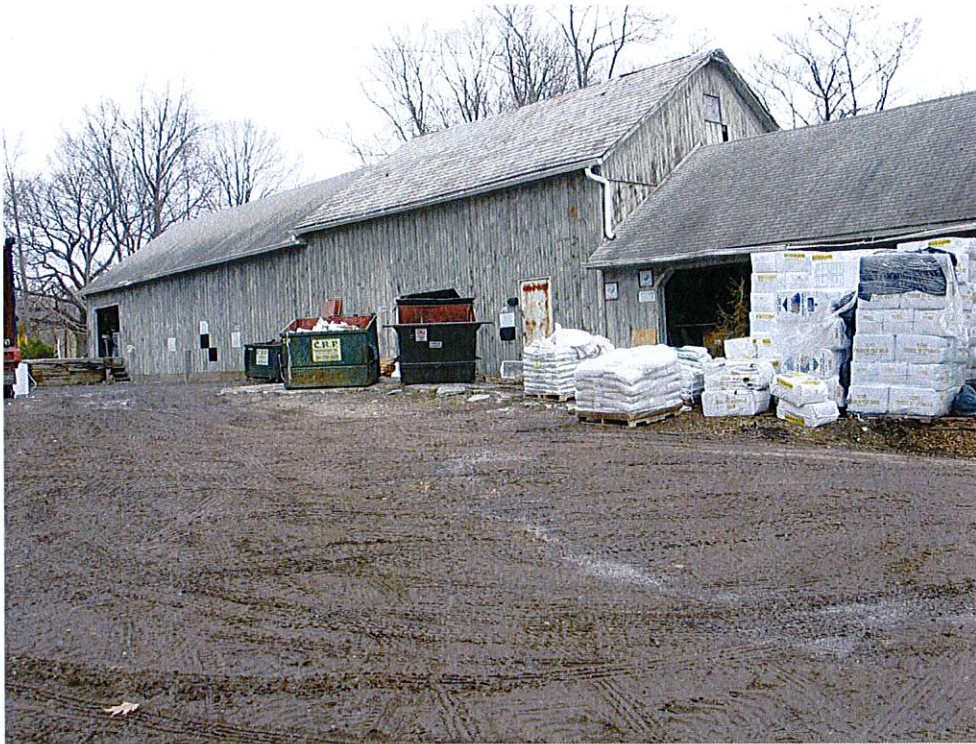
Photograph 15: Northwestern elevation of two story frame barn, comprised of three distinct sections. View looking northeast.

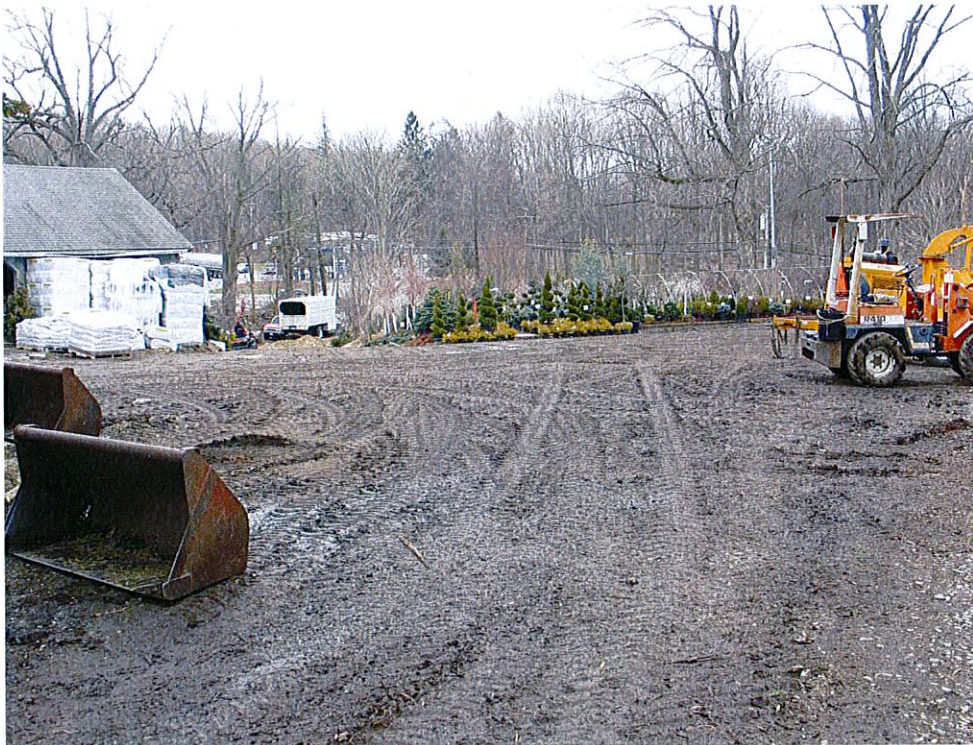
Photograph 16: Example of grounds and roads within nursery property. View looking south.

The grounds surrounding these buildings are in use as a nursery and it is clear that there has been significant earthmoving on the property to create the terraced and mulched levels of the nursery and the access roads to the buildings (Photographs 16 and 17). At the time of the site visit the ground was wet from a recent rainstorm and there was very thick mud with no vegetation on much of the parcel. The grounds contain a sewage disposal area to the west of the buildings, potable and non-potable wells, and a subgrade sprinkler system.

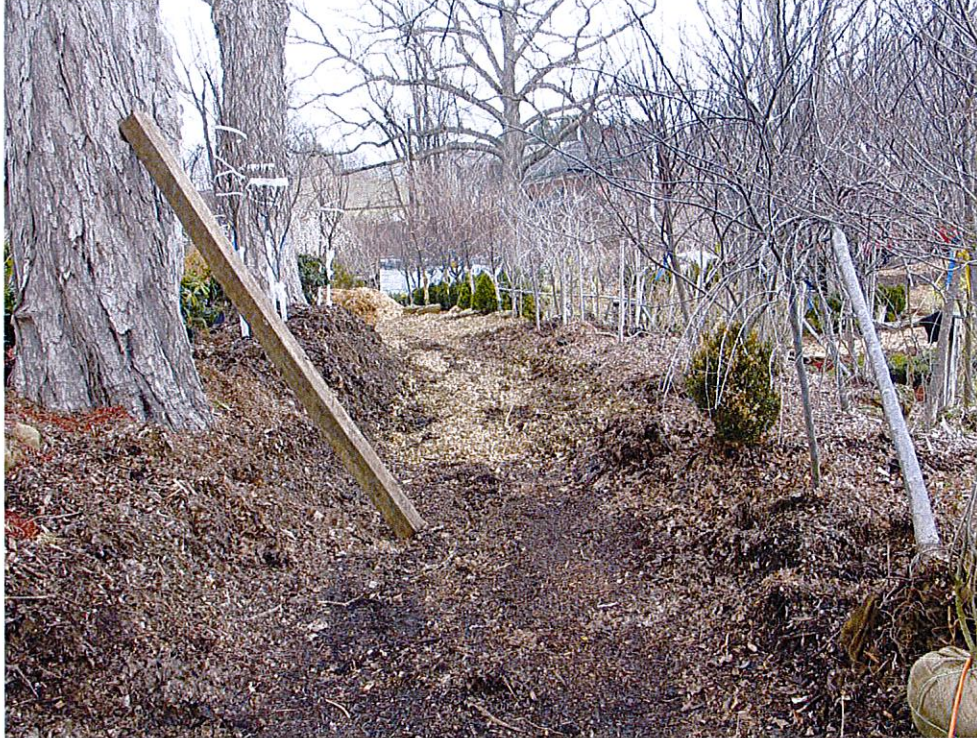
Photograph 17: Example of terraced and mulched portion of the nursery. View looking east.

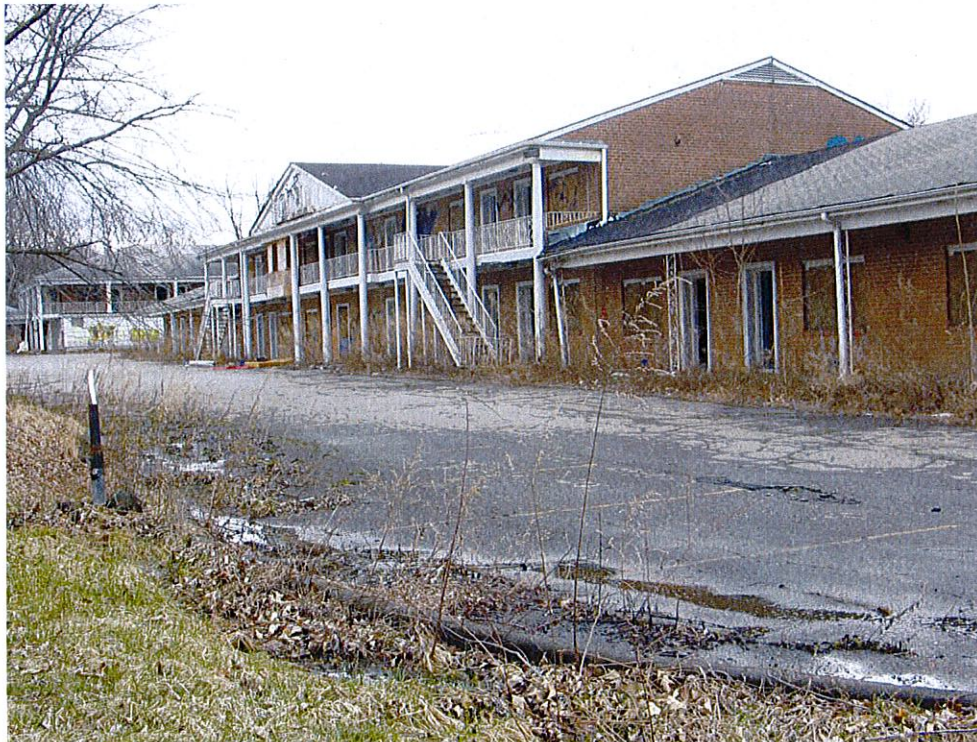
Photograph 18: Vacant motel complex showing eastern side of two former motel buildings. View looking southwest.

Parcel 26.18-1-19, within the central and northern portion of the property, contains a vacant motel complex with two former motel buildings and two sheds. The motel buildings include a former two story office and restaurant building on the south, and the main portion of the motel, also two stories, where the rooms were located, immediately to the north (Photographs 18-21). There is an asphalt parking lot surrounding these two buildings, accessed by a looped entry driveway from Crompond Road (Photograph 22). Two one-story frame structures, noted in the environmental reports as "sheds," are located to the west and southwest of these buildings, just bordering the former parking lot. The southern of the two sheds is built on a concrete slab (Photograph 23). The northern of the two sheds has a basement that contains a generator for the motel (Photograph 24). There is a septic system for the motel to the northwest of the main building, and the landform in this area is unnaturally flat and devoid of heavy vegetation (Photograph 25). According to the Phase I and Phase II environmental reports (EcolSciences 2008 and 2010), the property surrounding the former motel has been affected by infilling of a former swimming pool and two ponds to the east of the motel buildings, in an area with topographic undulations between the motel and the TSP (Photographs 26 and 27). Additionally, there has been disturbance to the north and west sides of the parcel from dumping and likely earthmoving, as evidenced by the unnatural terrain, which is undulating to the north (Photograph 28) and both mounded and flattened or terraced to the west (Photographs 29 and 30). The Phase I environmental report notes that mounding to the west of the hotel was more severe in the 1960s, when aerial photographs show distinct disturbance here. As-built plans for the motel are on file at the Town of Yorktown Department of Buildings and show that the two-story motel was constructed in 1958, and altered in 1978 and 1989. The inground swimming pool and wading pool were demolished and backfilled in 1990.

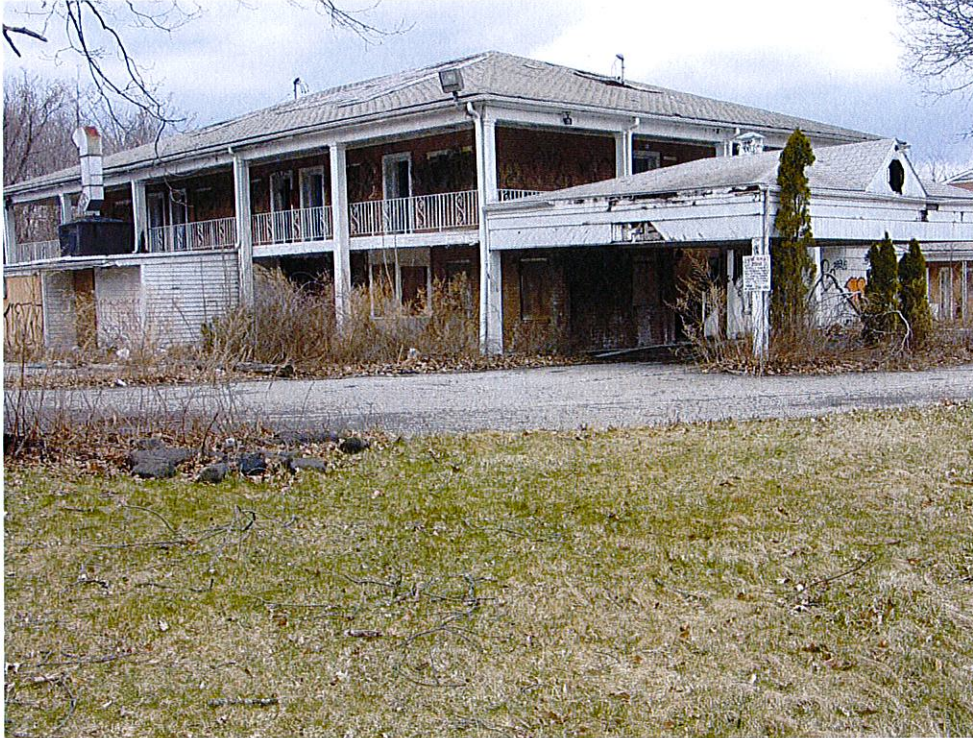
Photograph 19: Former two story office and restaurant building. View looking northwest.

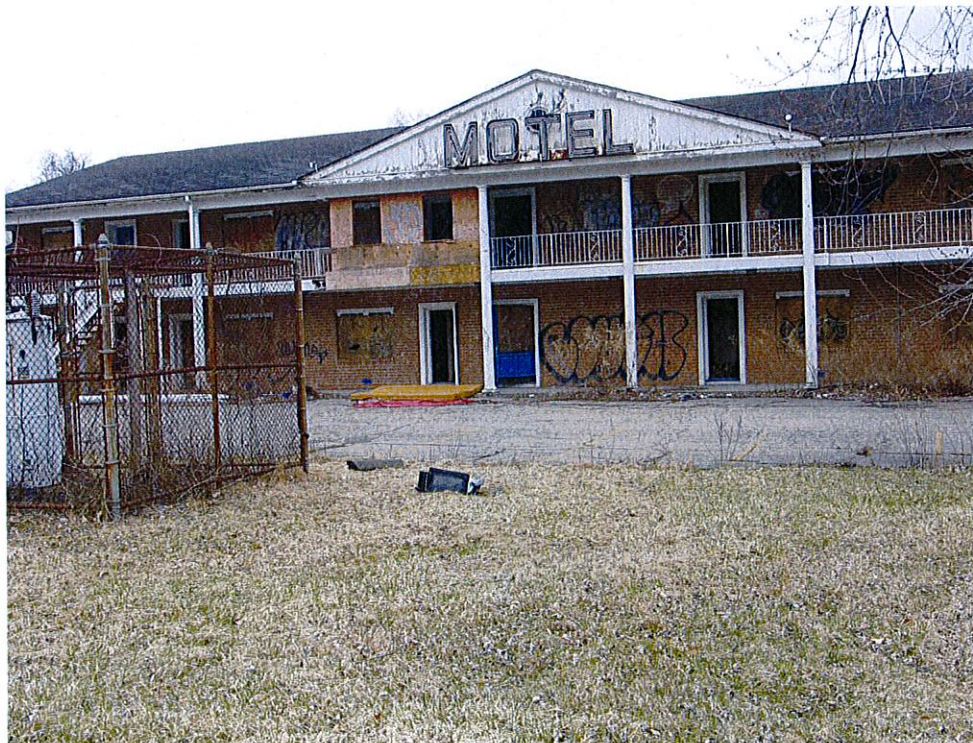
Photograph 20: Vacant motel showing eastern side of former motel building, where the rooms were located. View looking southwest.

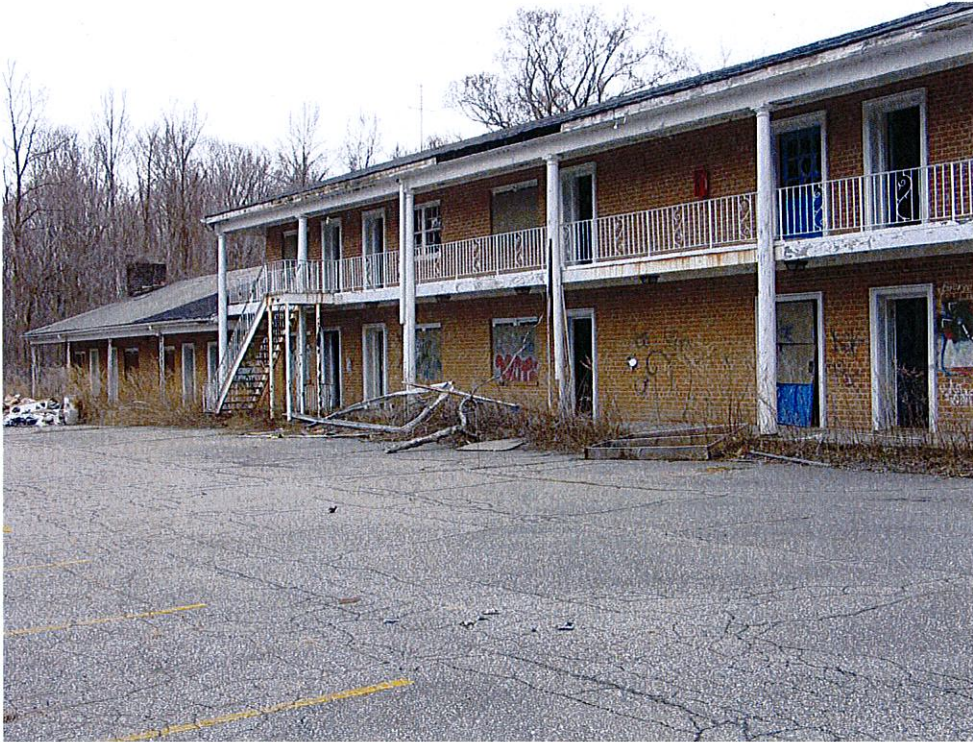
Photograph 21: Vacant motel showing western side of former motel building, where the rooms were located. View looking northeast.

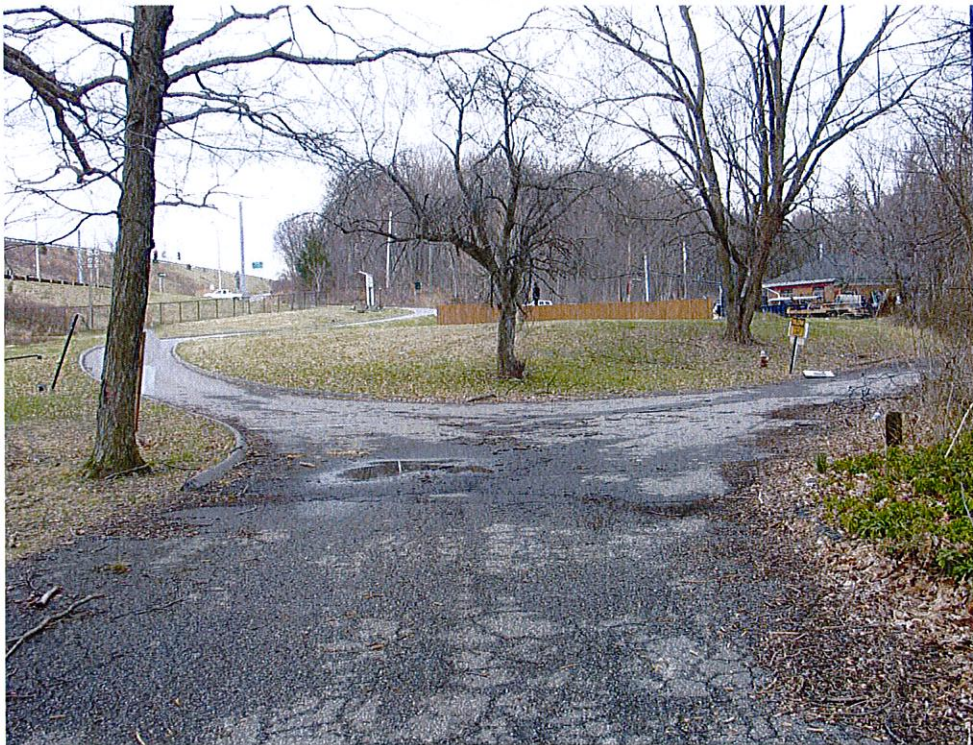
Photograph 22: Looped access driveway leading to former motel complex from Crompond Road. View looking southeast.

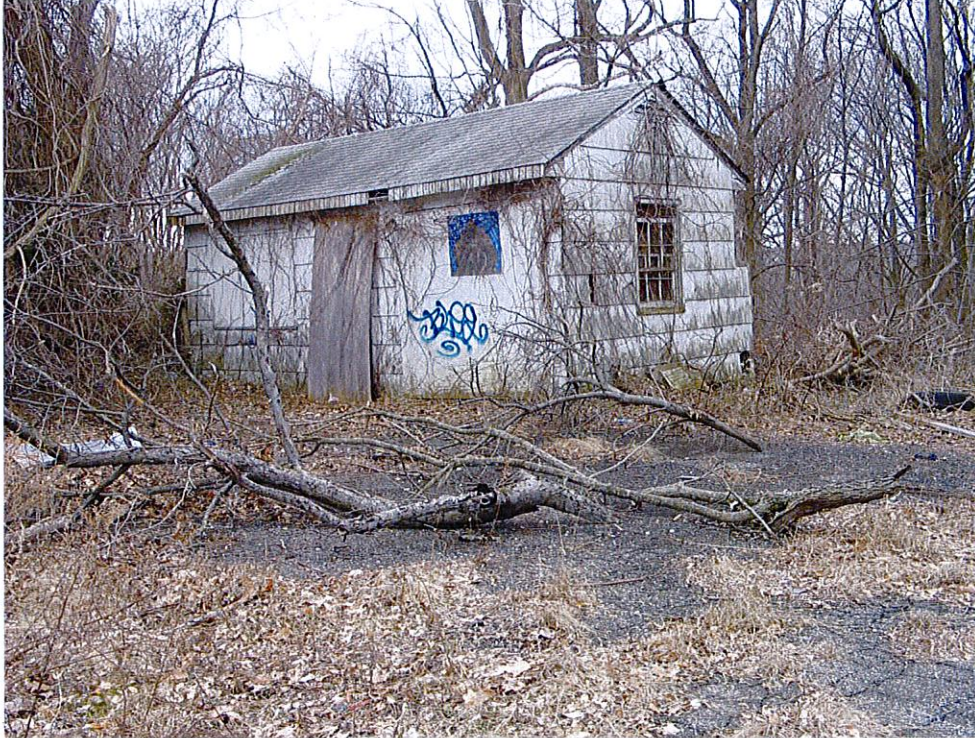
Photograph 23: One-story frame structure located to the southwest of the former motel buildings. View looking southwest.

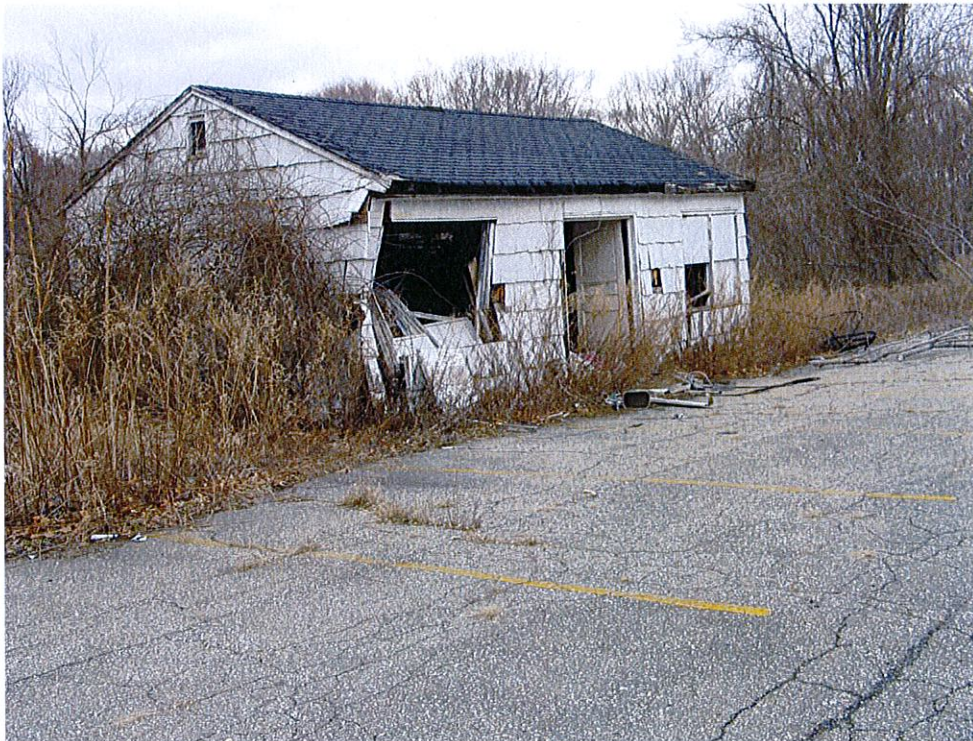
Photograph 24: One-story frame structure located to the west of the former motel complex, containing a basement with a generator for the motel. View looking northwest.

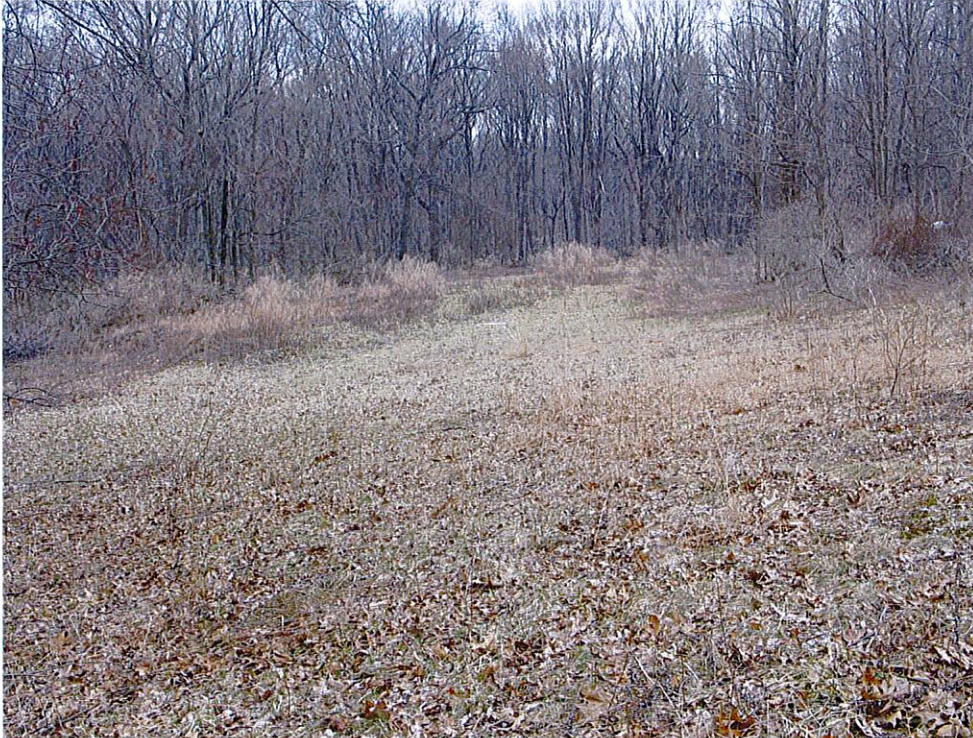
Photograph 25: Location of septic field for the former motel complex. View looking north.

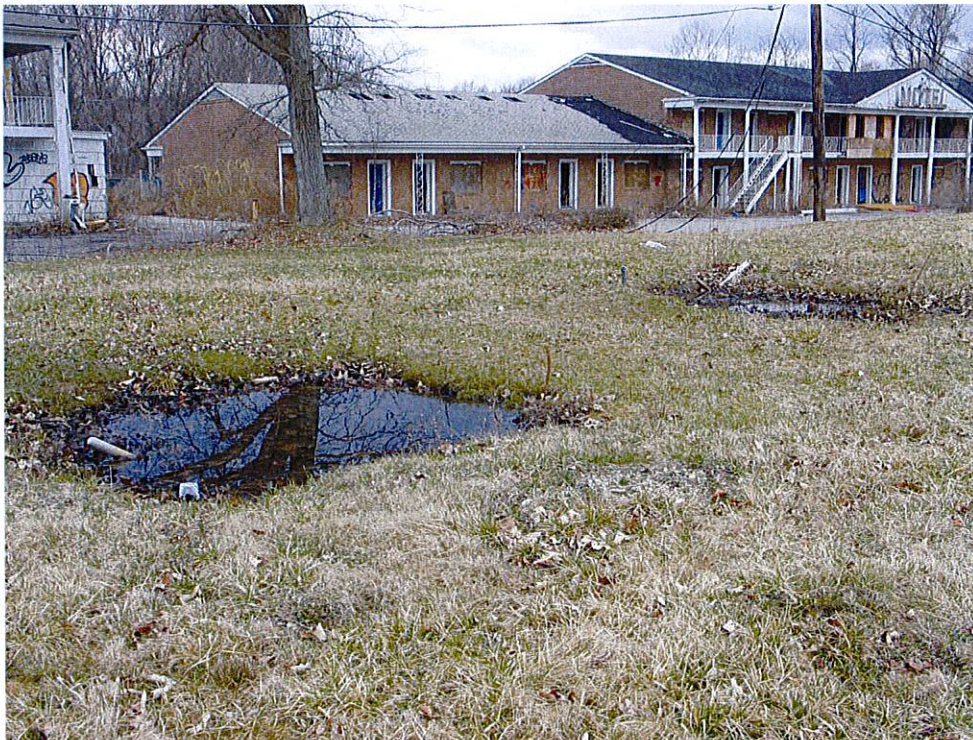
Photograph 26: Location of former swimming pool and two ponds, which have been infilled. View looking northwest.

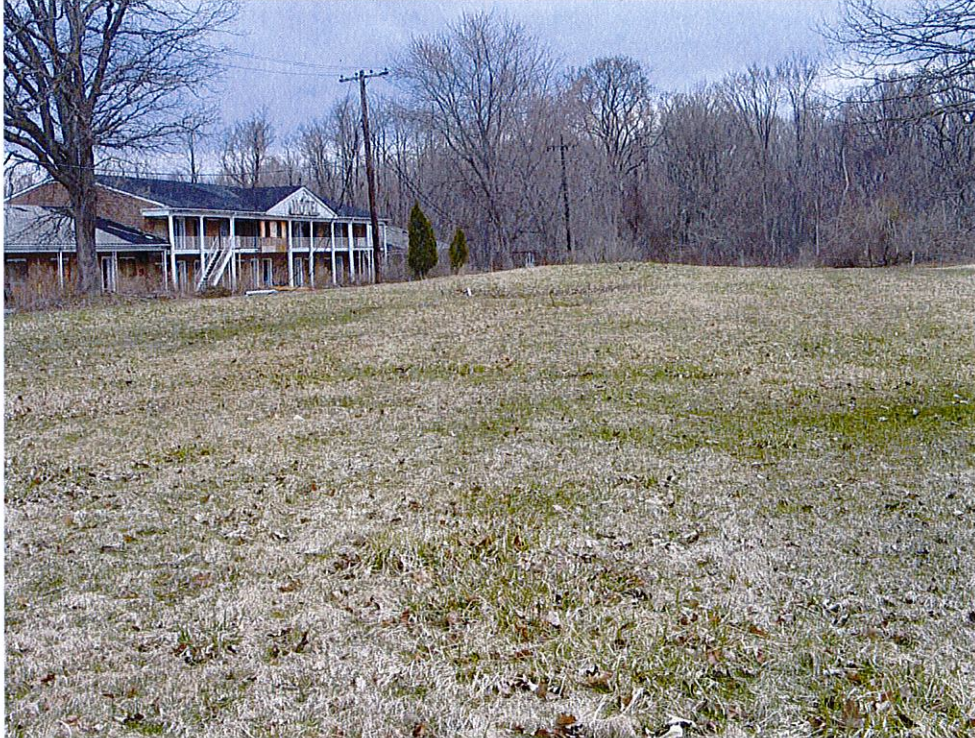
Photograph 28: Area north of former motel complex showing disturbed landform. View looking south.

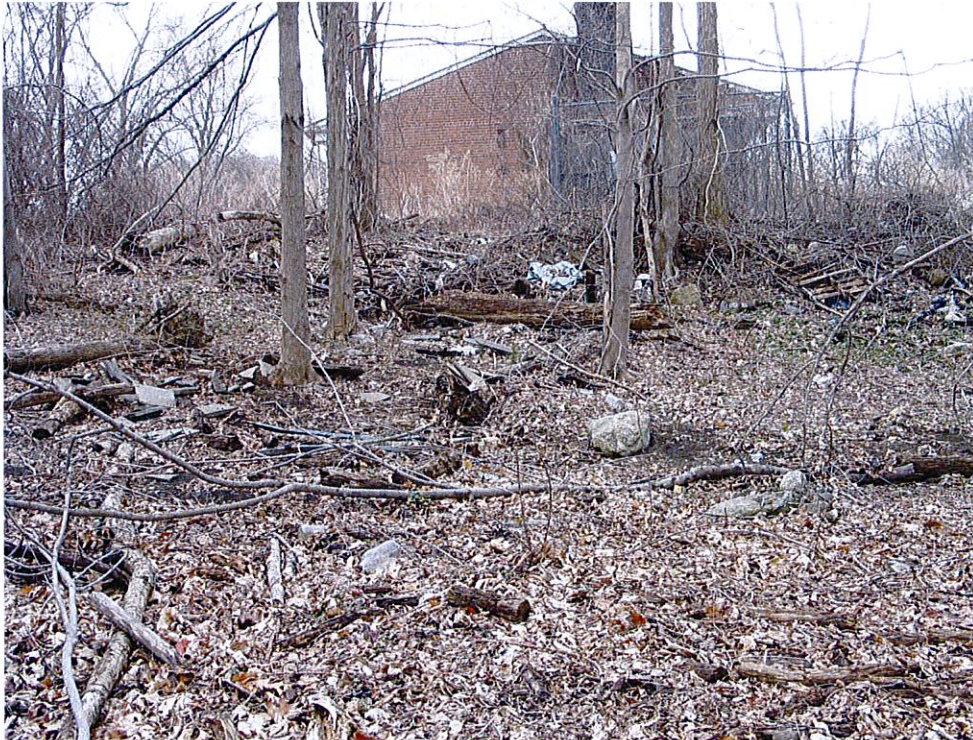
Photograph 29: Area west of former motel complex showing disturbed landform. View looking south.
