**Phase IA Archaeological and Historic Resources Assessment**  
**Costco Wholesale**  
**U.S. Route 202/N.Y. Route 35, Yorktown**  
**Westchester County, New York**

February 2012

Phase of Survey: **Phase IA Archaeological and Historic Resources Assessment**

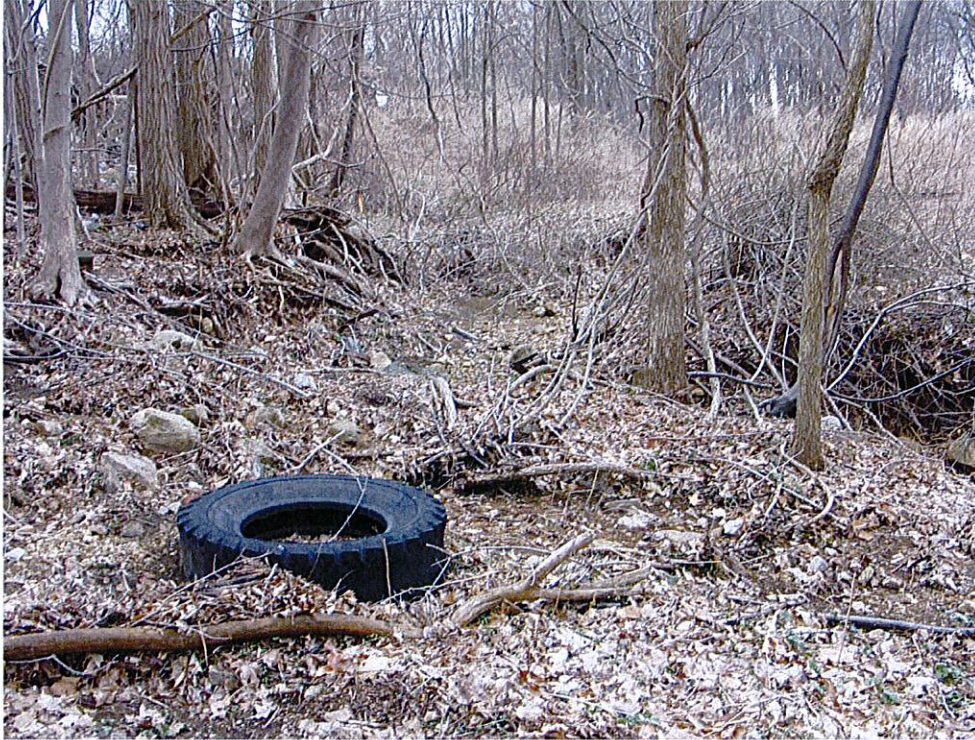
Photograph 30: Area west of former motel complex showing disturbed landform. View looking southeast.

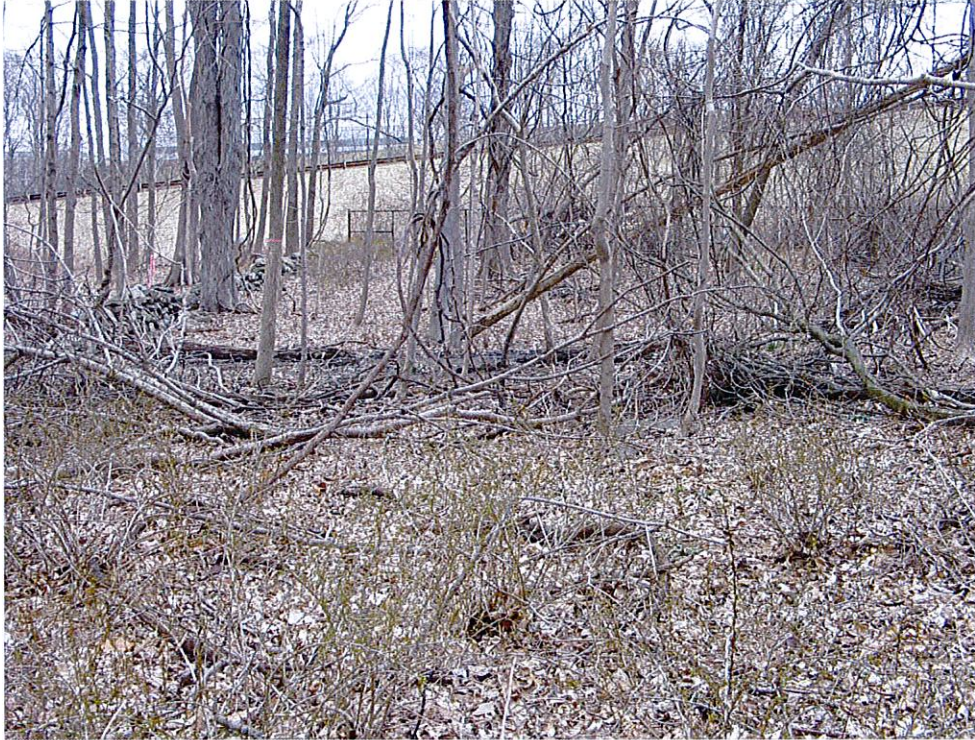
Photograph 31: Flagged wetland at northeast corner of project site. View looking northeast.

There are stone walls surrounding the motel portion of the parcel on the north and west. The northern stone wall also marks the edge of the parcel, beyond which is woodlands belonging to New York State. A small wetland has been identified at the northeast corner of the site (Photograph 31). To the west of the stone wall on the west is a sloped area leading down to the larger of the two wetlands on the site (Photographs 32 and 33). This area is wooded, but also shows evidence of dumping. The wetland is part of a tributary to Hunters Brook.

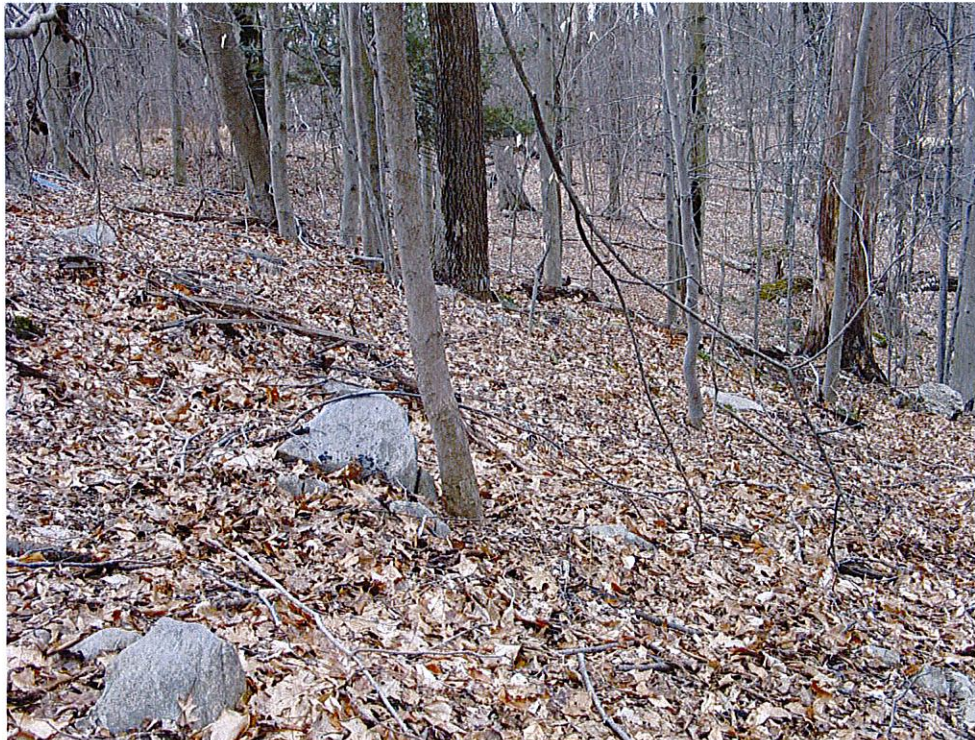
Photograph 32: Sloped area on western side of project site leading down to the larger of the two wetlands on the site. View looking south.

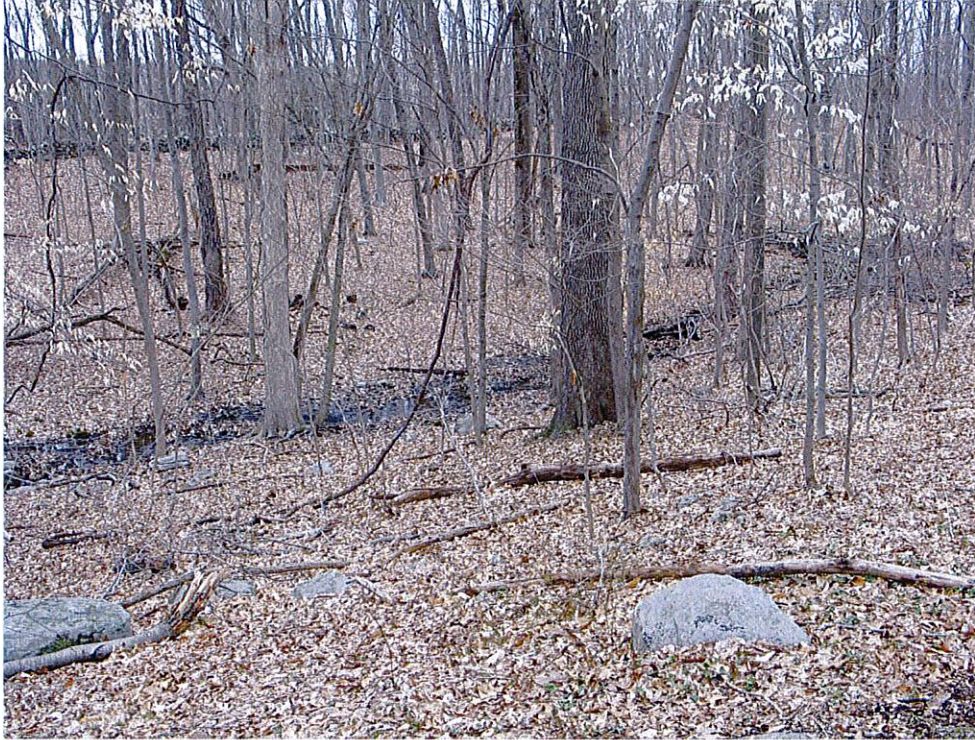
Photograph 33: Wetland on western side of project site. View looking northwest.

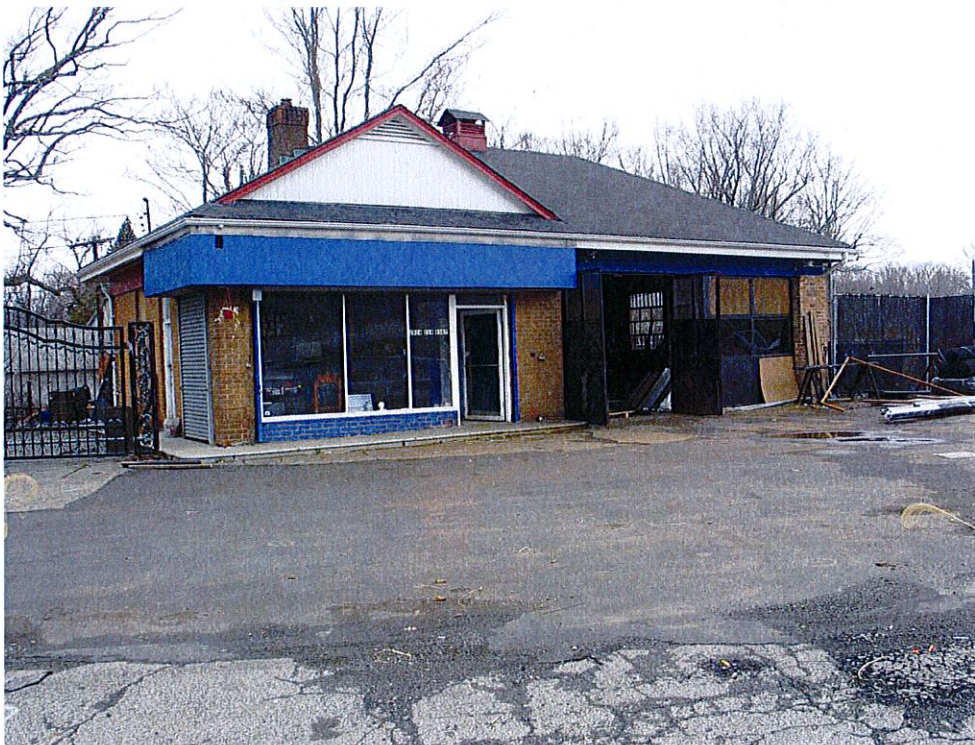
Photograph 34: Former gas station building fronting Crompond Road. View looking northwest.

Parcel 26.19-1-1, at the southeastern side of the property fronting Route 35/202, was a former gas station which is now used as a gate and fence supplier. There is a single building remaining on the lot, the former gas station, and the remainder of the parcel is paved (Photographs 34 and 35). Town of Yorktown Department of Buildings records

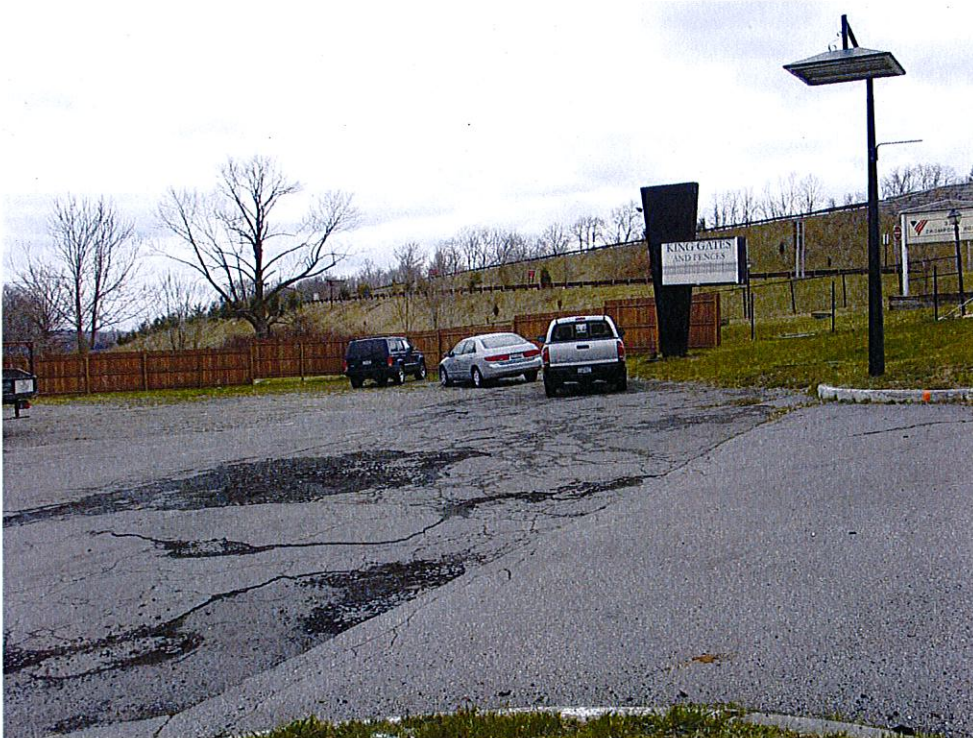
Photograph 35: Paved parking area associated with former gas station. View looking northeast, with Taconic State Parkway in background.

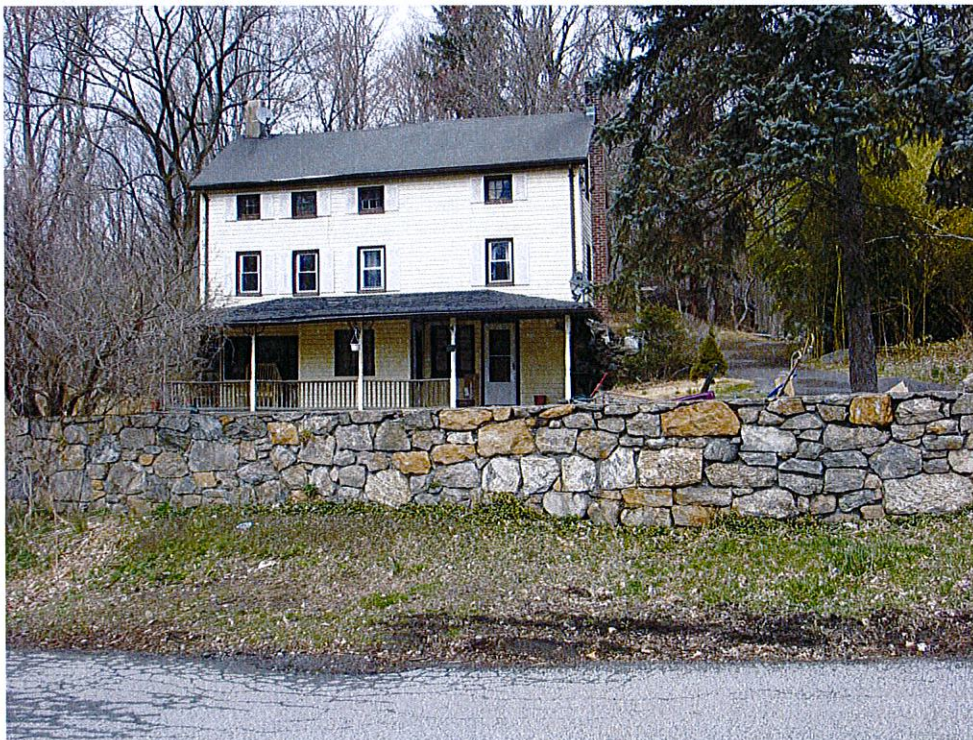
Photograph 36: Residence at 3258 Old Crompond Road, abutting the project site on the west. View looking northeast.

There are several structures along Old Crompond Road that either adjoin or are within the viewshed of the project site. Abutting the project site on the west is a dwelling at 3258 Old Crompond Road that the Town of Yorktown historic resources survey dates to ca. 1850 (Photograph 36). There are two additional residences on the opposite side of Old Crompond Road that are within the viewshed. The dwelling at 3275 Old Crompond Road also has been dated by the Town of Yorktown historic resources survey to ca. 1850, but this may be an error since it does not appear on any nineteenth century historic maps (Photograph 37). The dwelling at 3261 Old Crompond Road is of obvious modern construction and as such was not included in the Town of Yorktown historic resources survey (Photograph 38). The only structure on Crompond Road (Route 202/35) within the viewshed is a modern Mobil gasoline station immediately across the street from the project site (Photograph 39).

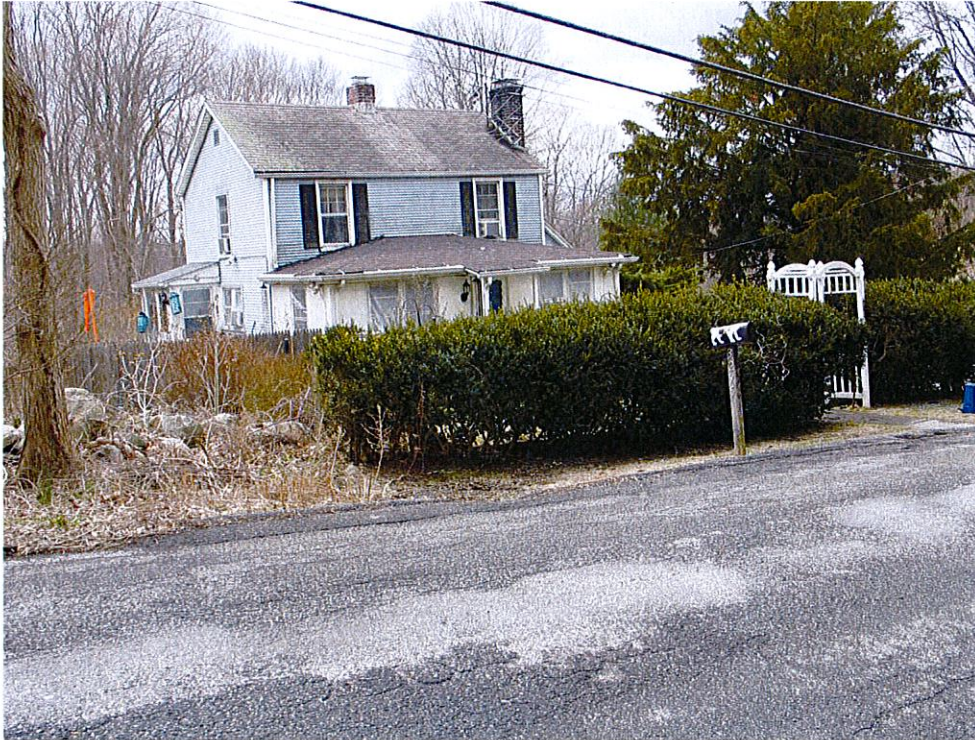
Photograph 37: Residence at 3275 Old Crompond Road, across the street and within the viewshed of the project site. View looking southwest.

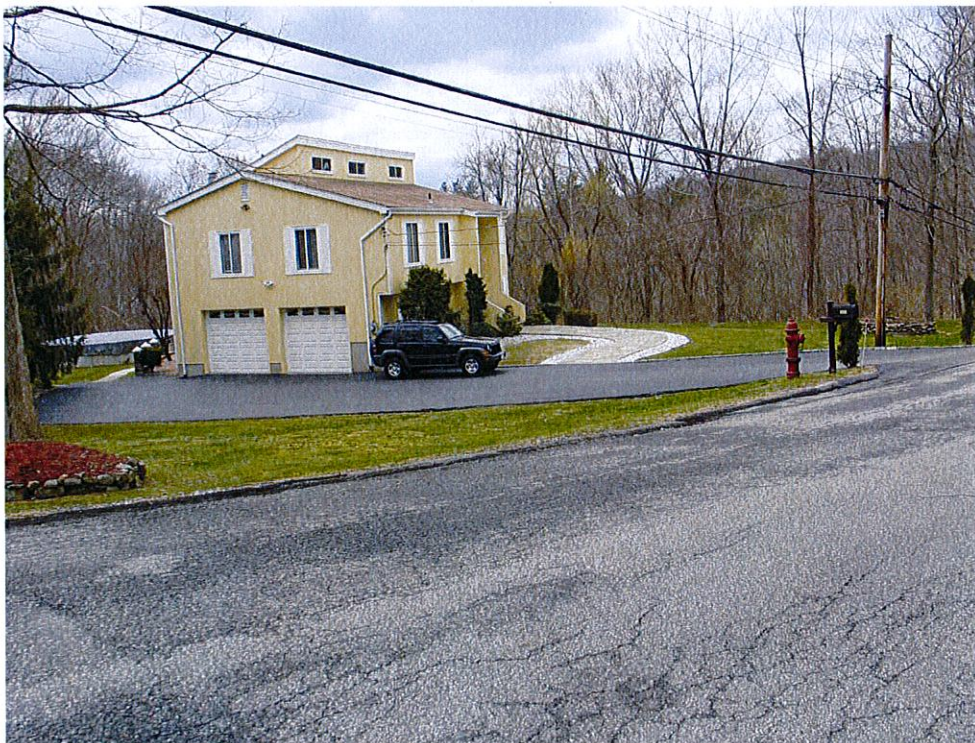
Photograph 38: Residence at 3261 Old Crompond Road, across the street and within the viewshed of the project site. View looking southwest.

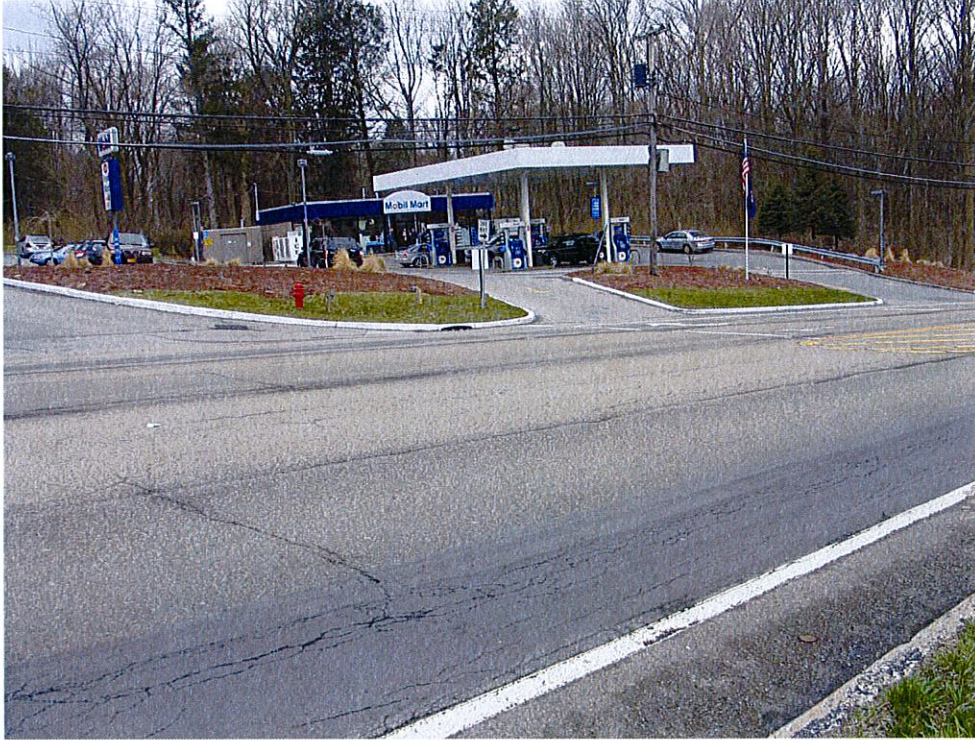
Photograph 39: Mobil gas station across the street from the project site on Crompond Road. View looking southeast.

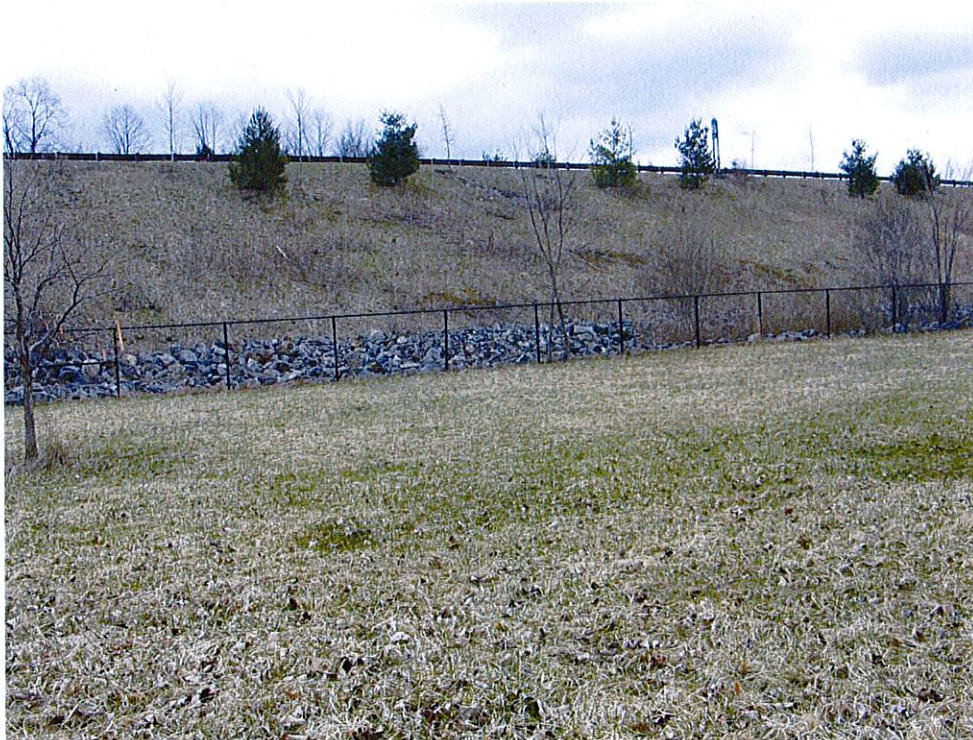
Photograph 40: Taconic State Parkway situated approximately 35-40 feet above the eastern side of the project site, with a steep, fenced embankment separating the highway from the project site. View looking southeast.

- Appropriate landscaping should be introduced on the east side of the project site at the rear of the warehouse building abutting the parkway to shield the viewshed of the parkway traveler as much as possible. The conceptual landscaping plan for the project proposes an extensive planting zone within the TSP right-of-way immediately east of the project site boundaries, in coordination with the DOT, which is intended to screen the development from the roadway.

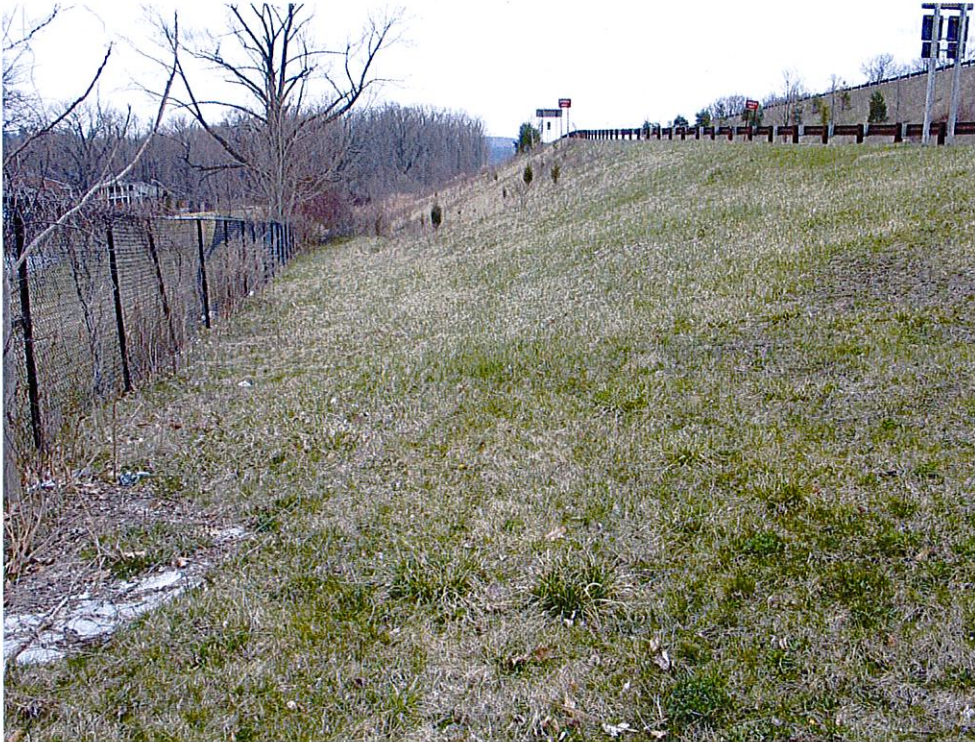
Photograph 41: Detail of embankment separating the Taconic State Parkway from the project site. View looking northwest.

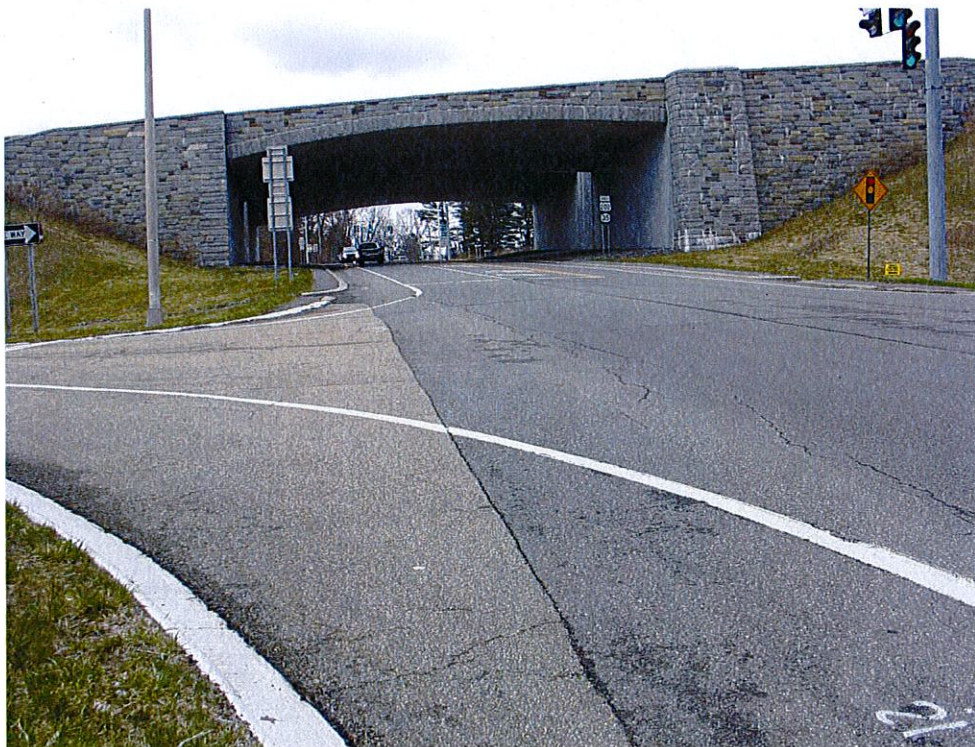
Photograph 42: Bridge carrying the Taconic State Parkway over Route 202/35, which was replaced in 2003-2006.
