3.3 Vegetation

YORKTOWN FARMS
TOWN OF YORKTOWN
WESTCHESTER CO., N.Y.
APRIL 14, 2004
SHEET OF SHEETS

Figure 3.3-5: Proposed Undisturbed Areas
Yorktown Farms Subdivision
Town of Yorktown, Westchester County, New York
Source: Ralph G. Mastromonaco, P.E., P.C., rev. 10/26/04
Scale: As shown

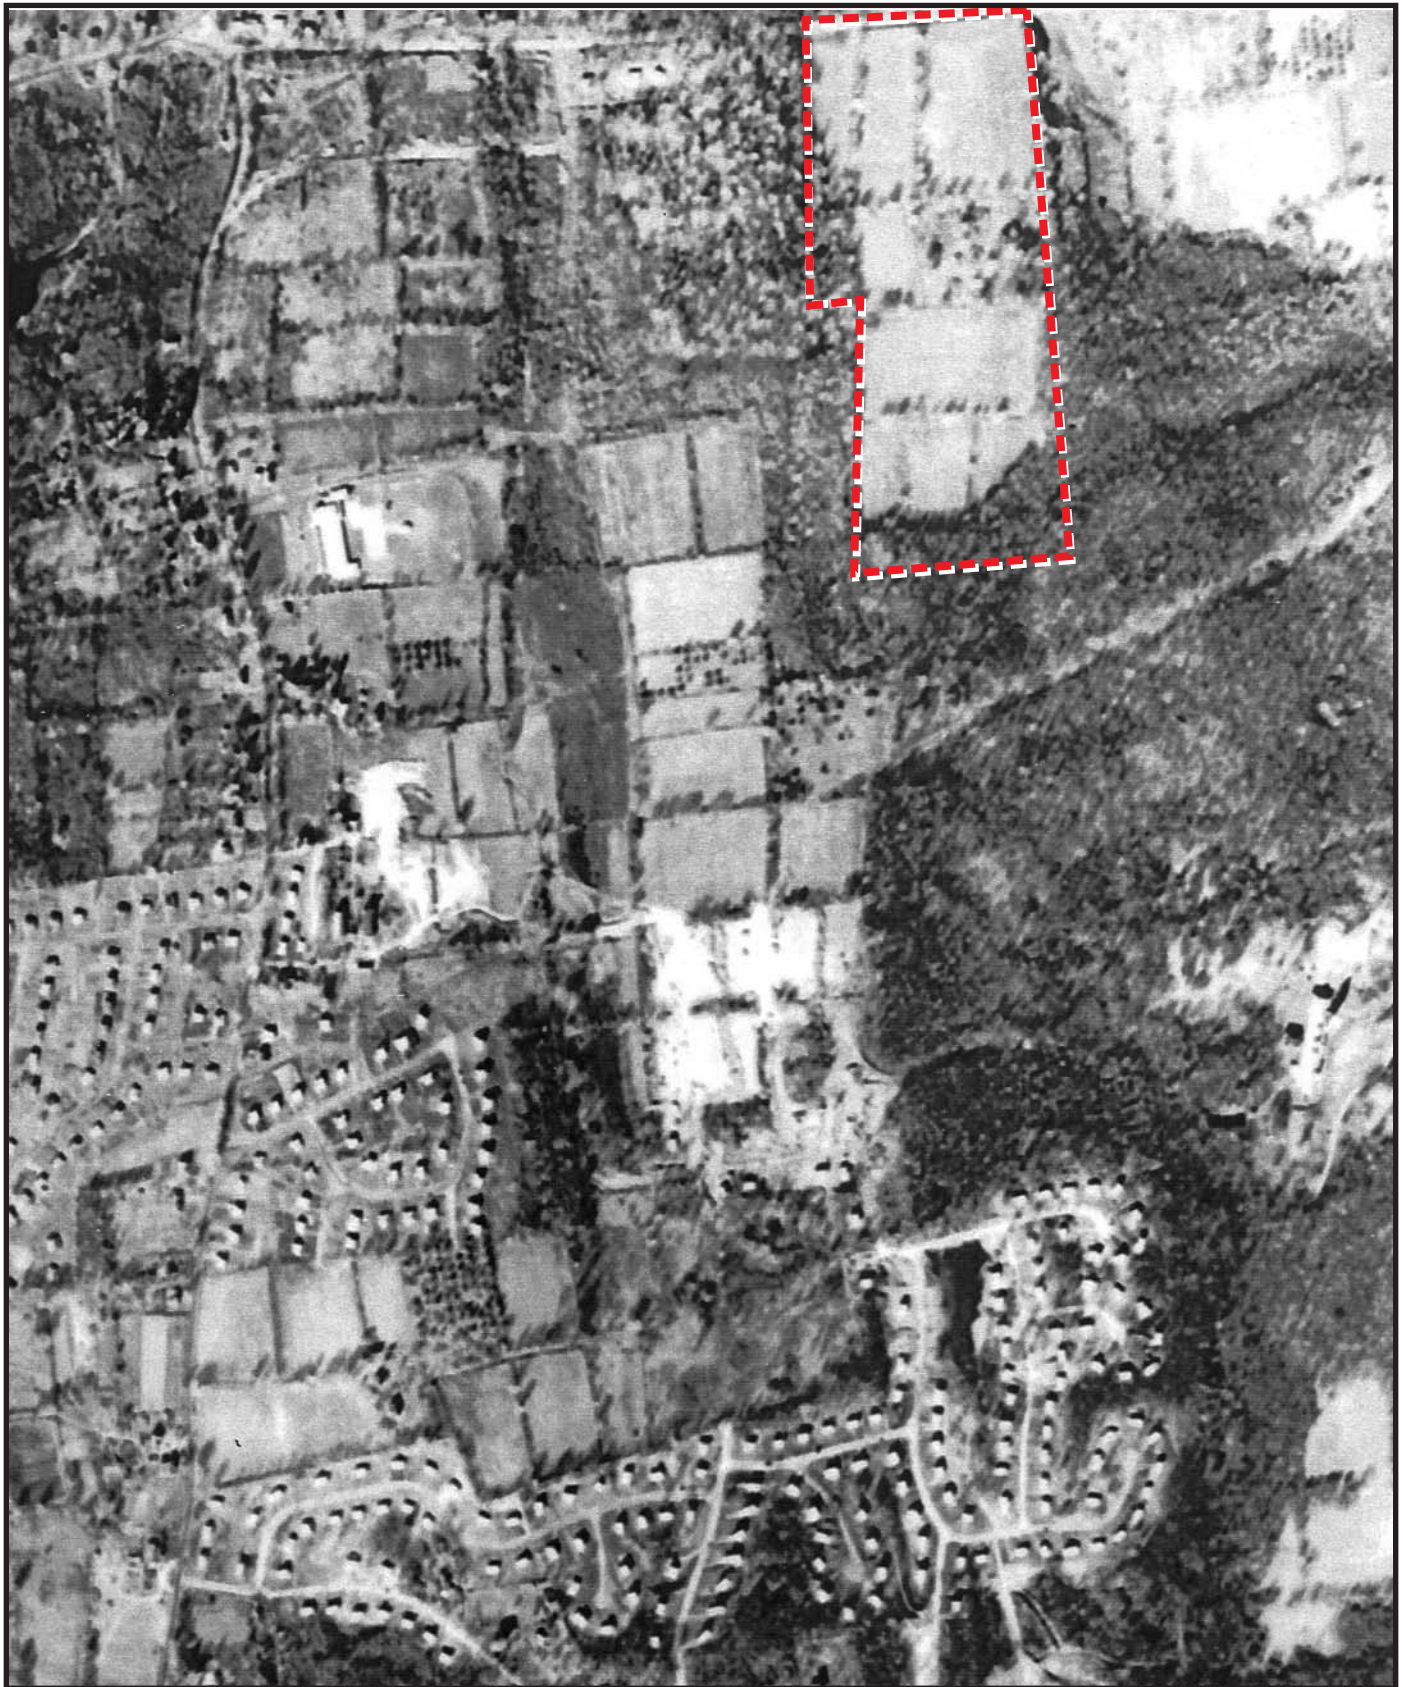
Figure 3.3-1. 1960 Aerial Photograph
Route 6 Property
Town of Yorktown, Westchester County, New York
Source: E Data Resources, Inc.
Scale: 1" = 833'

Based on aerial photography available from Westchester County, the New York State DEC and private sources, the site was used for agricultural purposes through at least 1960 (Figure 3.3-1). At that time, approximately 90 percent of the site was mowed or used as pasture, with the exception of the wet and more steeply sloped area in the southeast corner of the site. Subsequent aerial photos (Figure 3.3-2, from 1974, and Figure 3.3-3, from 1993) show the transition of parts of the site from agricultural fields to wooded areas.

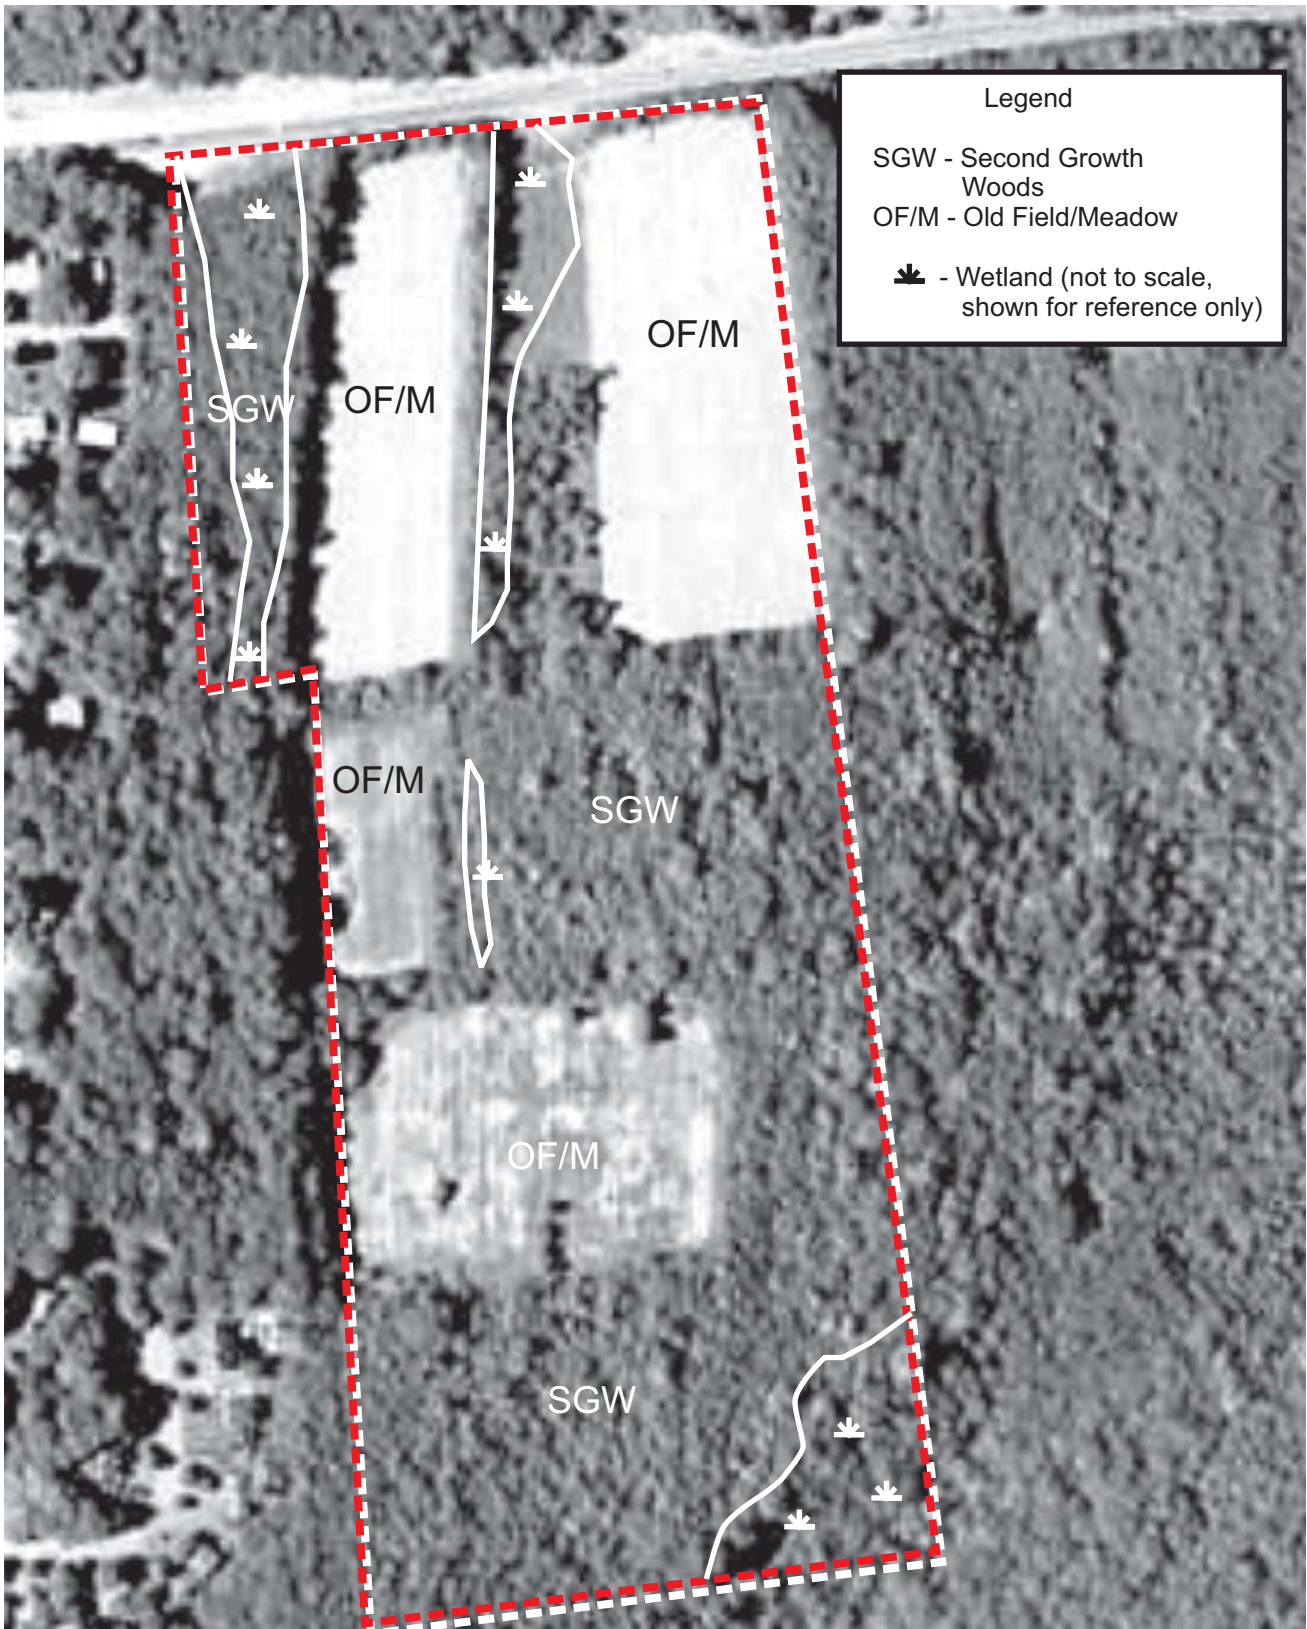
Figure 3.3-4. Vegetative Associations
 Yorktown Farms
 Town of Yorktown, Westchester County, New York
 Source: Westchester County 1993 Aerial Photo
 Scale: 1" = 655'

There are two general vegetation types present on the property: second growth hardwood forest and old field meadow. The hardwood forest is divided somewhat into areas of dry substrate versus areas where depressional areas and/or intermittent watercourses result in a moist substrate that supports a shrub and herbaceous layer that is tolerant of wet conditions. The locations of these associations are indicated on Figure 3.3-4, Vegetative Associations.

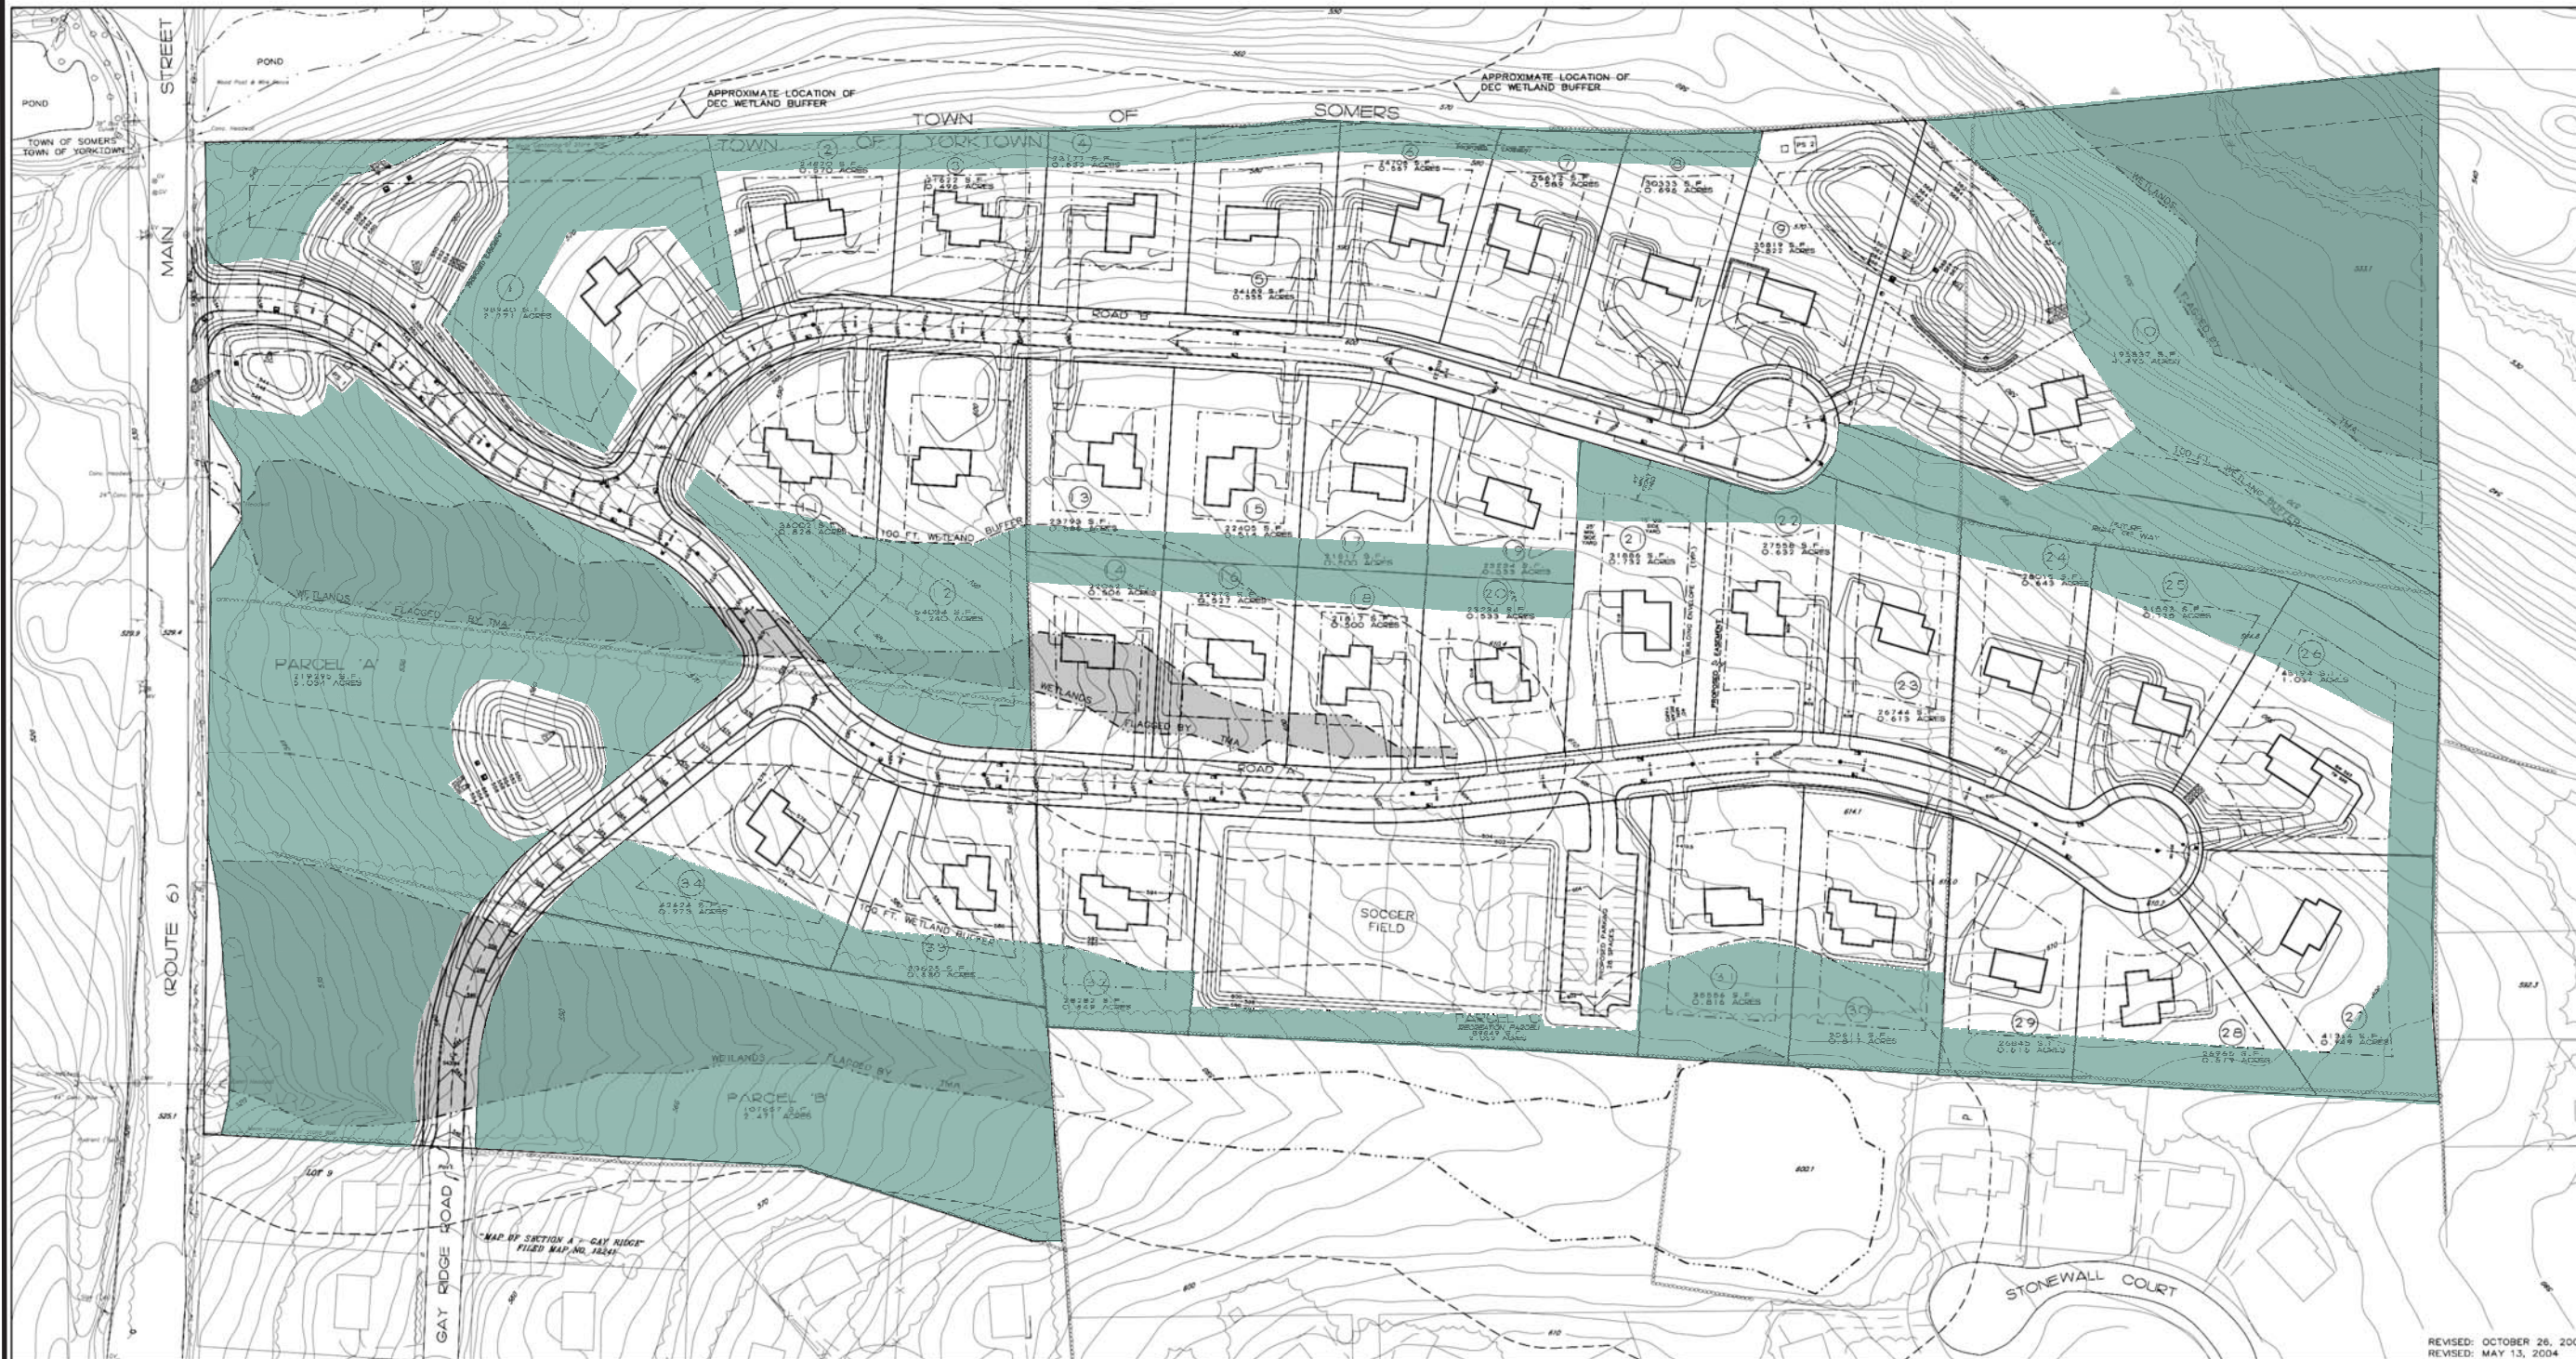
As shown on Table 3.3-1, this project will result in the alteration of the vegetative character of a portion of this property, and the elimination of vegetation from those areas that will become impervious surfaces. Up to 12.8 acres of upland forest vegetation will be removed as a result of the proposed project, and 11.1 acres of open meadow will be removed. A total of 24.7 acres of the site will be affected as a result of clearing and grading necessary for the creation of a residential subdivision on this parcel (Figure 3.3-5).
