**ALTERNATIVES ANALYSIS**  
**FLORAL VILLA**  
**SOUNDVIEW- UNDERHILL FARM PROJECT**

370 UNDERHILL AVENUE  
YORKTOWN HEIGHTS, WESTCHESTER COUNTY, NEW YORK

July 2021

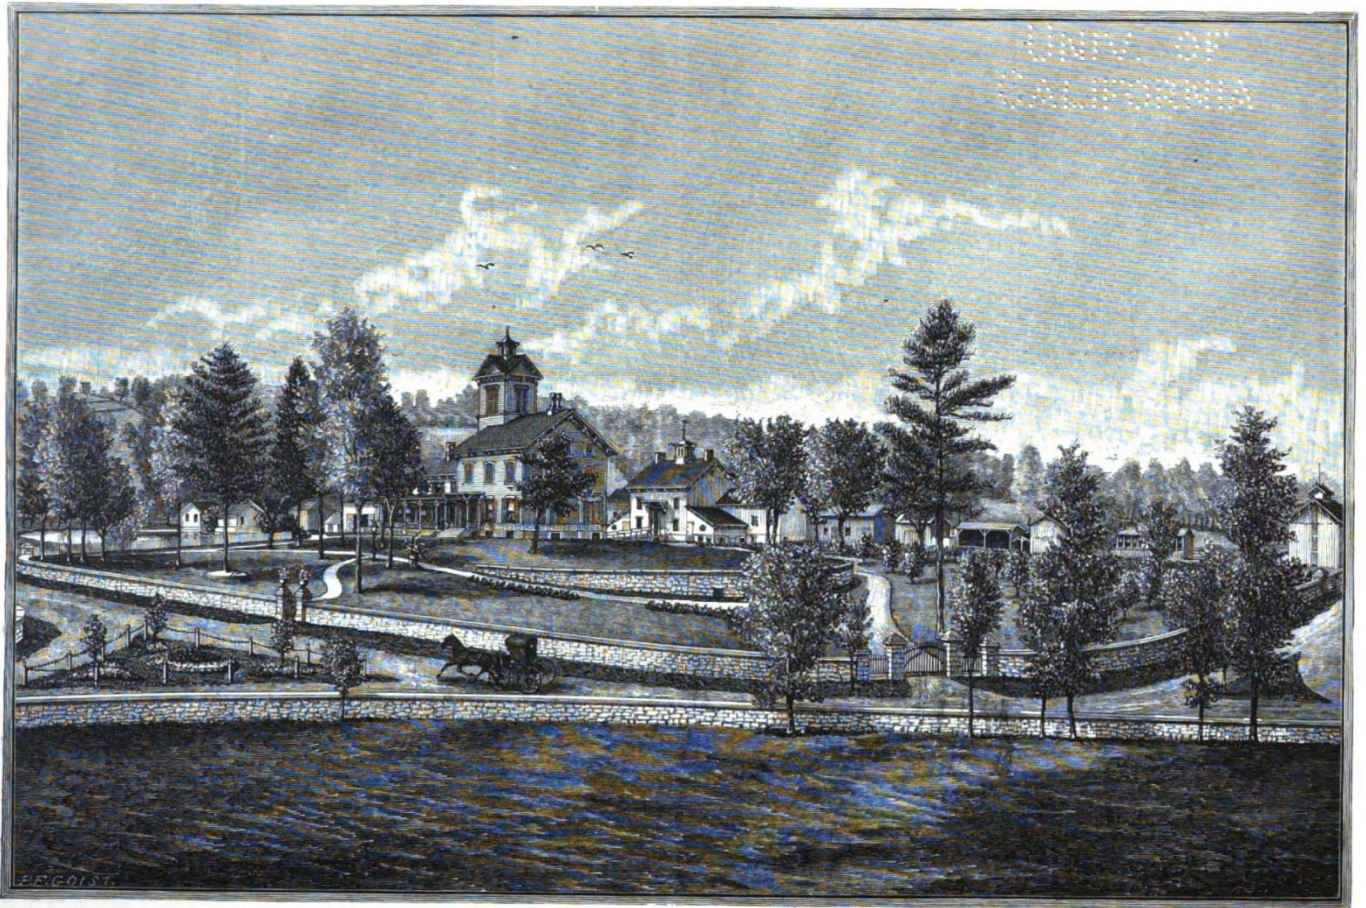
Figure 4: 1886 Lithograph of the Edward B Underhill Estate. (Source: Scharf 1886).

“FLORAL VILLA.”  
RESIDENCE OF EDWARD B. UNDERHILL,  
YORKTOWN, WESTCHESTER CO., N. Y.

Edward Underhill passed away in 1888. At that time, his estate included livestock barn, storage and hay barns and several other outbuildings. The lithograph of the Floral Villa, published in 1886, shows several lean-to, a pig-sty and a small boat house by the pond. This lithograph (Figure 4) also shows a series of stone lined paths around the buildings with wrought iron gates at the access to Underhill Avenue.

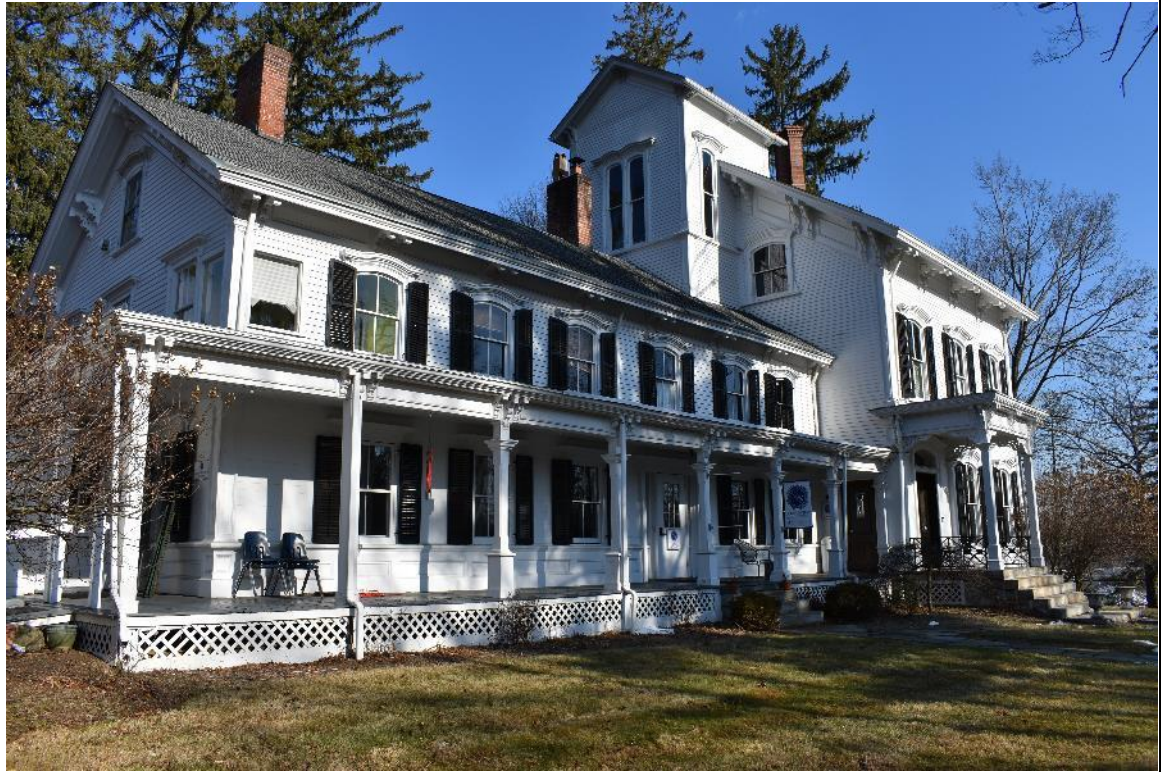
Building A is in good condition and is going to be retained as part of the proposed project. The proposed rehabilitation efforts are principal aspect of this overall project.

1. Underhill Estate/Sound view School (Building A). View to the northeast.

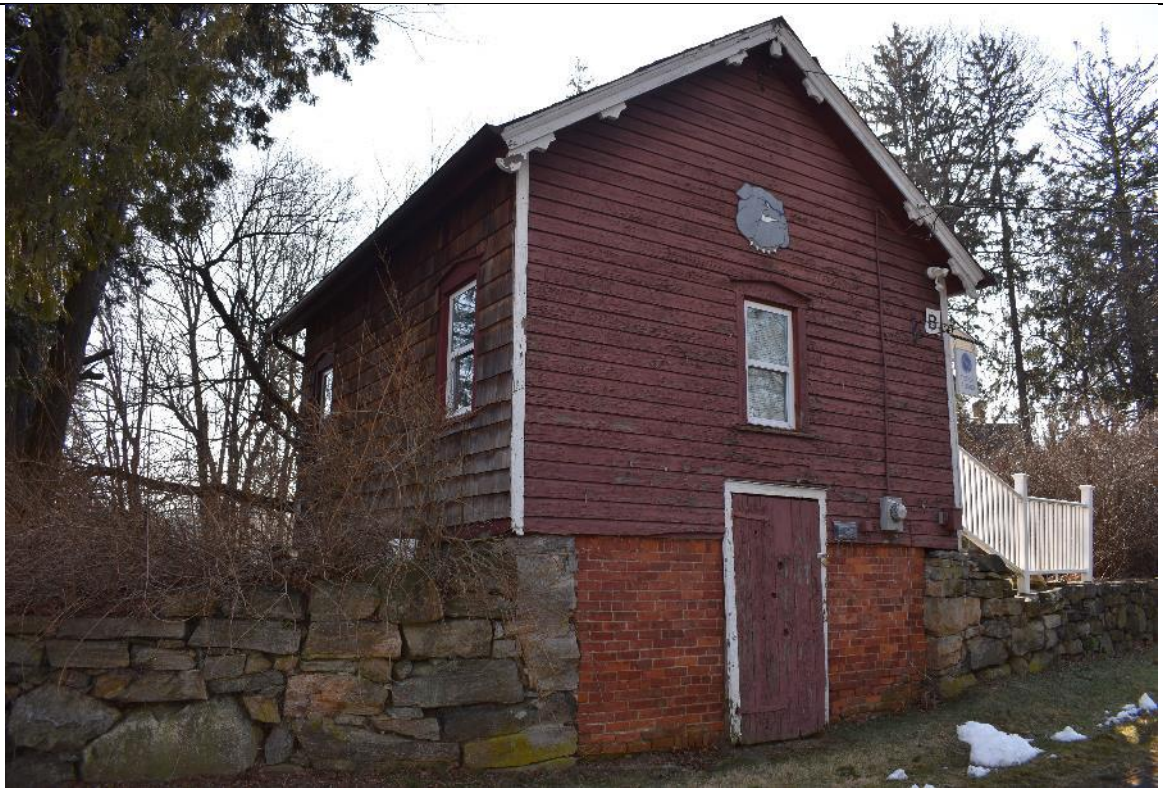
The historic integrity of the building has been modified substantially in the past 30-50 years, to the extent that the original purpose of the building cannot be identified. The structural integrity of this building is considered poor to fair. The stability of the foundation would need to be improved, to meet existing building codes.

2. A small storage building (Building B) served as the School's design studio.

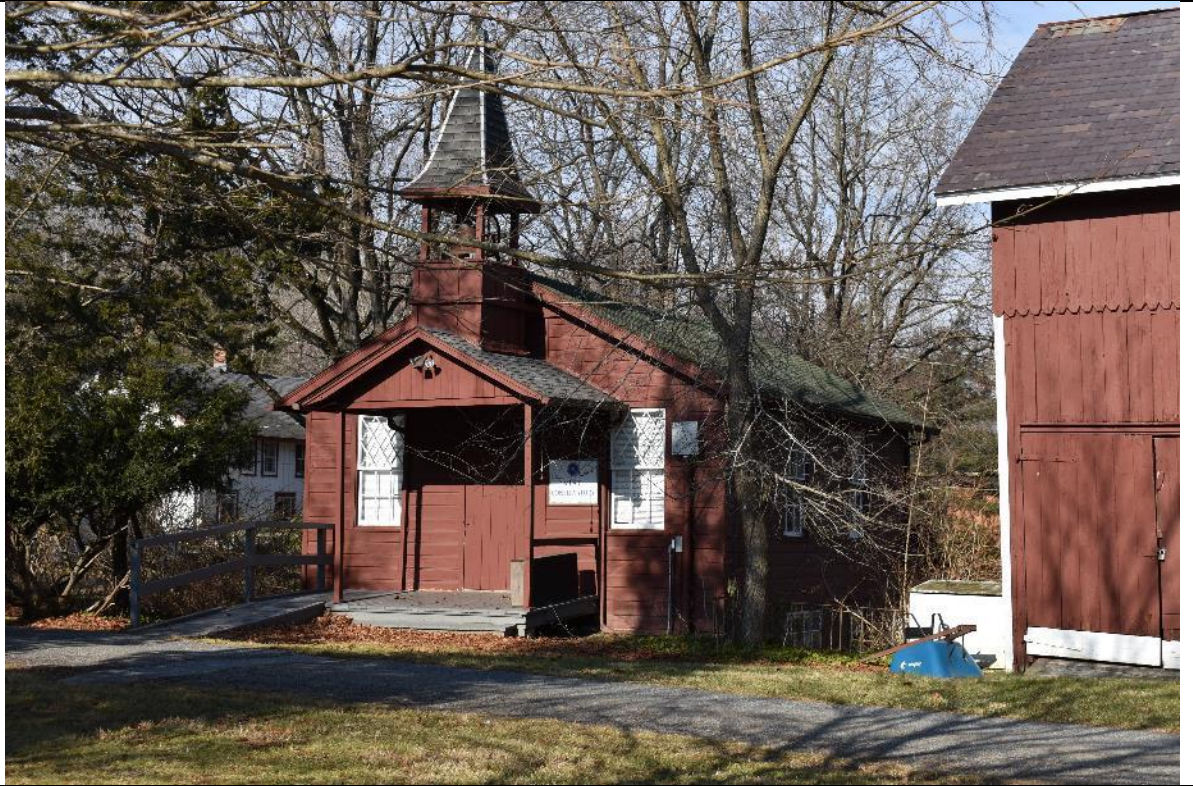
The structural condition is fair. This building has been a chapel and an assembly hall space. A substantial amount of rehabilitation would be required to convert this structure for any other use.

3. The Chapel  
(Building H).

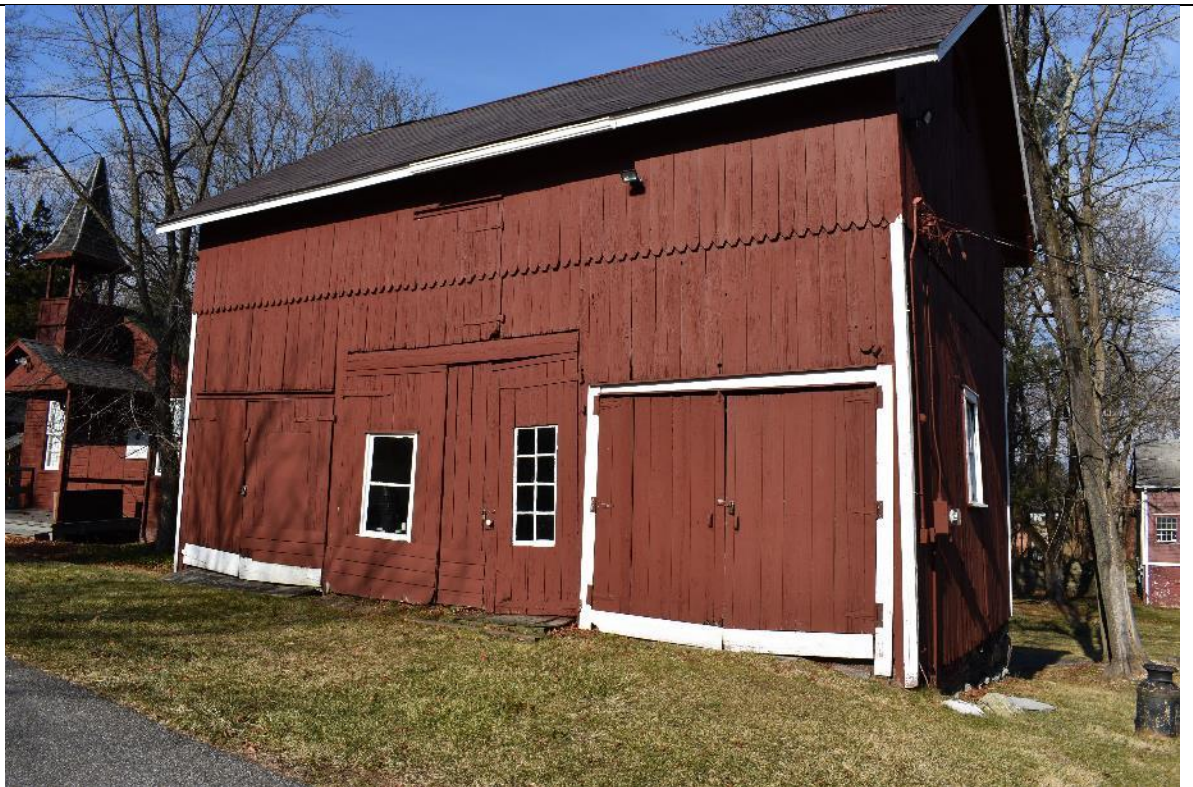
The interior of the barn has been subdivided sometime in the past 30-50 years. The floors have been reinforced with plywood and other modern materials. The load bearing joists show signs of bowing, causing an overall shifting of the building. The foundation is two sided, and constructed of stone, on the eastern and western sides. The southern wall of the foundation is built into the hill, and the northern side is wood frame. The openings on the northern side have been closed over. The second level is currently, and formerly storage space.

The historic integrity of the building has been modified, but the historic intention can still be discerned. The structural condition is fair. As this structure has been historically a barn, and is still utilized as equipment storage, a substantial amount of rehabilitation would be required to convert this structure into any other purpose.

4. Building G  
was formerly  
a carpenter's  
workshop,  
and is used  
for storage.

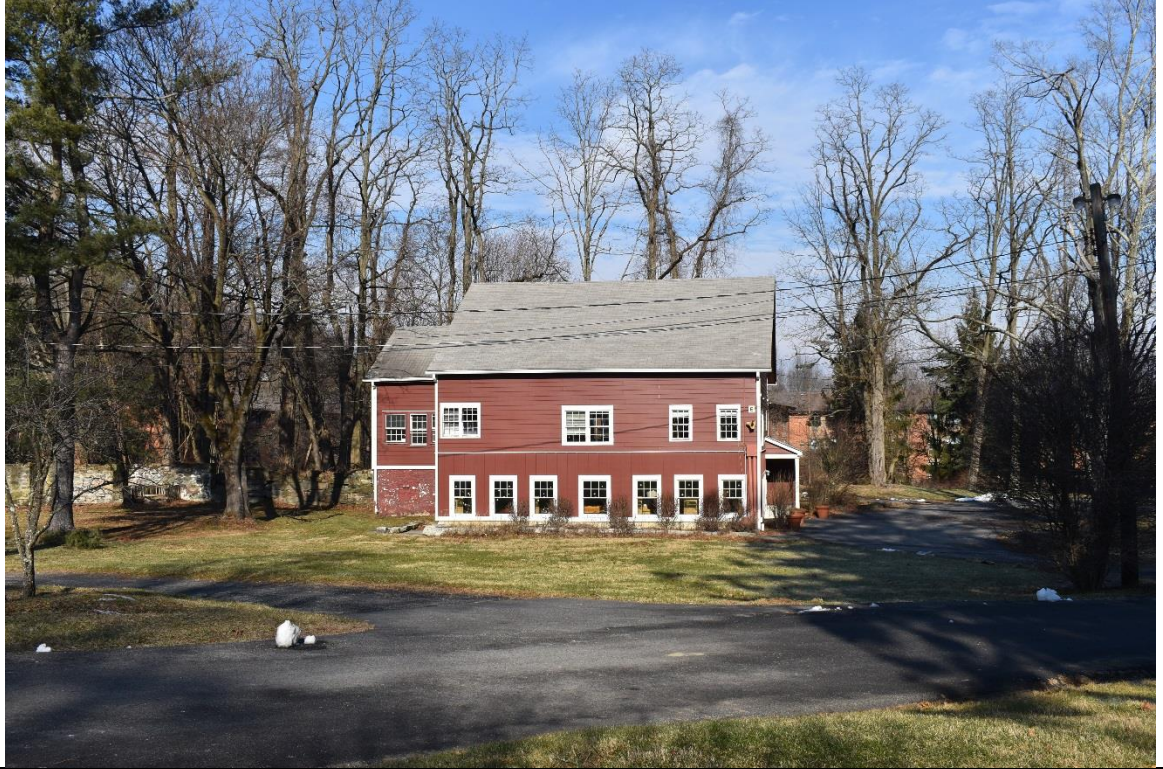
The historic integrity of the building has been modified substantially in the past 30-50 years, to the extent that the original purpose of the building only evident on the exterior, and it's unclear if this barn was original to the Floral Villa farm. The structural integrity of this building is considered good to excellent, due to the 2012 renovations.

5. Building E is the Science building. This structure, formerly the carriage house, was substantially rehabilitated in 2012.

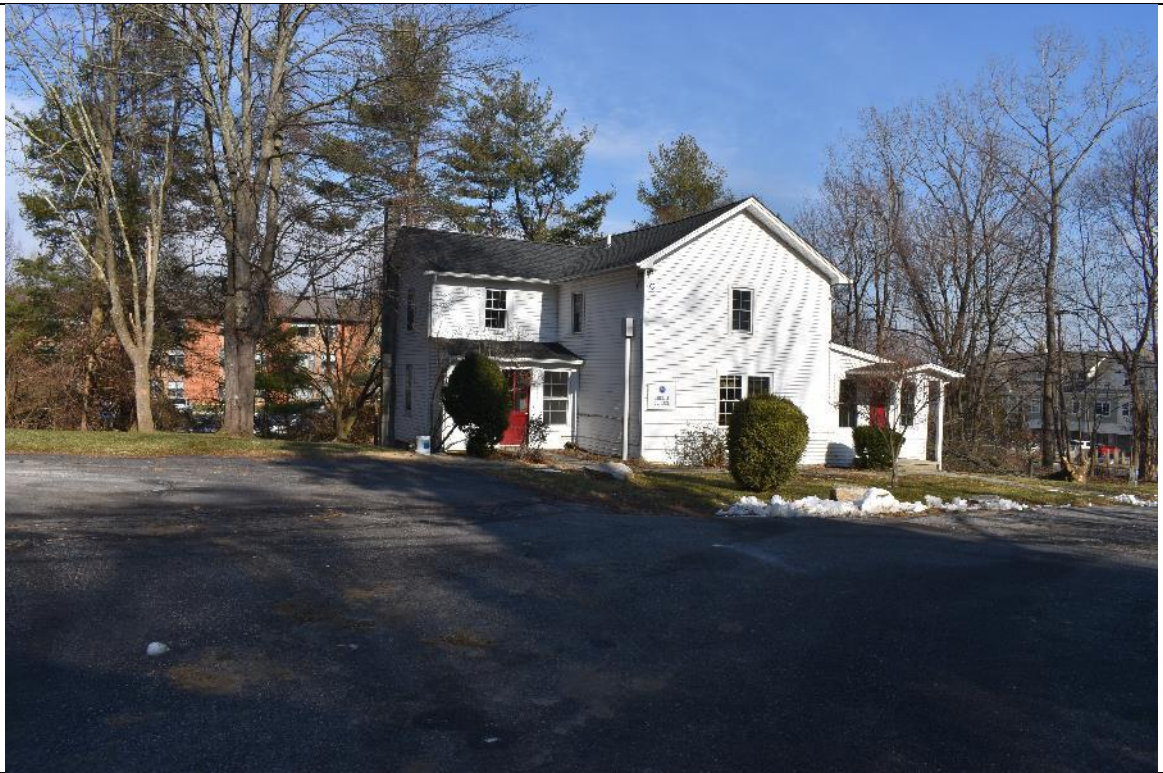
The interior of this building has recently been renovated, with new carpets, wall treatments (sheet rock, paint) and other cosmetic improvements. The only early nineteenth century elements that remain within the building are the interior stairs, an interior door, and closet. The interior of the building has been renovated to the extent that the original use of the building, (i.e. single family, vs multiple guests) by the Beaver Conference Farm, cannot be determined. The structural integrity of this building is considered good.

6. Building C served as the middle school classroom for Soundview School.

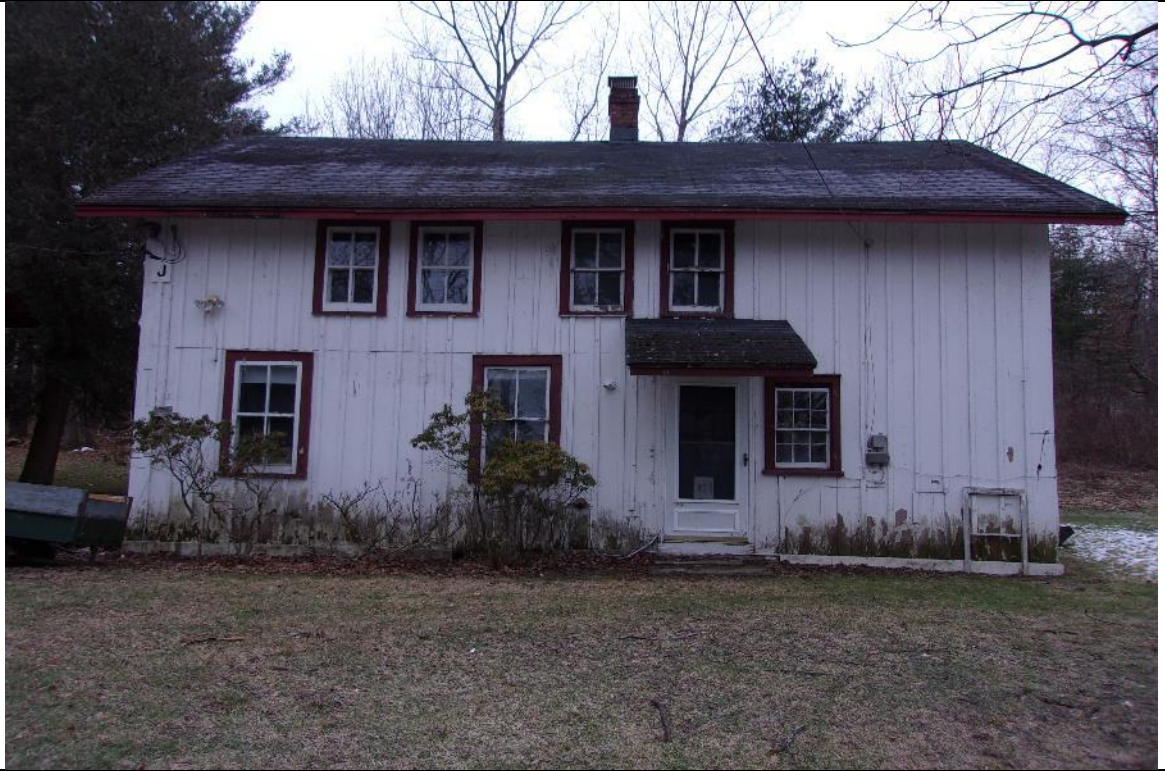
This structure appears to have been originally constructed in the twentieth century as residential space. This building is not structurally sound as parts of the floor in interior have collapsed. Any renovation to this building would involve substantial changes.

7. Building J, is a small residential cottage.

Building J has already begun to become structurally unstable, adaptive reuse is not a viable option for this structure.

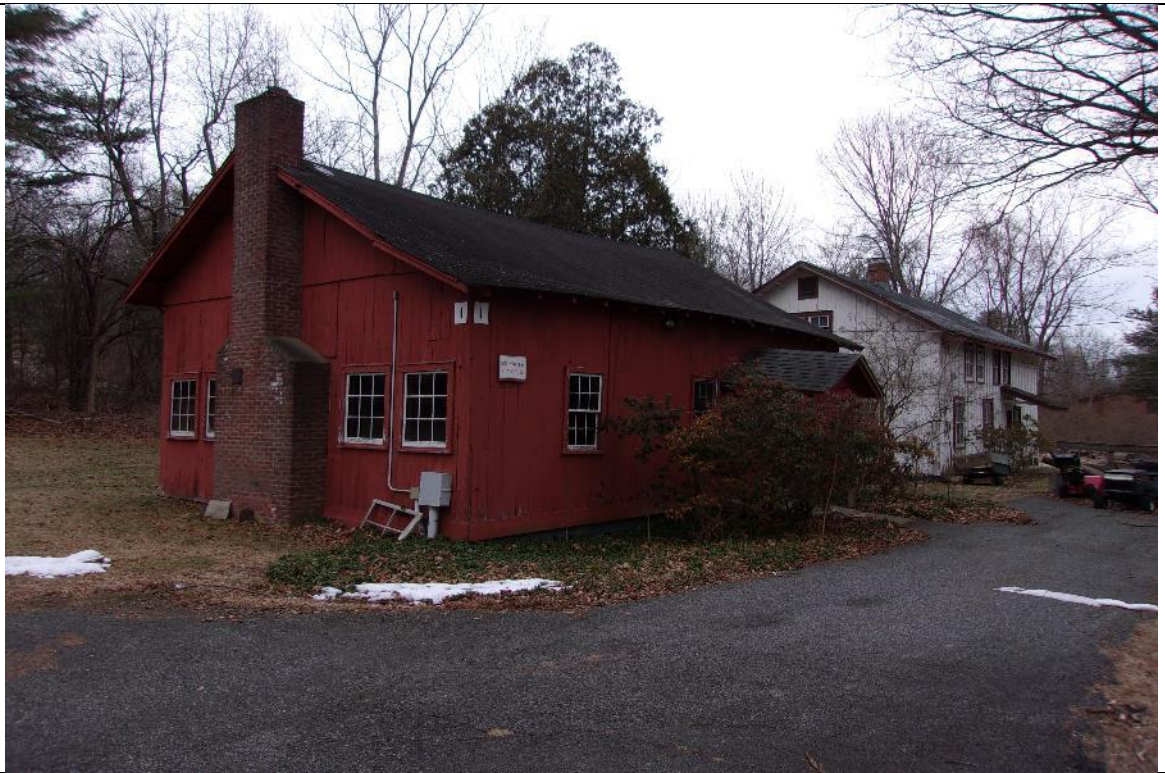
The historic integrity of the building has been modified in the early twentieth century, to function as either an assembly space or residential space. A brick fireplace was added, and the upper level enclosed. The hand hewn beams of the original barn can still be seen in the interior, and are supported by modern vertical beams. The structural conditions is fair to poor. There is not foundation to speak of, as the original is a course of dry laid stone. The exterior boards are rotting at the base, due to the proximity to the ground. As this structure has historically been a barn, a substantial amount of rehabilitation would be required to convert this structure for another purpose.

8. Building I served as the Soundview School Playhouse.

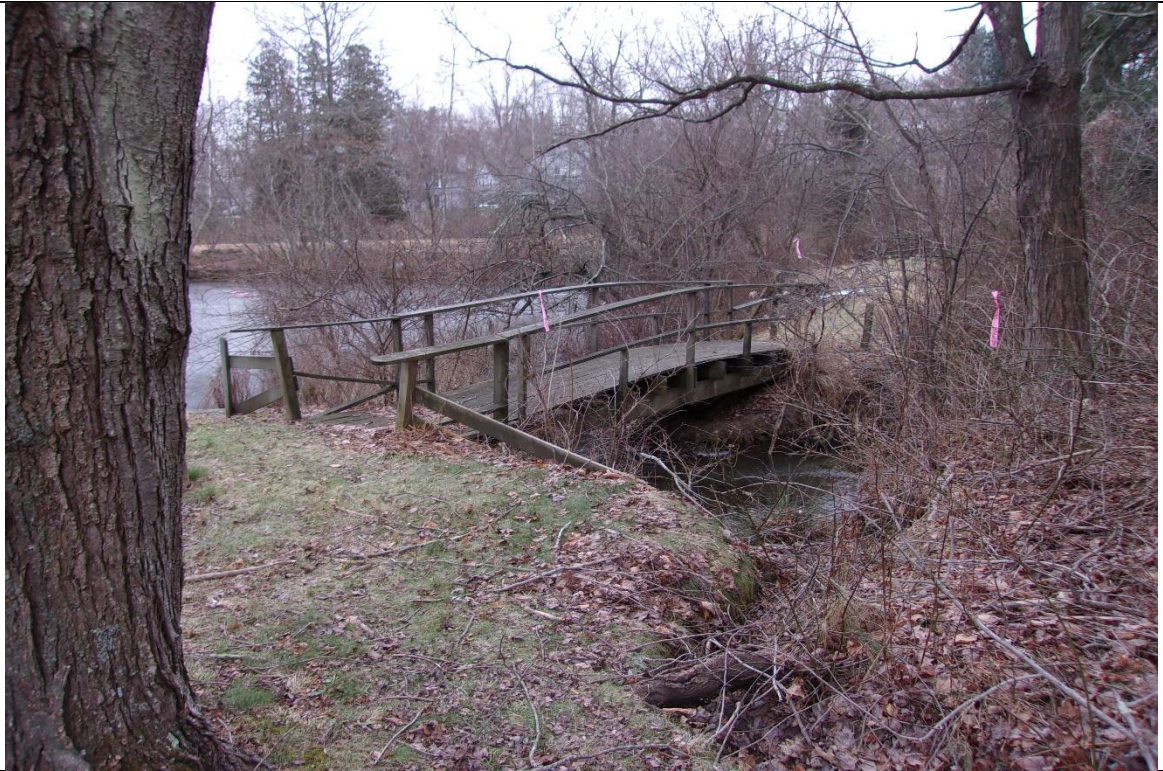
11. View to the southwest of the former ice pond.

The project plans include the rehabilitation of the existing mansion, updating the older additions, and reinvigorating the exterior. The former ice pond will also be restored. This pond is currently silted in and the stabilizing walls have collapsed. The immediate setting around the Mansion and pond is going to be revived, to allow for both public and private access to the property. Currently the property appears shabby and worn out.
