**TIM
MILLER
ASSOCIATES, INC.**

April 18, 2022

RE: Wetlands Delineation
Underhill Farm, Underhill Avenue
Town of Yorktown, Westchester County

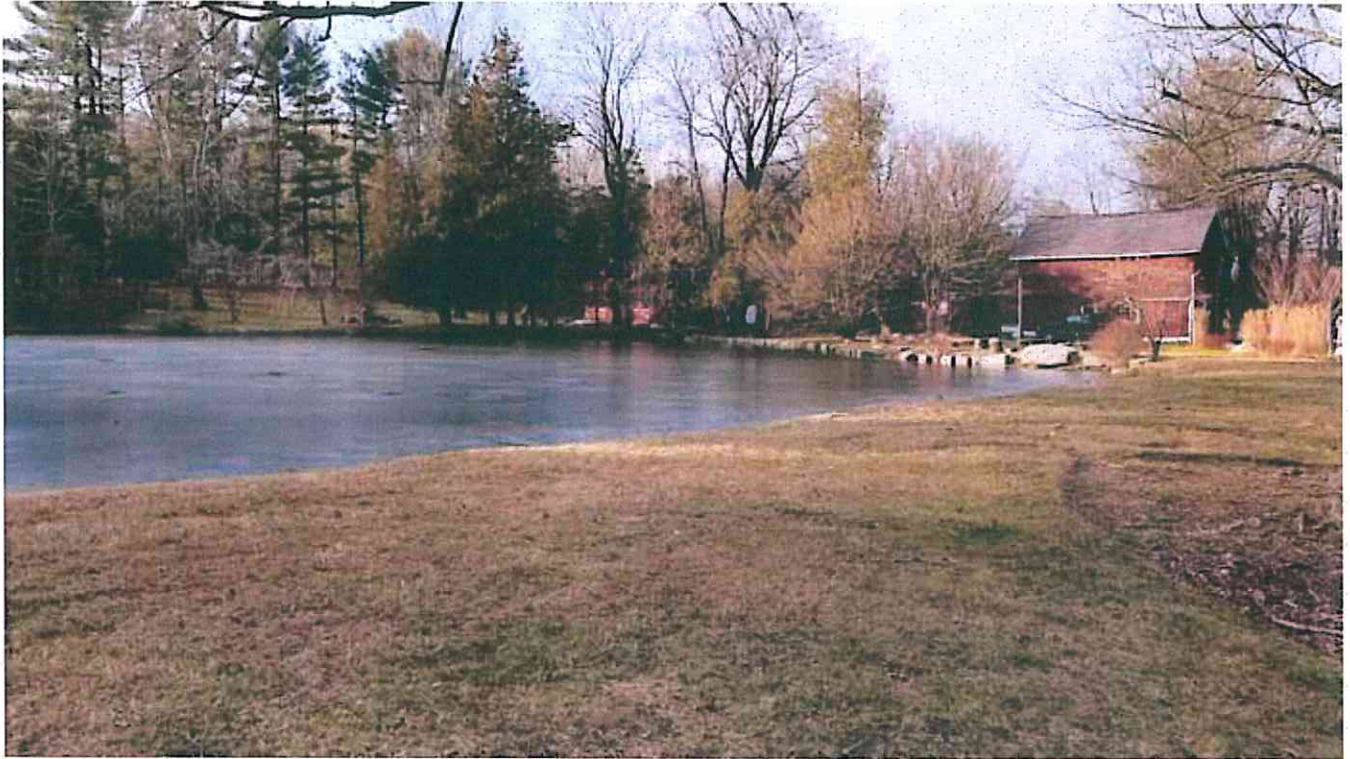
The watercourse flows into the existing pond on site. Known to exist since at least 1936 (1936 USGS mapping), the pond is relatively shallow and bordering on eutrophic. A significant part of the pond edge is bordered with stone. The pond outlet is a stone culvert on the north side, with a significant drop to a deep culvert underground to the Beaver Ridge property. Total area of the regulated wetland area, including the incoming watercourse and the pond, is approximately 37,000 square feet. A total of 44 flags were hung for Wetland A.

Existing Pond Looking North

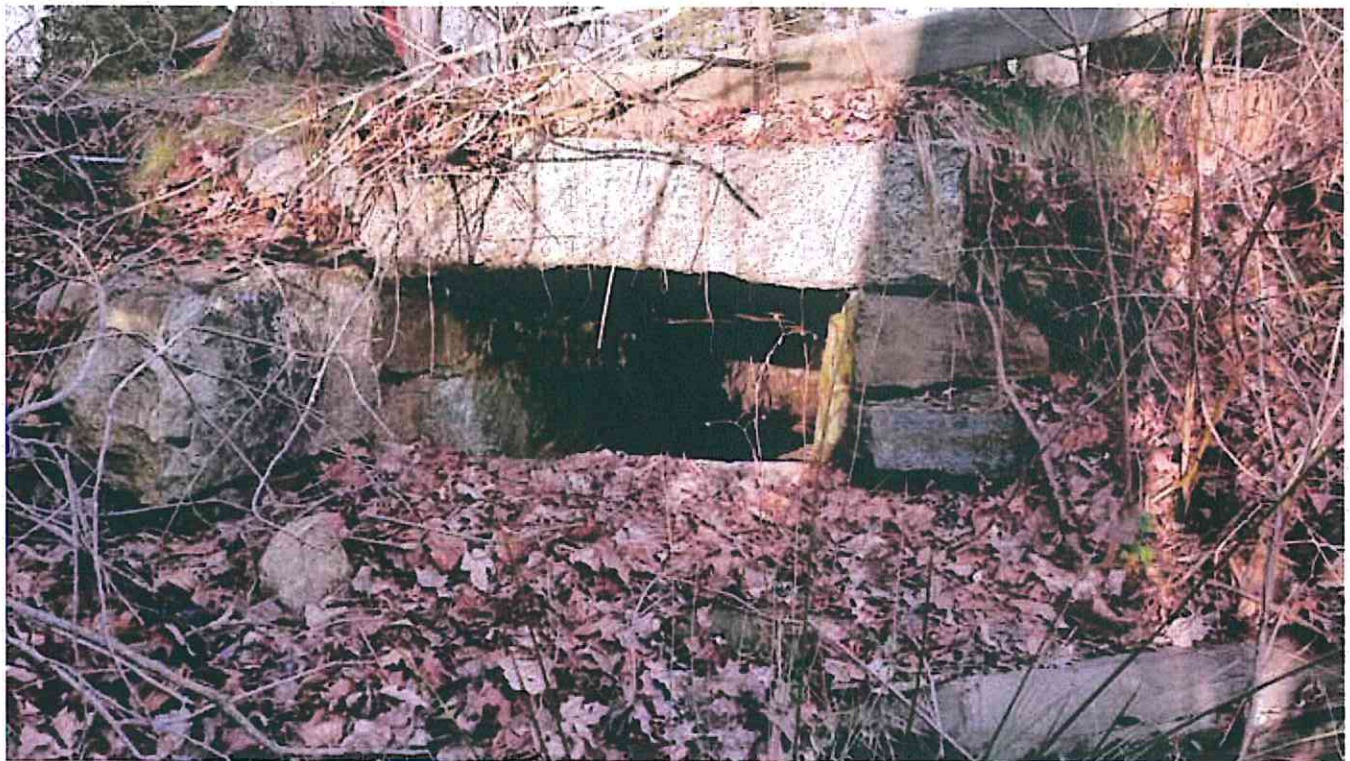
Existing Pond Outlet

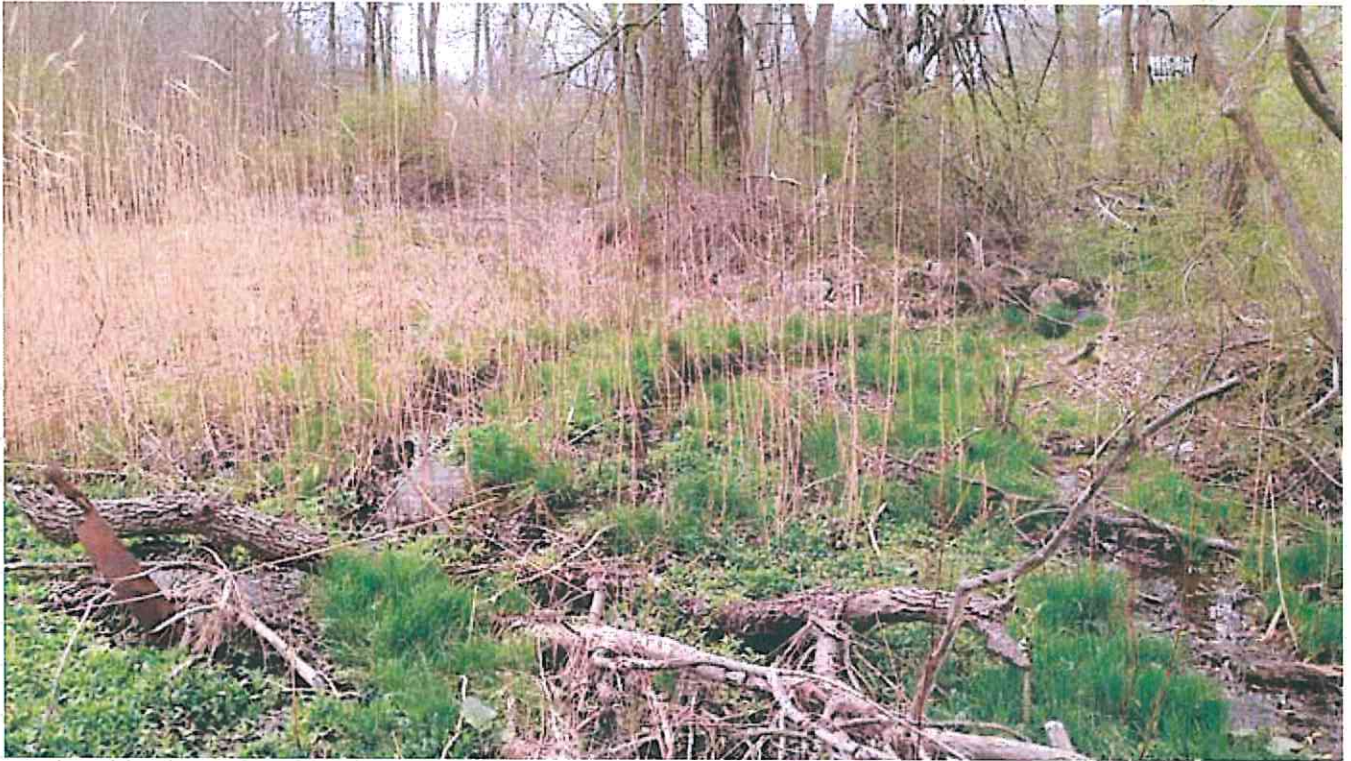
Wetland A is made up of a watercourse corridor that flows from a culvert under Glen Rock Street in the southwest corner of the site. The main flow is from collected stormwater runoff, but there does appear to be a baseflow component from shallow groundwater discharge that results in the

Wetland A west of access road

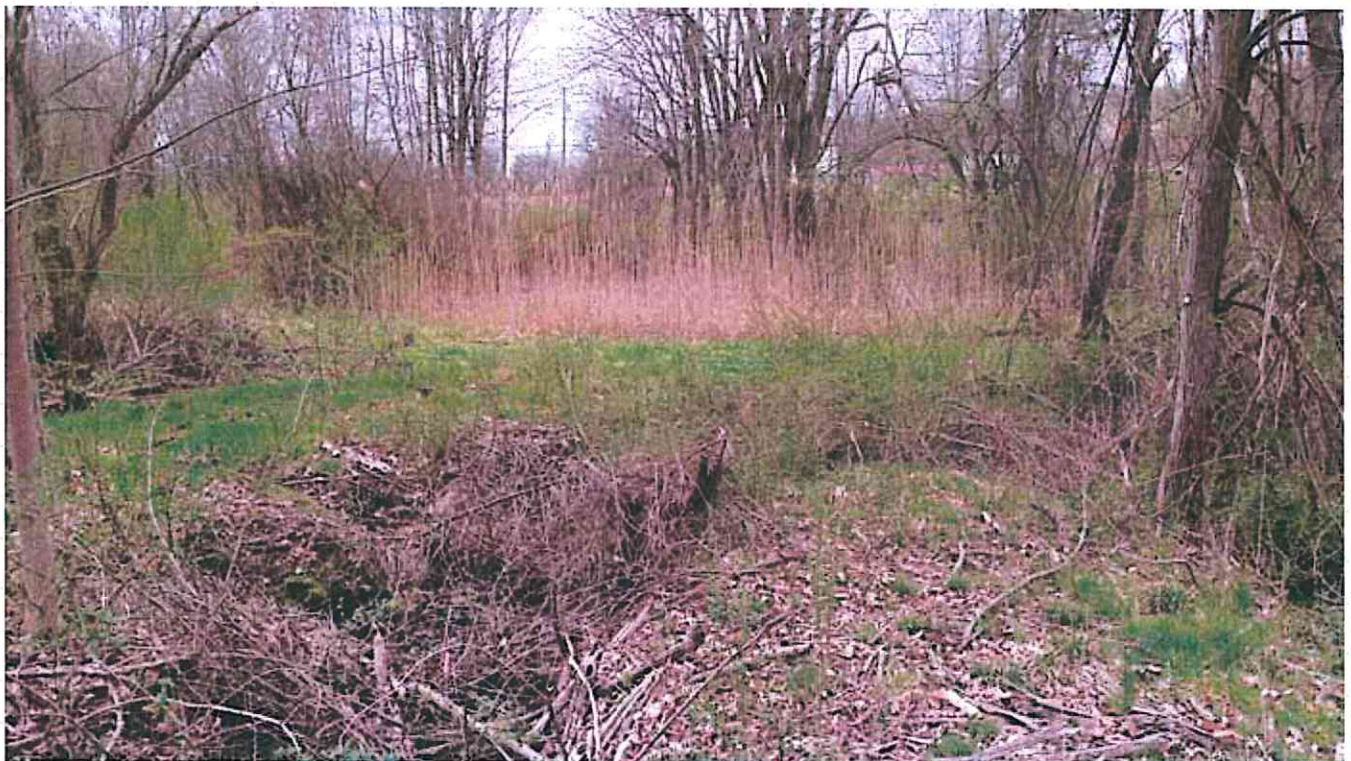
watercourse flowing for a significant part of the year. Based on a review of the aerial photos, the path of this watercourse has changed over the years, but always ends up in the site pond. With the construction of the Beaver Ridge development, a new emergency access was created and a culvert installed to carry the flows under this access. However, with time the culvert has clogged and now water and sediments flow across the access, creating a saturated condition that resulted in the flagging of this area as a town wetland. It is likely that if the culvert was cleared and flow restored under the road, a significant part of this "wetland" would dry out. The wetland exclusive of the pond is approximately 10,000 square feet.

Wetland A with outlet from clogged culvert in foreground,
Glen Rock Street in background

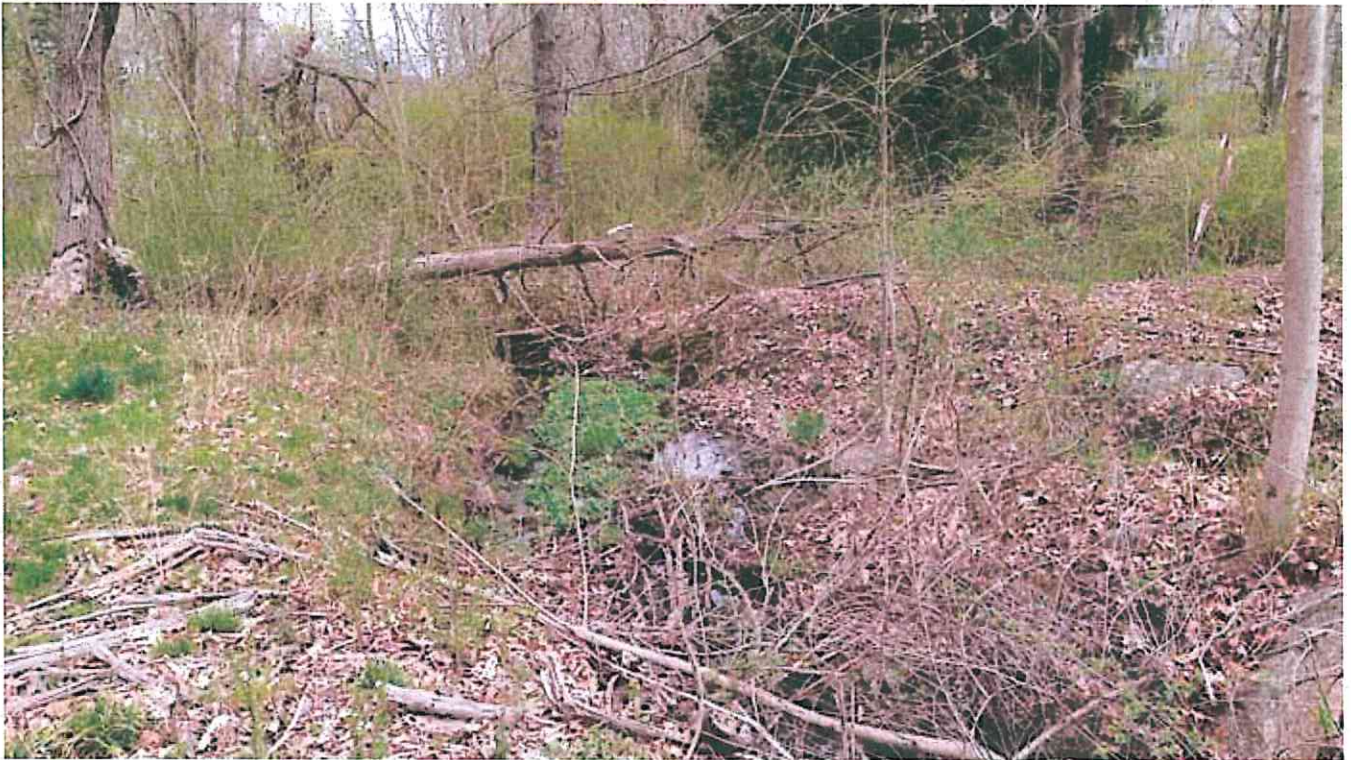
Wetland A looking west towards pond

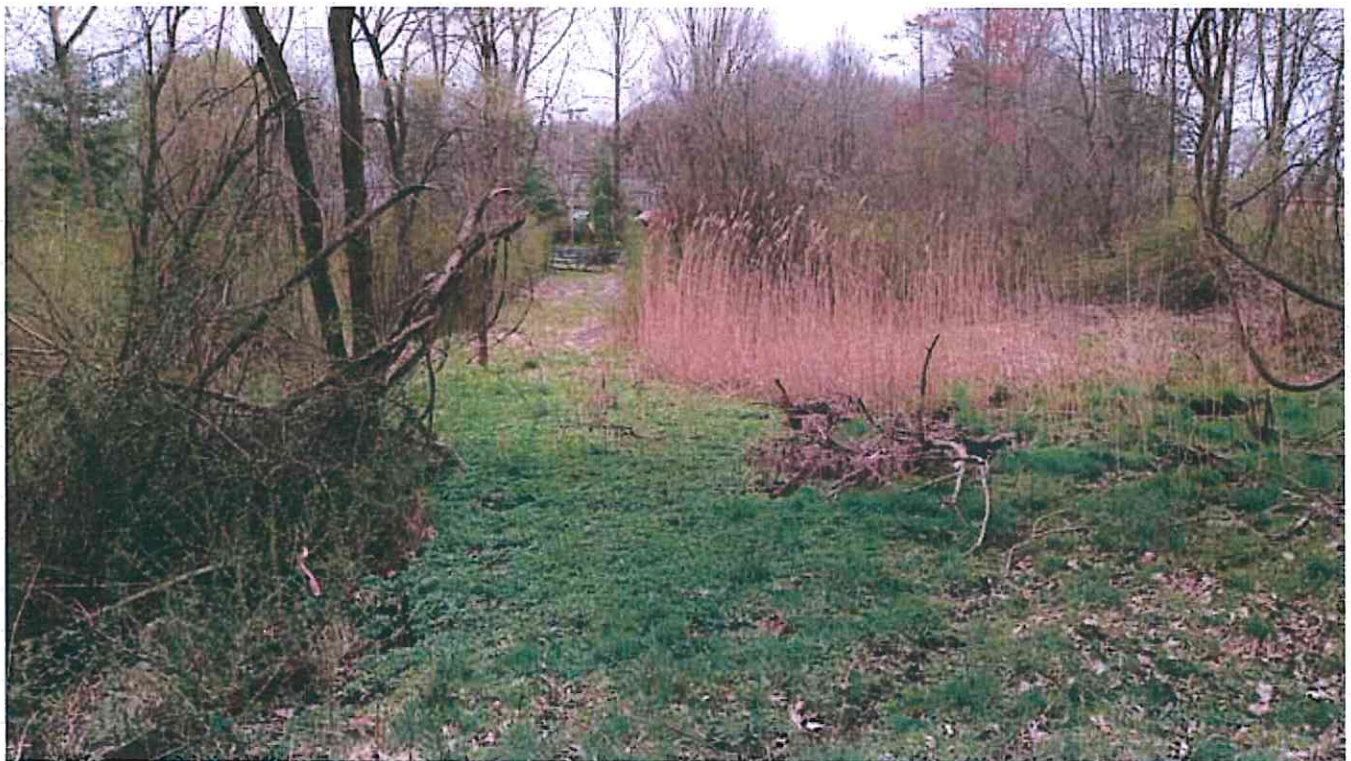
Existing access road looking south (gate in background)

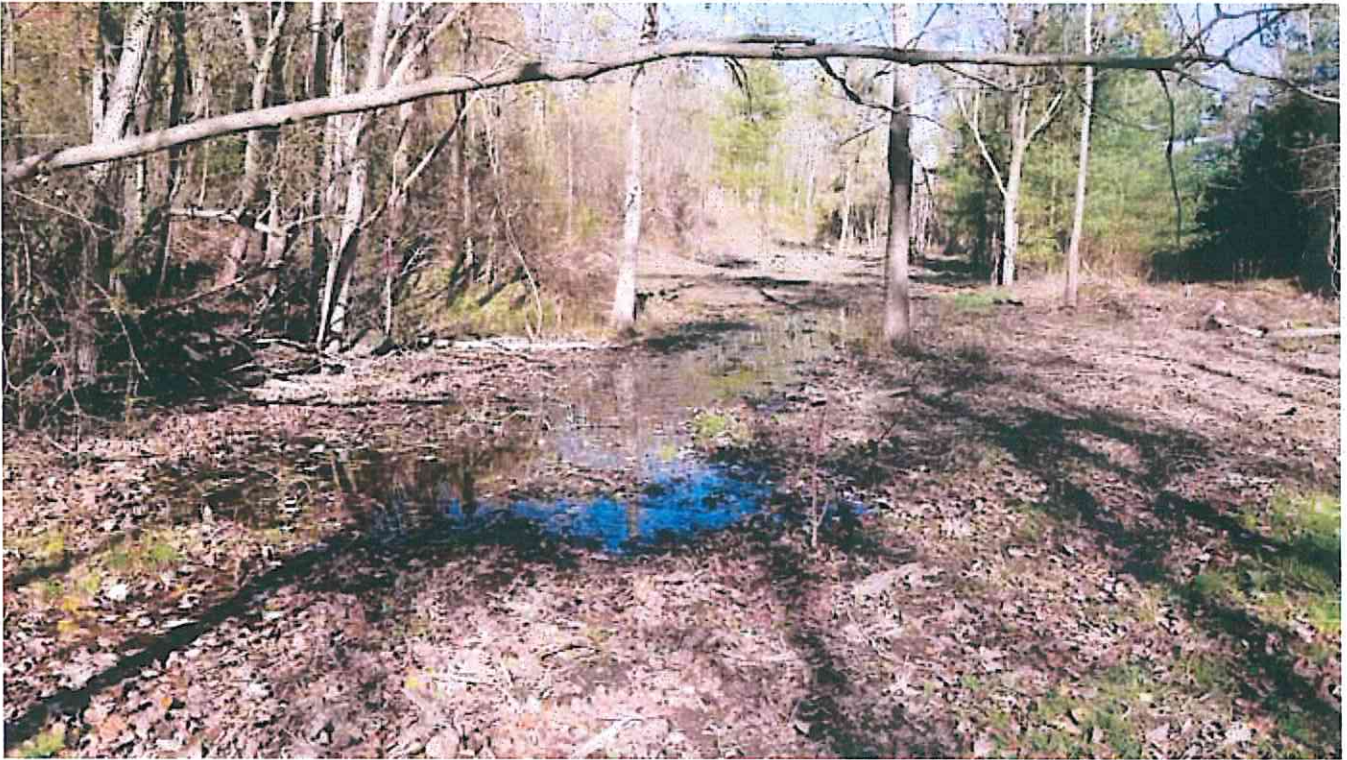
Wetlands B and C are two small pockets of saturated soils (each about 2,000 square feet) on the west side of the emergency access way. When the emergency access was constructed, soil was stripped and piles of fill were left on either side. Wetland B was likely a borrow pit where soil was extracted to level out the road. This combined with the lack of a culvert under the access created a damming effect that allows water to pool in Wetlands B and C for a significant portion of the growing season. A total of 14 flags were hung for wetlands B and C. Wetland vegetation is largely absent in both wetlands.

Wetland C looking north

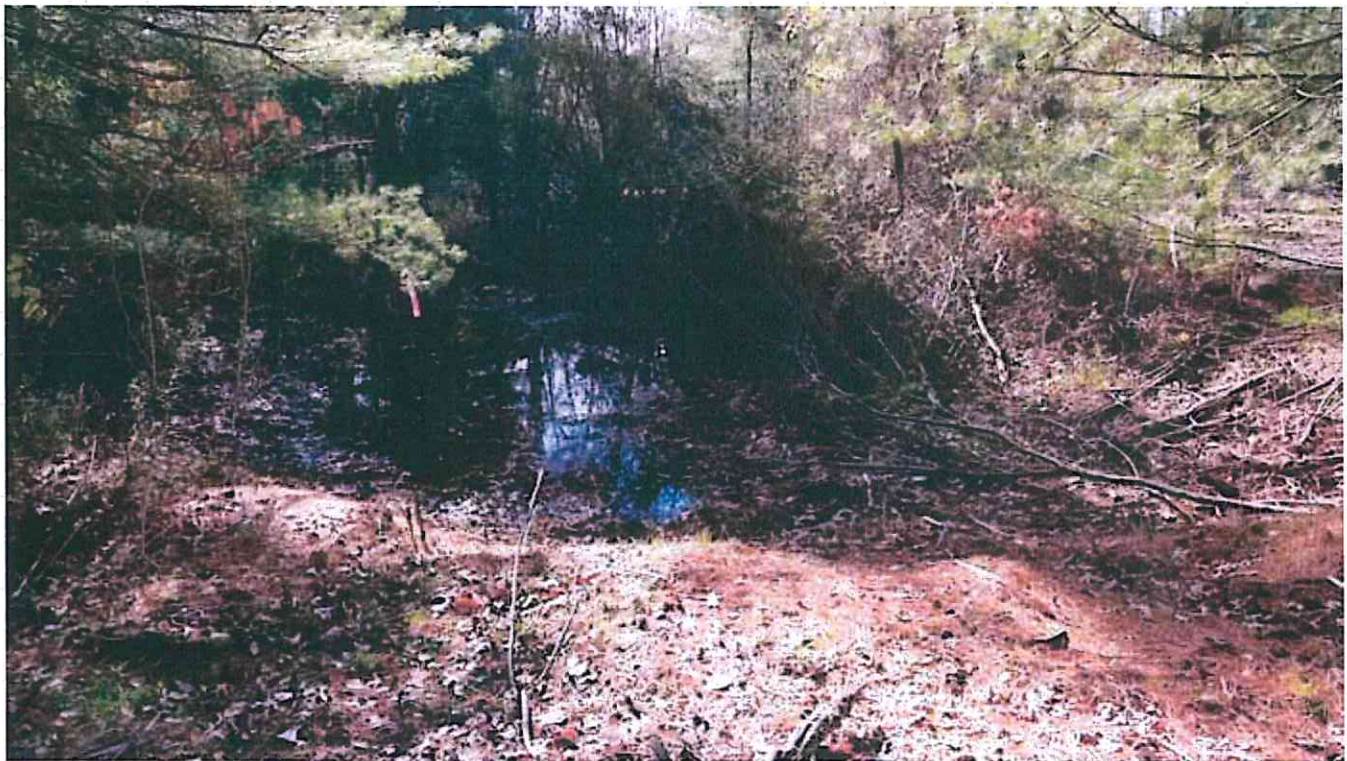
Wetland B looking south

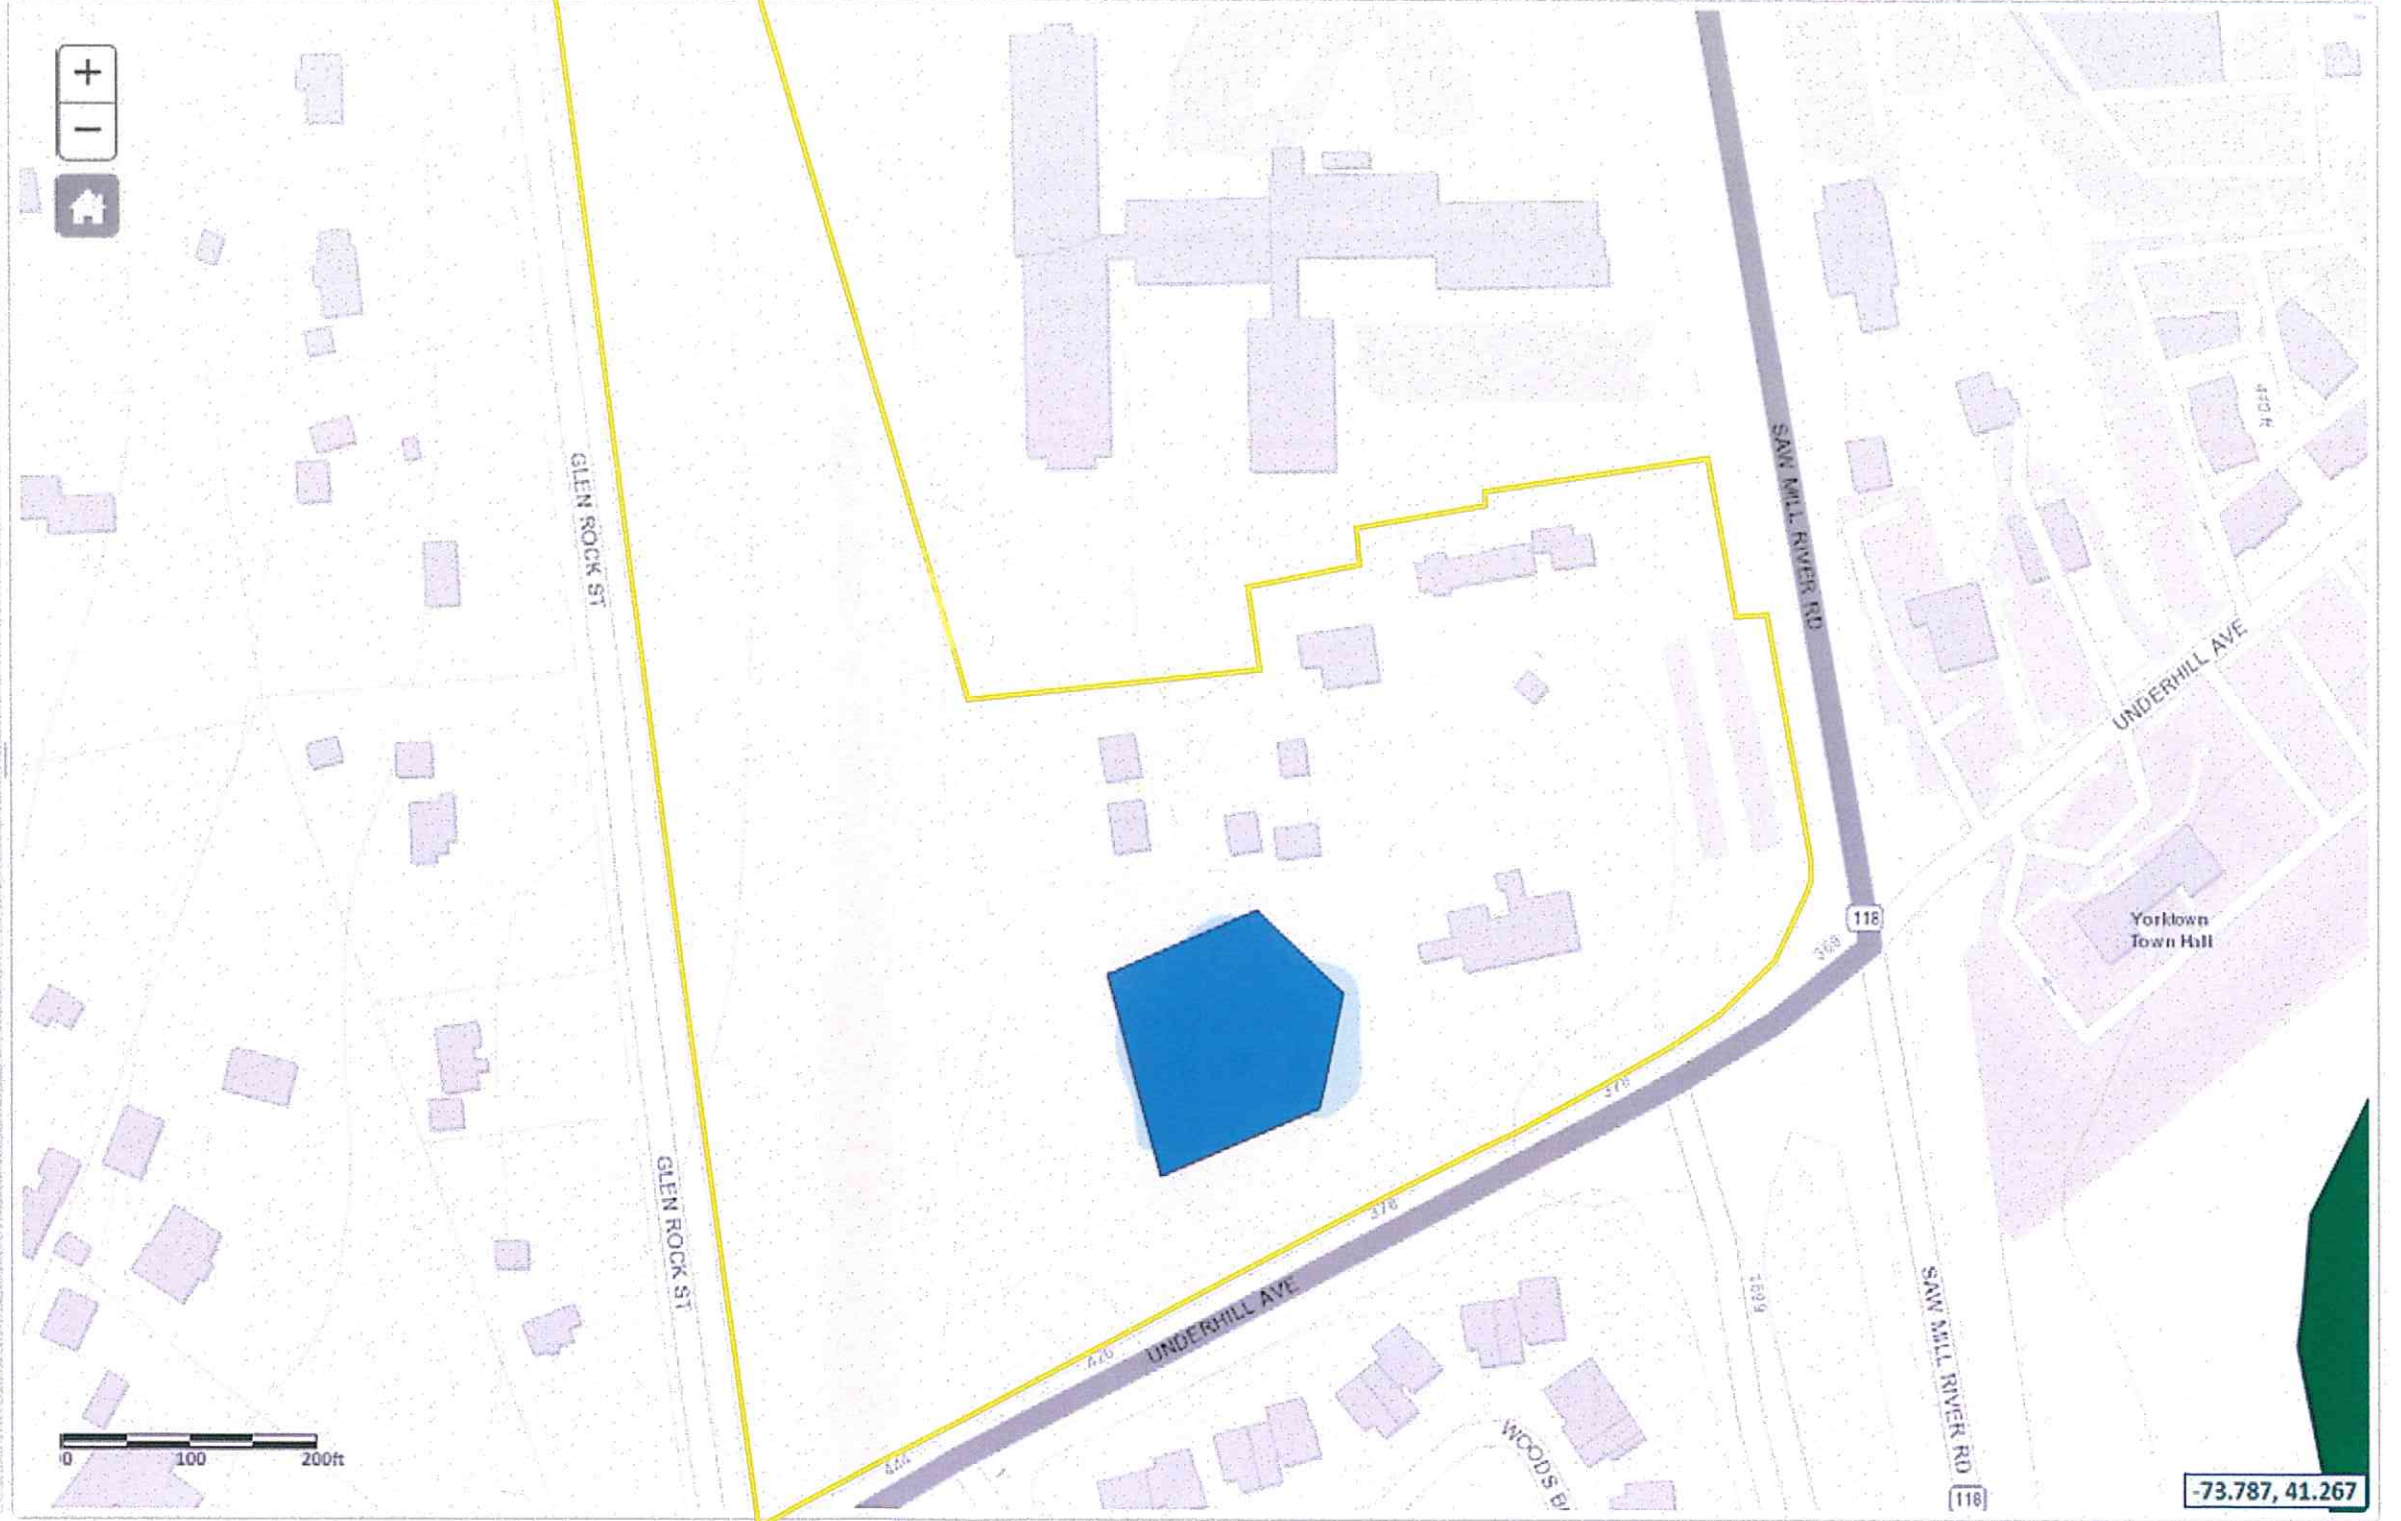
No New York State mapped wetlands exist on the site. The existing pond is mapped on the National Wetland Inventory as "freshwater pond". During the site visits, three areas were identified that meet the delineation criteria of Chapter 178 of the Town of Yorktown Code.

National Wetland Inventory Wetland Map
 Underhill Farm
 Underhill Avenue, Yorktown
 Source: DEC Environmental Resource Mapper

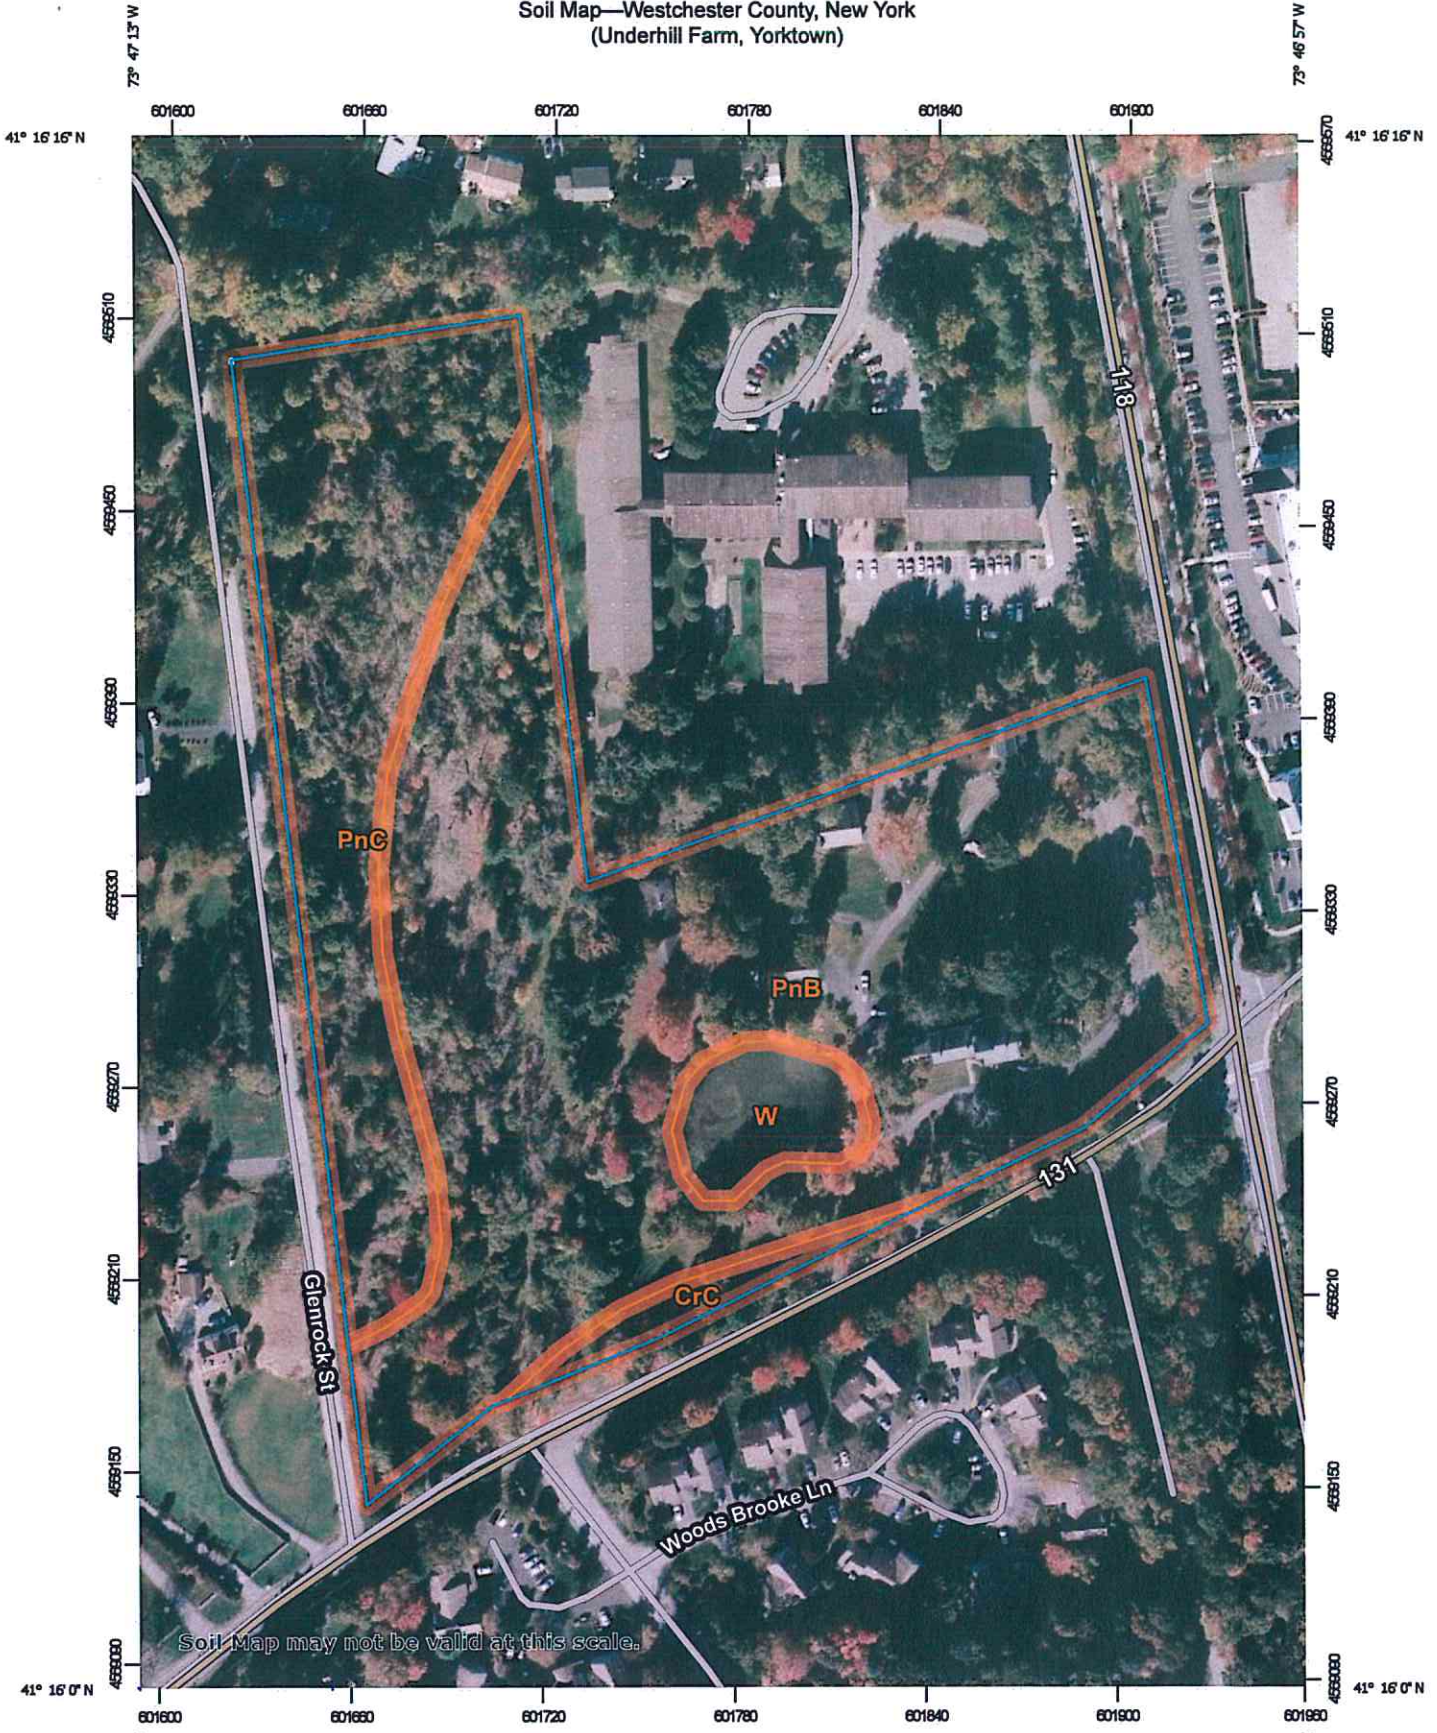
Soil Map—Westchester County, New York
(Underhill Farm, Yorktown)

Map Unit Symbol	Map Unit Name	Acres in AOI	Percent of AOI
CrC	Charlton-Chatfield complex, 0 to 15 percent slopes, very rocky	0.3	2.0%
PnB	Paxton fine sandy loam, 3 to 8 percent slopes	9.5	68.8%
PnC	Paxton fine sandy loam, 8 to 15 percent slopes	3.5	25.3%
W	Water	0.5	4.0%
Totals for Area of Interest		13.8	100.0%
