Visual Impact Assessment

SCS Dell 014136 Yorktown, LLC Dell Avenue Solar Farm Yorktown, New York, 10514

TRC Companies
650 Suffolk Street, Suite 200
Lowell, MA 01854

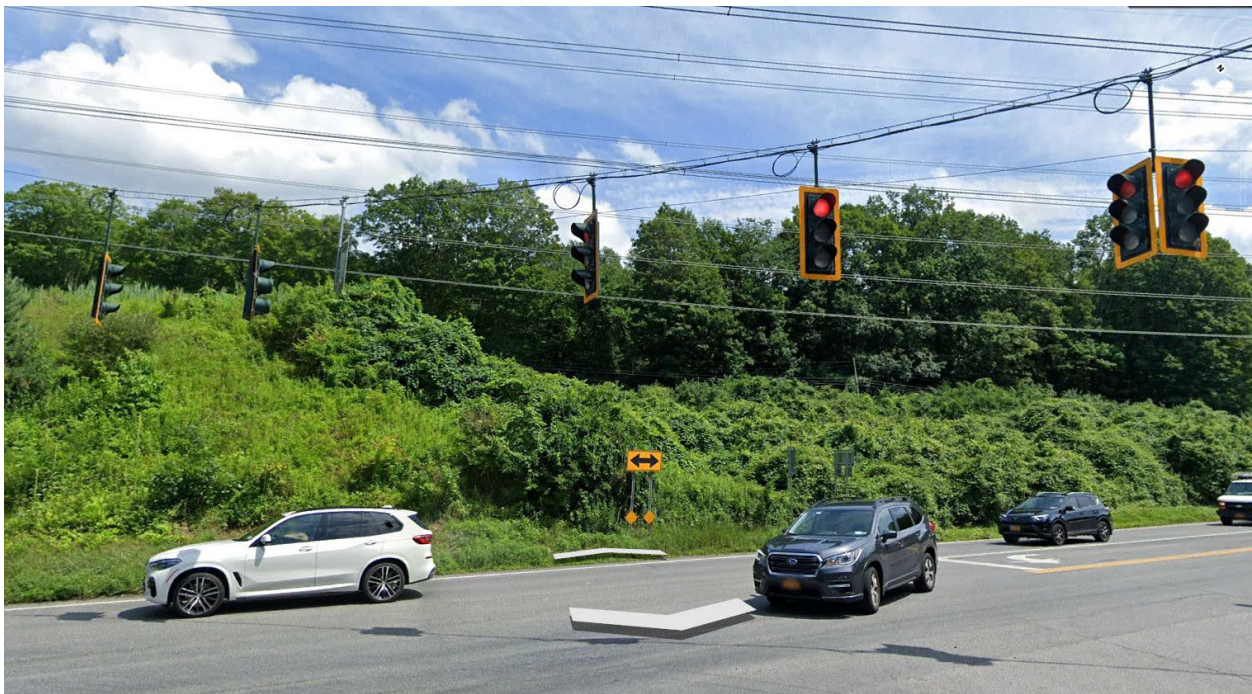
Inset 1. Intersection of Route 100 & Route 134

As also noted, left of center in the photograph below (Inset 1) shows a topographic obstruction along Route 100 that serves to preclude views to the “left” side of the Project. The LOS profile line was pulled to the right of this topographic feature through lower elevation terrain on the right to show worse-case. As such, there is a narrow line of dense shrubs that exist on the south side of the ROW between the viewer and (north of) Dell Avenue that screens views in this area. More significant screening of the Project occurs from existing taller trees that are approximately 40 feet deep and located on the south side of Dell Avenue (far background). Visual impacts are not expected due to topography as well as vegetative screening north of the perimeter fence.

LOS 3 is at the intersection of Route 100 and Route 134 and is a representative view for motorists at the intersection facing southeasterly towards the Project. There is a large high voltage transmission utility ROW that crosses at the intersection in front of the viewpoint. A Google Earth screenshot is provided below to assist in the narrative for this LOS. The viewpoint is essentially on Route 134 where the profile visual environment consists of several suspended traffic lights strung perpendicular across Route 100 and three vertical elevation levels of transmission line. (The ROW contains 2 parallel lattice transmission towers approximately 150 high. Each lattice tower consists of 6 davit arms, 2 per level. Therefore, there is a series of 12 wire bundles associated with the davit arms of 2 towers). These transmission wires can be seen sweeping across the view at the LOS 3 intersection.

No significant, unscreened views of the Project are expected at this location. Motorist viewing experiences are typically intermittent and of short duration. During leaf-on conditions, no views are expected.

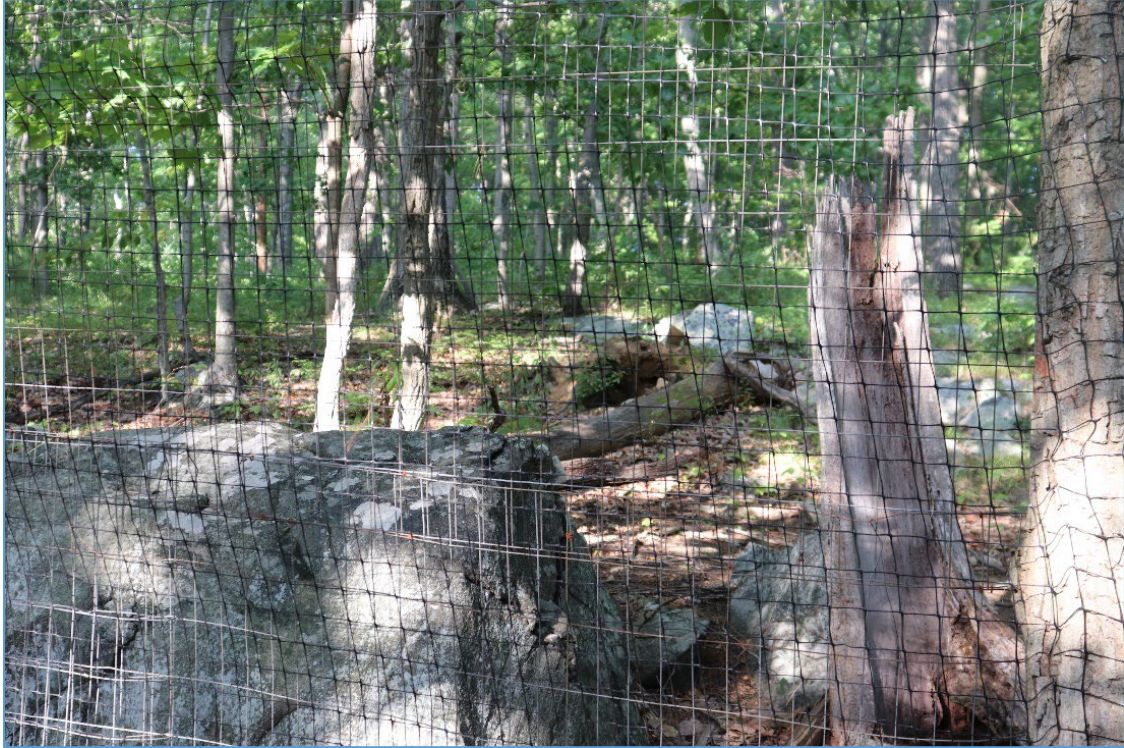
Inset 2. Existing 7 foot mesh fence at Hog Hill property (view toward Hog Hill property).

Insets 2 and 3 below illustrate the mesh fence. It is fairly restrictive impeding movement and therefore the simulation viewpoint photos could only be taken at the limits of this barrier. The fence has 1 to 2 inch mesh squares. It was observed that this fencing does provide a level of visual interference in and of itself and has the capacity to blur and diminish detail of objects on the opposing side (Insets 2 and 3). The photographer was not tall enough to see over the 7 foot fence. Due to the small mesh size and to obtain clear camera photos as best as possible, the position of the camera was forced directly on the fence to limit the visual interference of the mesh. Although this would not exactly represent how the view through the fence would normally be experienced, the clearest photographs that showed the least interference on the camera lens from the fence were chosen for simulations.

There is an existing mesh fence line (approximately 7 feet high) near the property boundary to the northwest (noted in Figure 3) that restricts movement between the two properties. When the Neighbor's property line was walked, observations were made along the fence and documented with gps. Figure 3 illustrates site conditions with the results of the site visit and depicts more specifically, the viewpoint locations where visibility of solar arrays within the Neighbor's property might occur. There are points along the fence where, with a high degree of confidence, the Project will not be seen (represented by a double green line in Figure 3). However, also as noted in Figure 3 (represented by the light green dotted lines) there are two linear areas along the fence where less frequent, intermittent, and very minimal visibility of the Project could be discerned by observation of the formerly placed orange snow fencing and high-visibility flagging through dense vegetation. Figure 3 also identifies a small discrete area at the furthest northwest corner of the property along approximately 125 feet of fencing where visibility of the Project takes place (represented by solid yellow line). Here, screened through vegetation, views of solar panels restricted to the northern array section will be obtained.

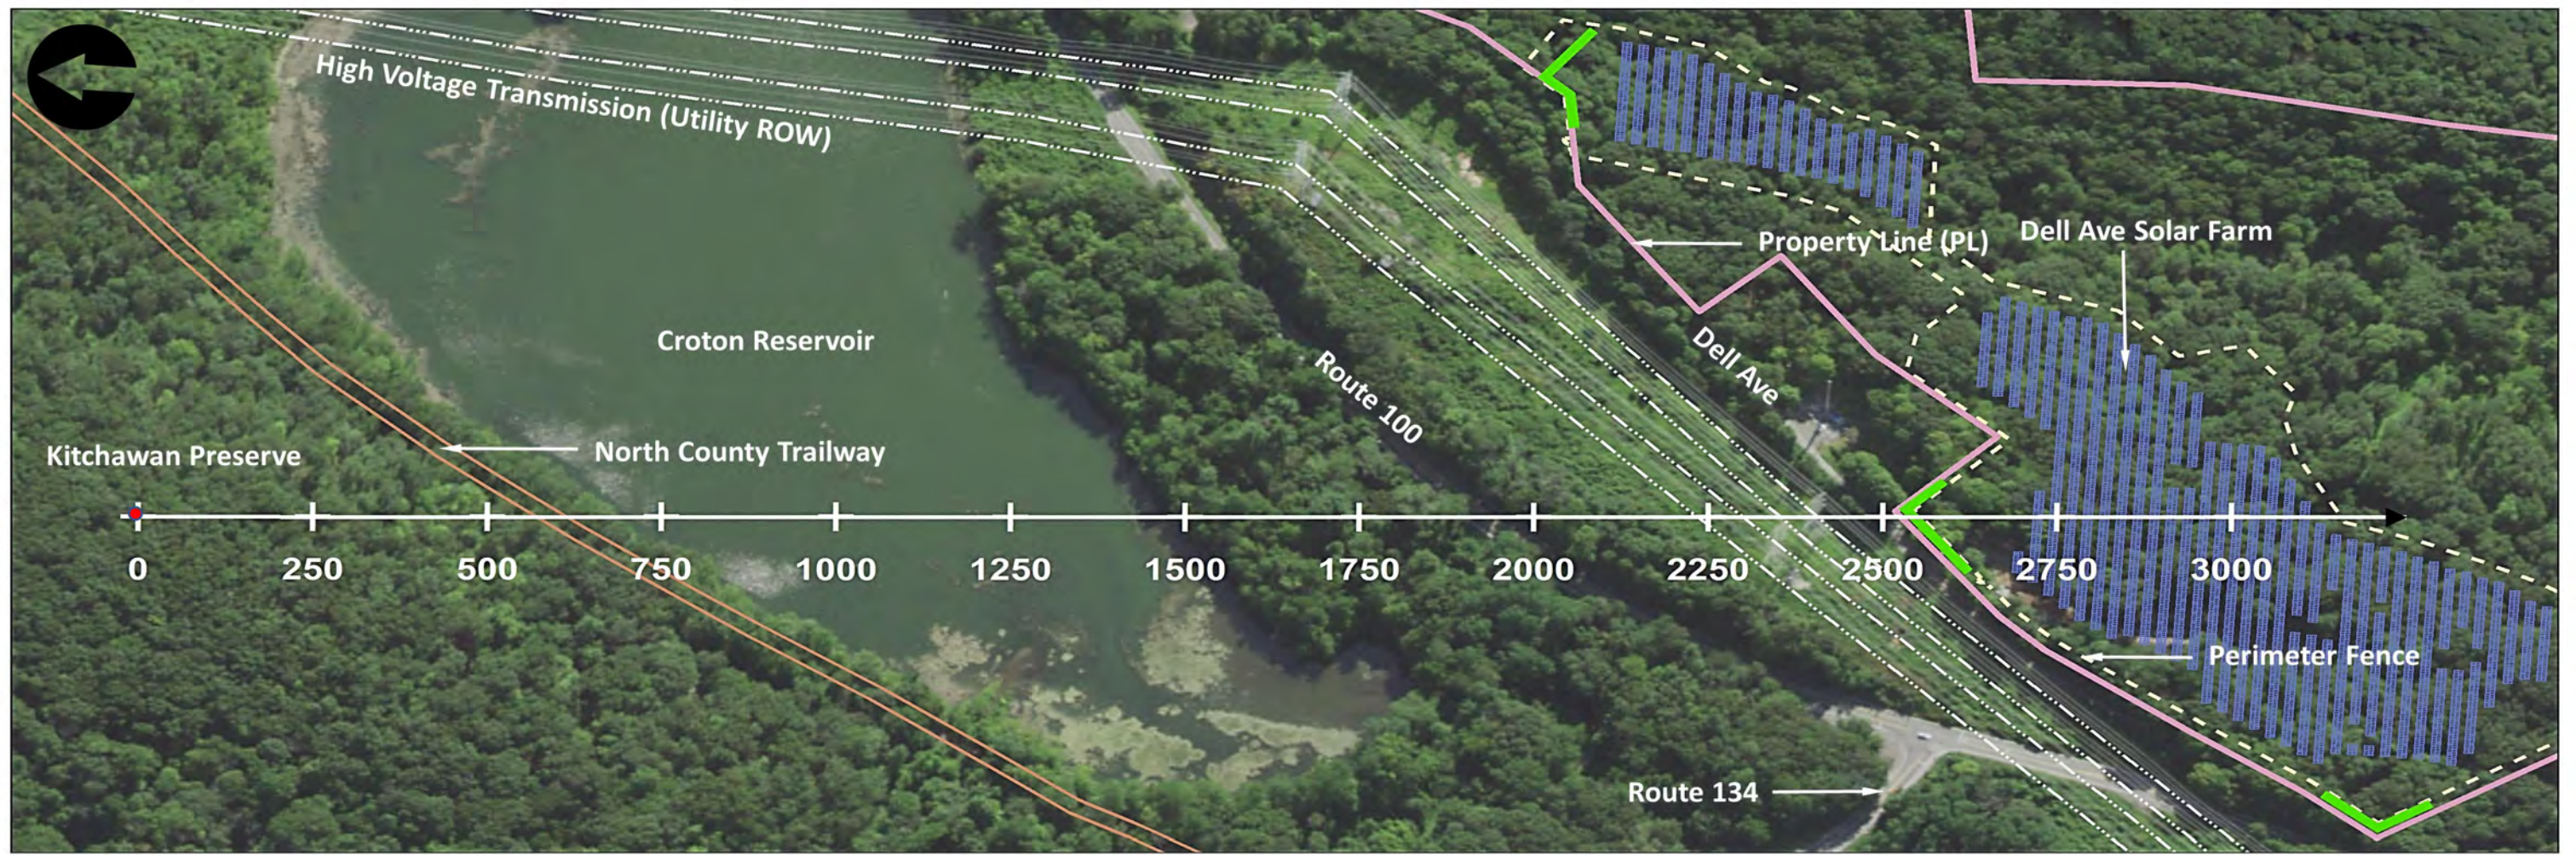
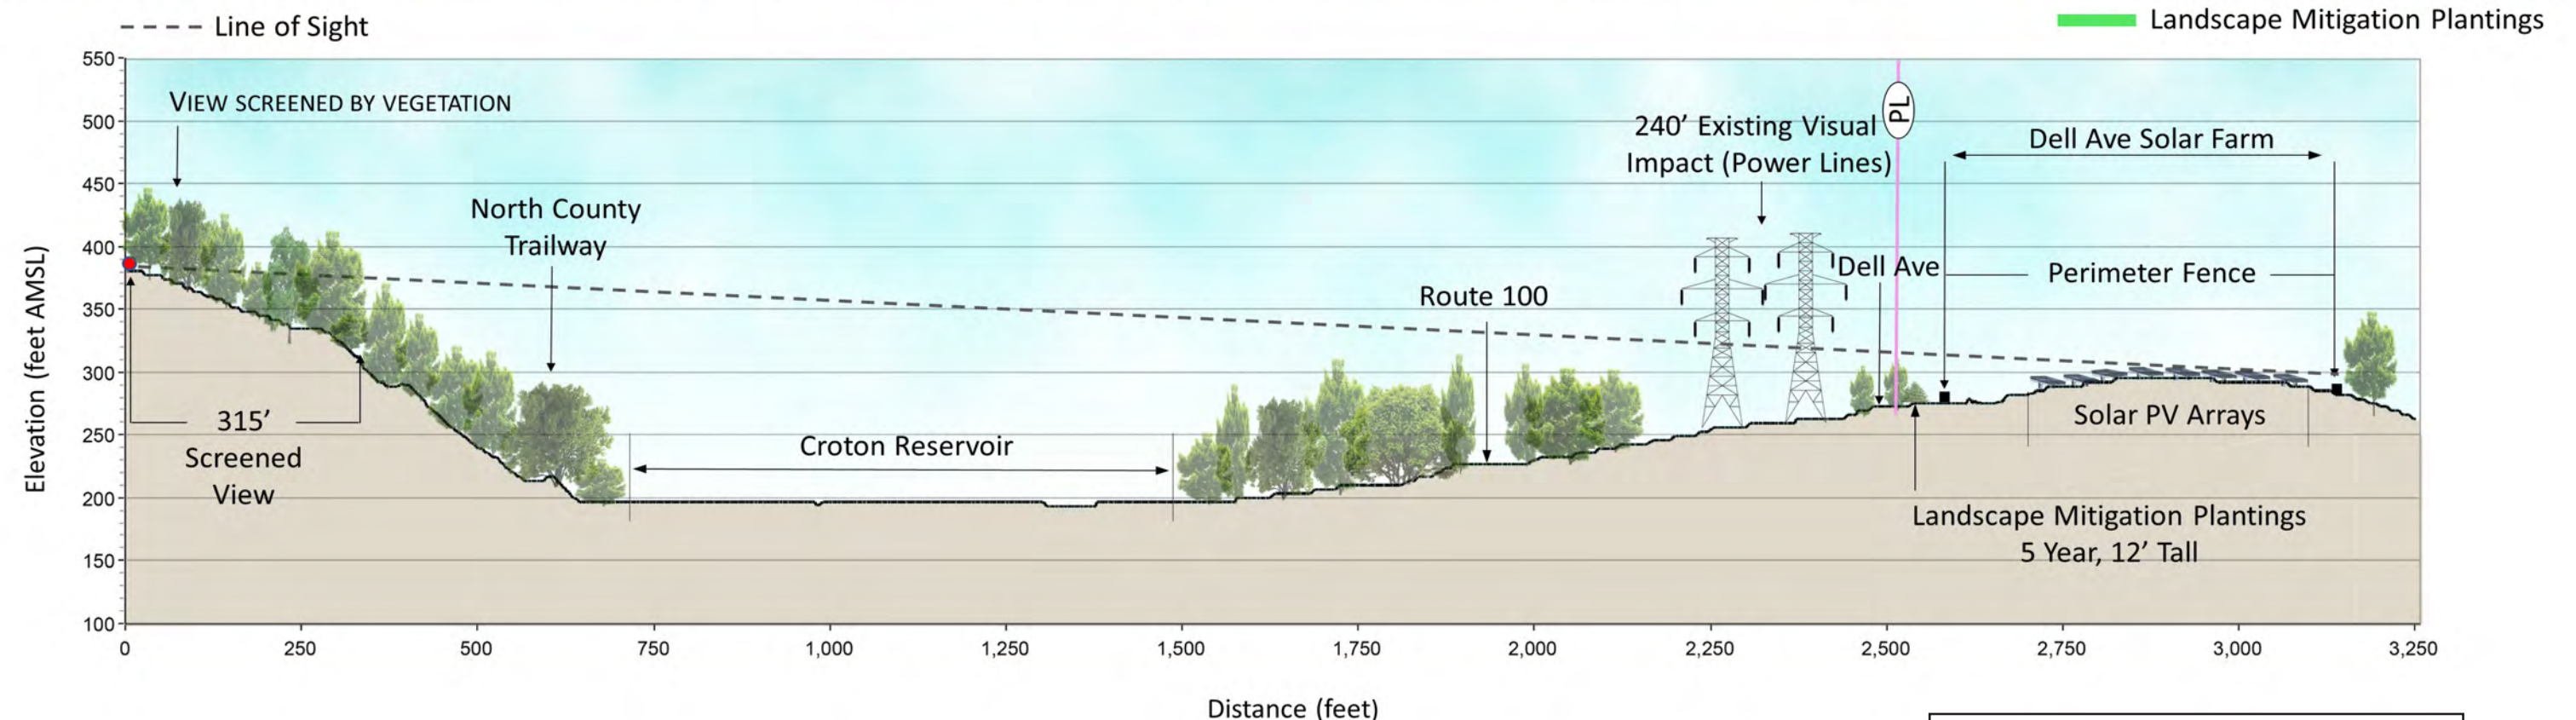
LOS 1- Kitchawan Preserve (top of hill)

Kitchawan Preserve is a 208-acre natural preserve bordered by Croton Reservoir and the North County Trailway. As noted in the aerial photo for LOS 1 in Attachment 2, the Preserve is wooded mainly with mature deciduous tree species. The viewpoint is positioned at a high point and overlooks a south-facing descending slope leading to Croton Reservoir. The LOS 1 viewpoint is higher than the Project. As the elevation profile shows, views are not anticipated because of the approximately 315 feet of existing vegetative screening from varying canopy levels in the forested environment. Prevalent along the profile environment also is the presence of a high voltage transmission utility corridor that is just north of the Project and Dell Avenue. The approximate 150 foot tall lattice towers (as measured by LiDAR data) provide a significant visual presence of their own in the general vicinity. The profile crosses 240 feet of ROW.

No adverse views of the Project are expected at this location due to 315 feet of vegetative screening.

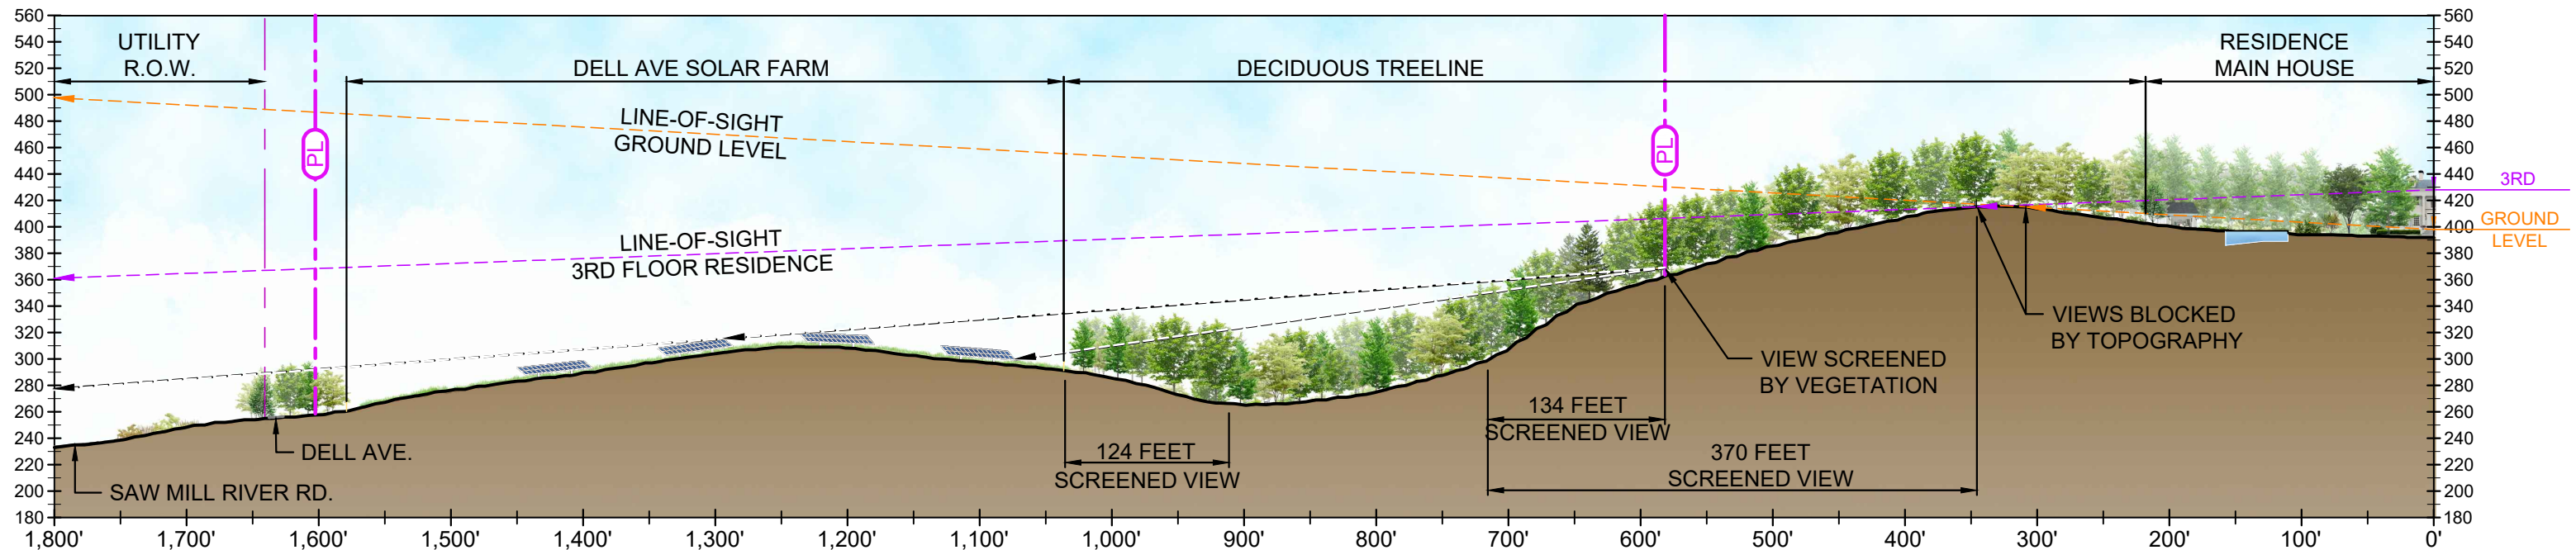
PROFILE VIEW: LINE-OF-SIGHT #15 (STA: 0 TO 1,800)

Horizontal and Vertical Scale - 1 : 1
