SCS Dell 014136 Yorktown, LLC Dell Avenue Solar Farm Yorktown, New York, 10514

Visual Impact Assessment

Revision 1

September 30, 2022

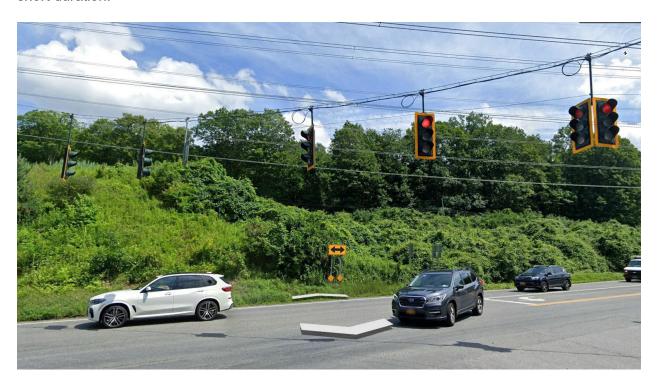
LOS 3 is at the intersection of Route 100 and Route 134 and is a representative view for motorists at the intersection facing southeasterly towards the Project. There is a large high voltage transmission utility ROW that crosses at the intersection in front of the viewpoint. A Google Earth screenshot is provided below to assist in the narrative for this LOS. The viewpoint is essentially on Route 134 where the profile visual environment consists of several suspended traffic lights

strung perpendicular across Route 100 and three vertical elevation levels of transmission line. (The ROW contains 2 parallel lattice transmission towers approximately 150 high. Each lattice tower consists of 6 davit arms, 2 per level. Therefore, there is a series of 12 wire bundles associated with the davit arms of 2 towers). These transmission wires can be seen sweeping across the view at the LOS 3 intersection.

As also noted, left of center in the photograph below shows a topographic obstruction along Route 100 that serves to preclude views to the "left" side of the Project. The LOS profile line was pulled to the right of this topographic feature through lower elevation terrain on the right to show worse-case. As such, there is a narrow line of dense shrubs that exist on the south side of the ROW between the viewer and (north of) Dell Avenue that screens views in this area. More significant screening of the Project occurs from existing taller trees that are approximately 40 feet deep and located on the south side of Dell Avenue (far background). Visual impacts are not expected due to topography as well as vegetative screening north of the perimeter fence.

Views are expected to be non-existent or worse-case, minor fragmented views through vegetation. However, viewing experiences from vehicular traffic are typically intermittent and of short duration.

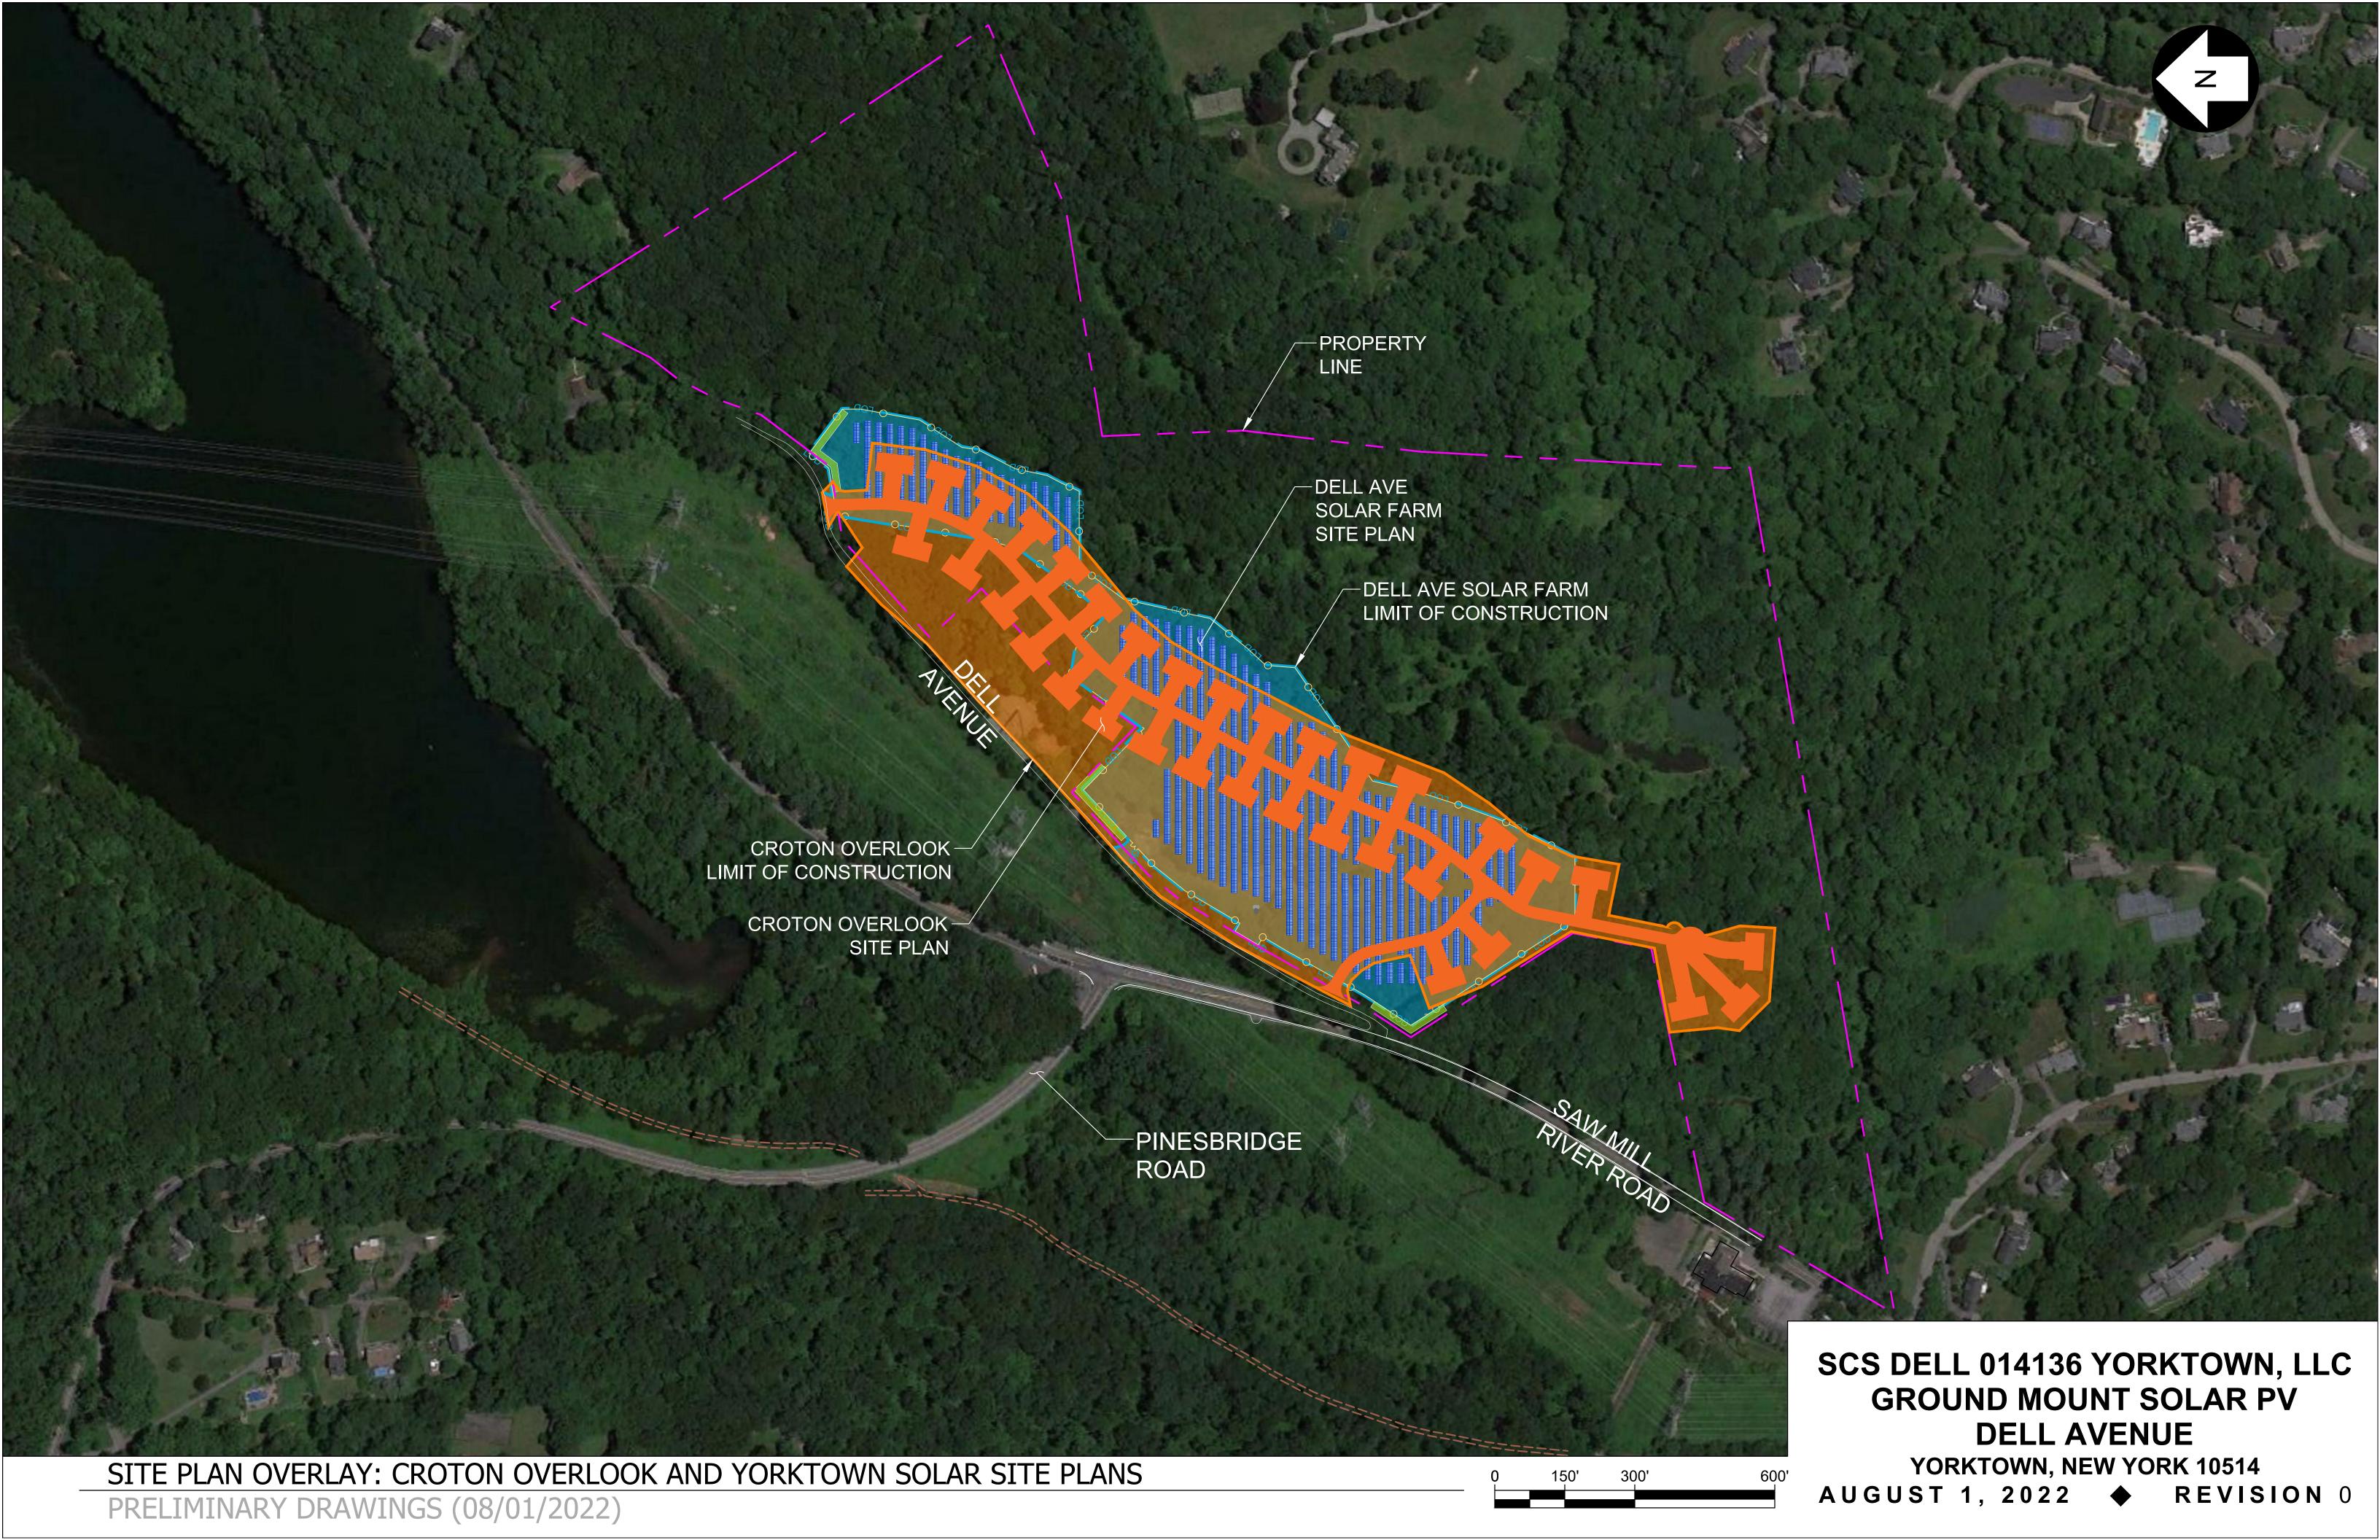
COMPARISON FOOTPRINT BETWEEN CROTON OVERLOOK AND DELL AVENUE SOLAR FARM

Upon examination of LOS and photographs from the Croton VIA, many of the views to the site were minimal to none. It is reasonable to conclude that visual impact of the Project is less than that represented by the Croton Overlook project, as the proposed vertical heights of buildings measured 28 feet tall at the top of roofline. There is also 9 years of additional vegetative growing seasons between data and photographs acquired in 2010 vs the published LiDAR data flown in 2019.

The Dell Avenue Solar Farm design, with a significantly lower vertical footprint than the Croton Overlook Development, includes the preservation of existing trees as natural buffers. Through appropriate siting and mitigation, the Applicant also has reasonably minimized or avoided adverse visual impacts to the maximum extent practicable, while also resolving to provide additional year-round evergreen landscape mitigation screening in several areas.

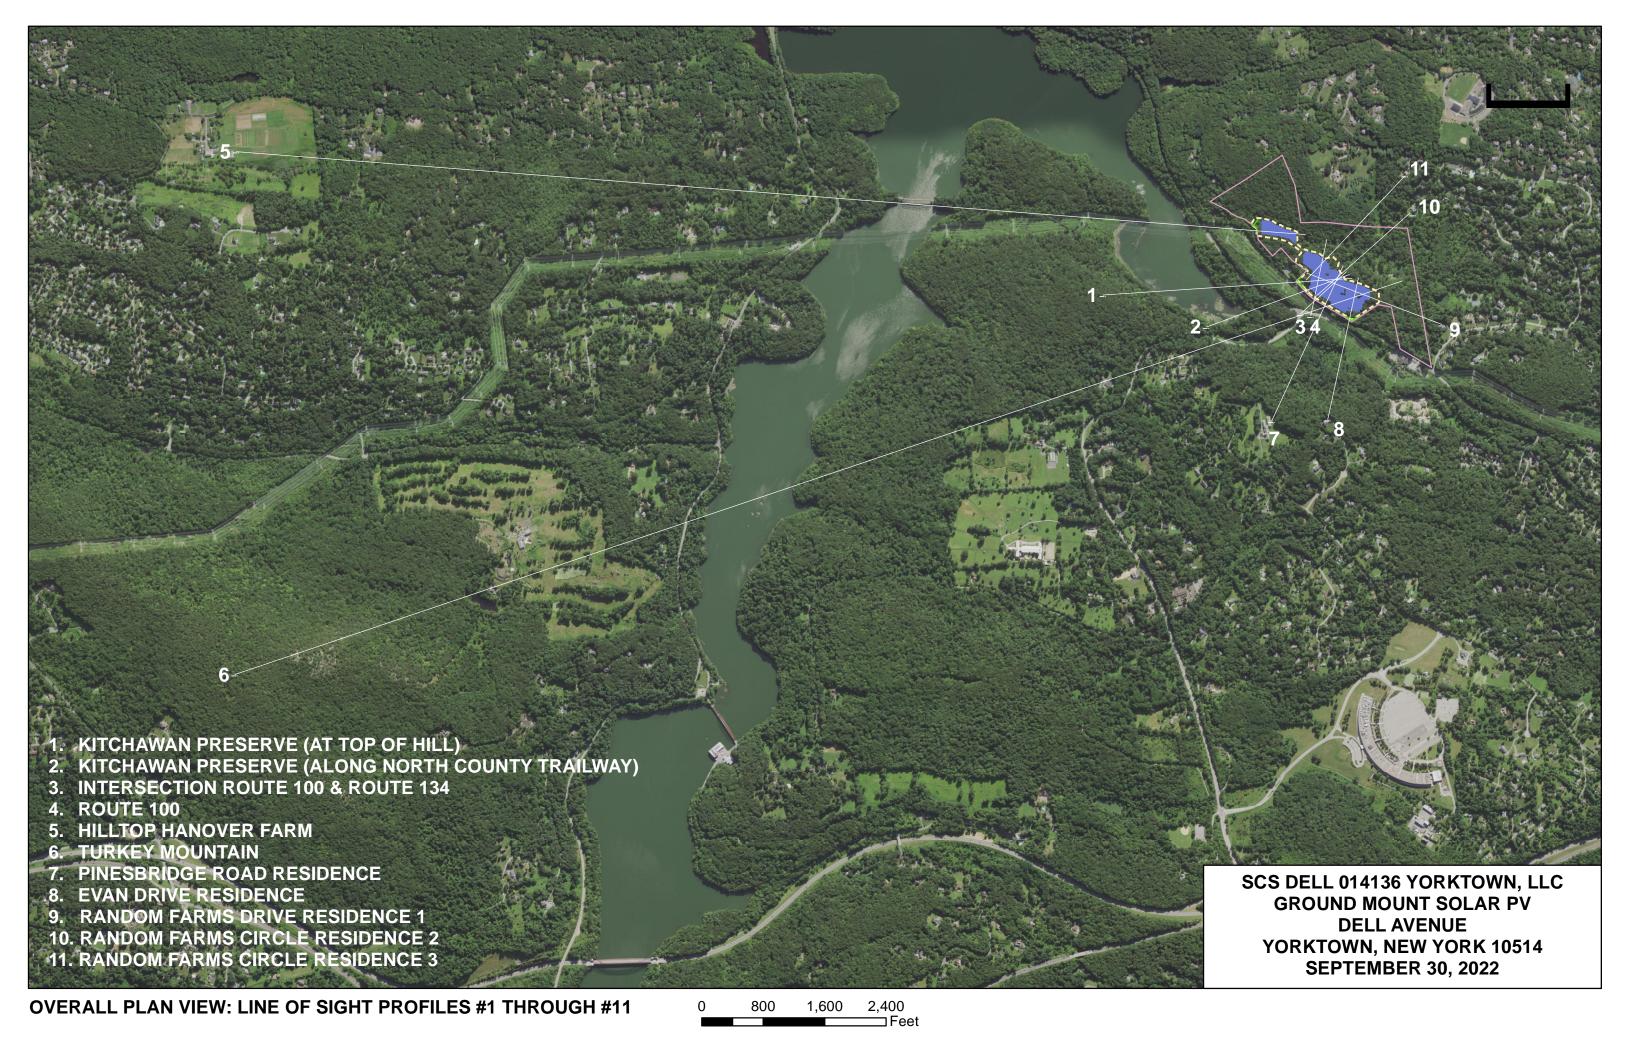
OVERALL PLAN VIEW: LINE OF SIGHT PROFILES #1 THROUGH #11

The LOS viewpoint locations are those requested by the Yorktown Planning Department, most of which originated from the Croton VIA. Please refer to the Overall Plan View in Attachment 2 for profile locations. Bald Mountain and the Taconic State Parkway are not included in this update. The Croton VIA previously concluded that there will be no views from these locations, as both viewpoints are blocked by topography.

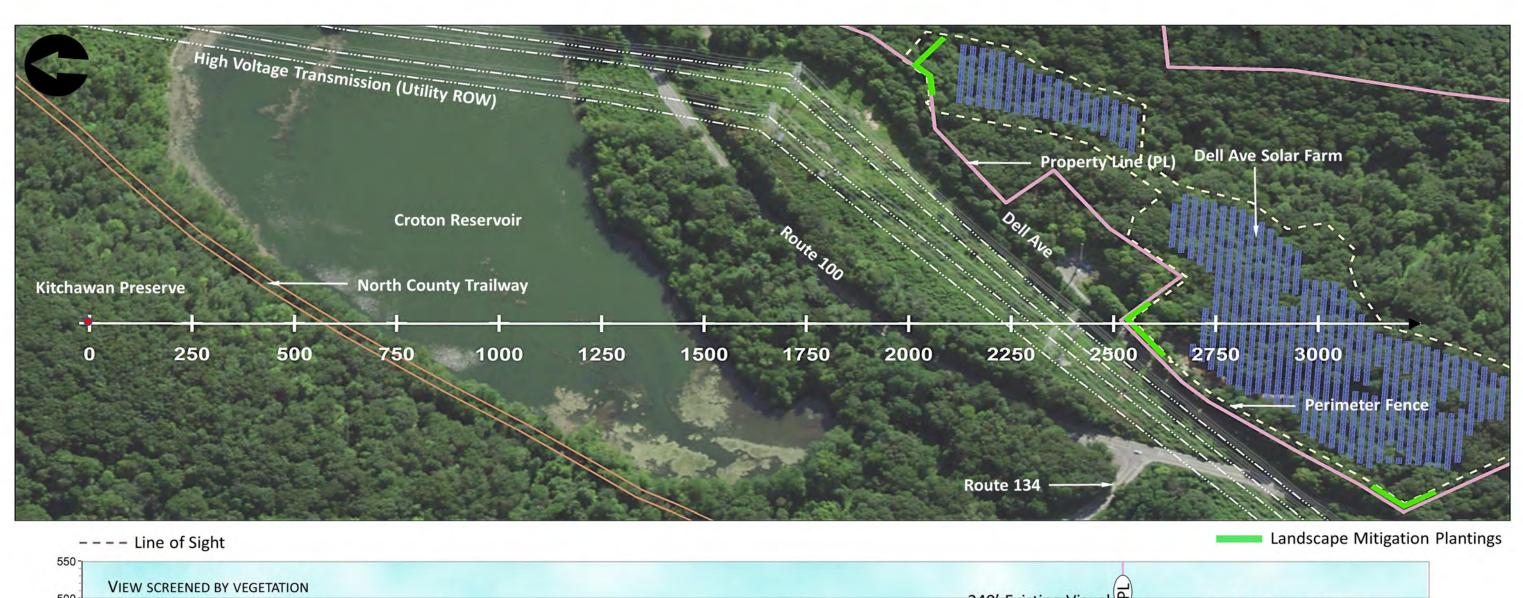
LINE OF SIGHT PROFILES

Kitchawan Preserve is a 208-acre natural preserve bordered by Croton Reservoir and the North County Trailway. As noted in the aerial photo for LOS 1 in Attachment 3, the Preserve is wooded mainly with mature deciduous tree species. The viewpoint is positioned at a high point and overlooks a south-facing descending slope leading to Croton Reservoir. The LOS 1 viewpoint is higher than the Project. As the elevation profile shows, views are not anticipated because of the approximately 315 feet of existing vegetative screening from varying canopy levels in the forested environment. Prevalent along the profile environment also is the presence of a high voltage transmission utility corridor that is just north of the Project and Dell Avenue. The approximate 150-foot tall lattice towers (as measured by LiDAR data) provide a significant visual presence of their own in the general vicinity. The profile crosses 240 feet of ROW.
