Section 3.0 Wetlands and Surface Water Resources

NYSDEC Wetland Map
Underhill Farm
Underhill Avenue, Yorktown
Source: DEC Environmental Resource Mapper

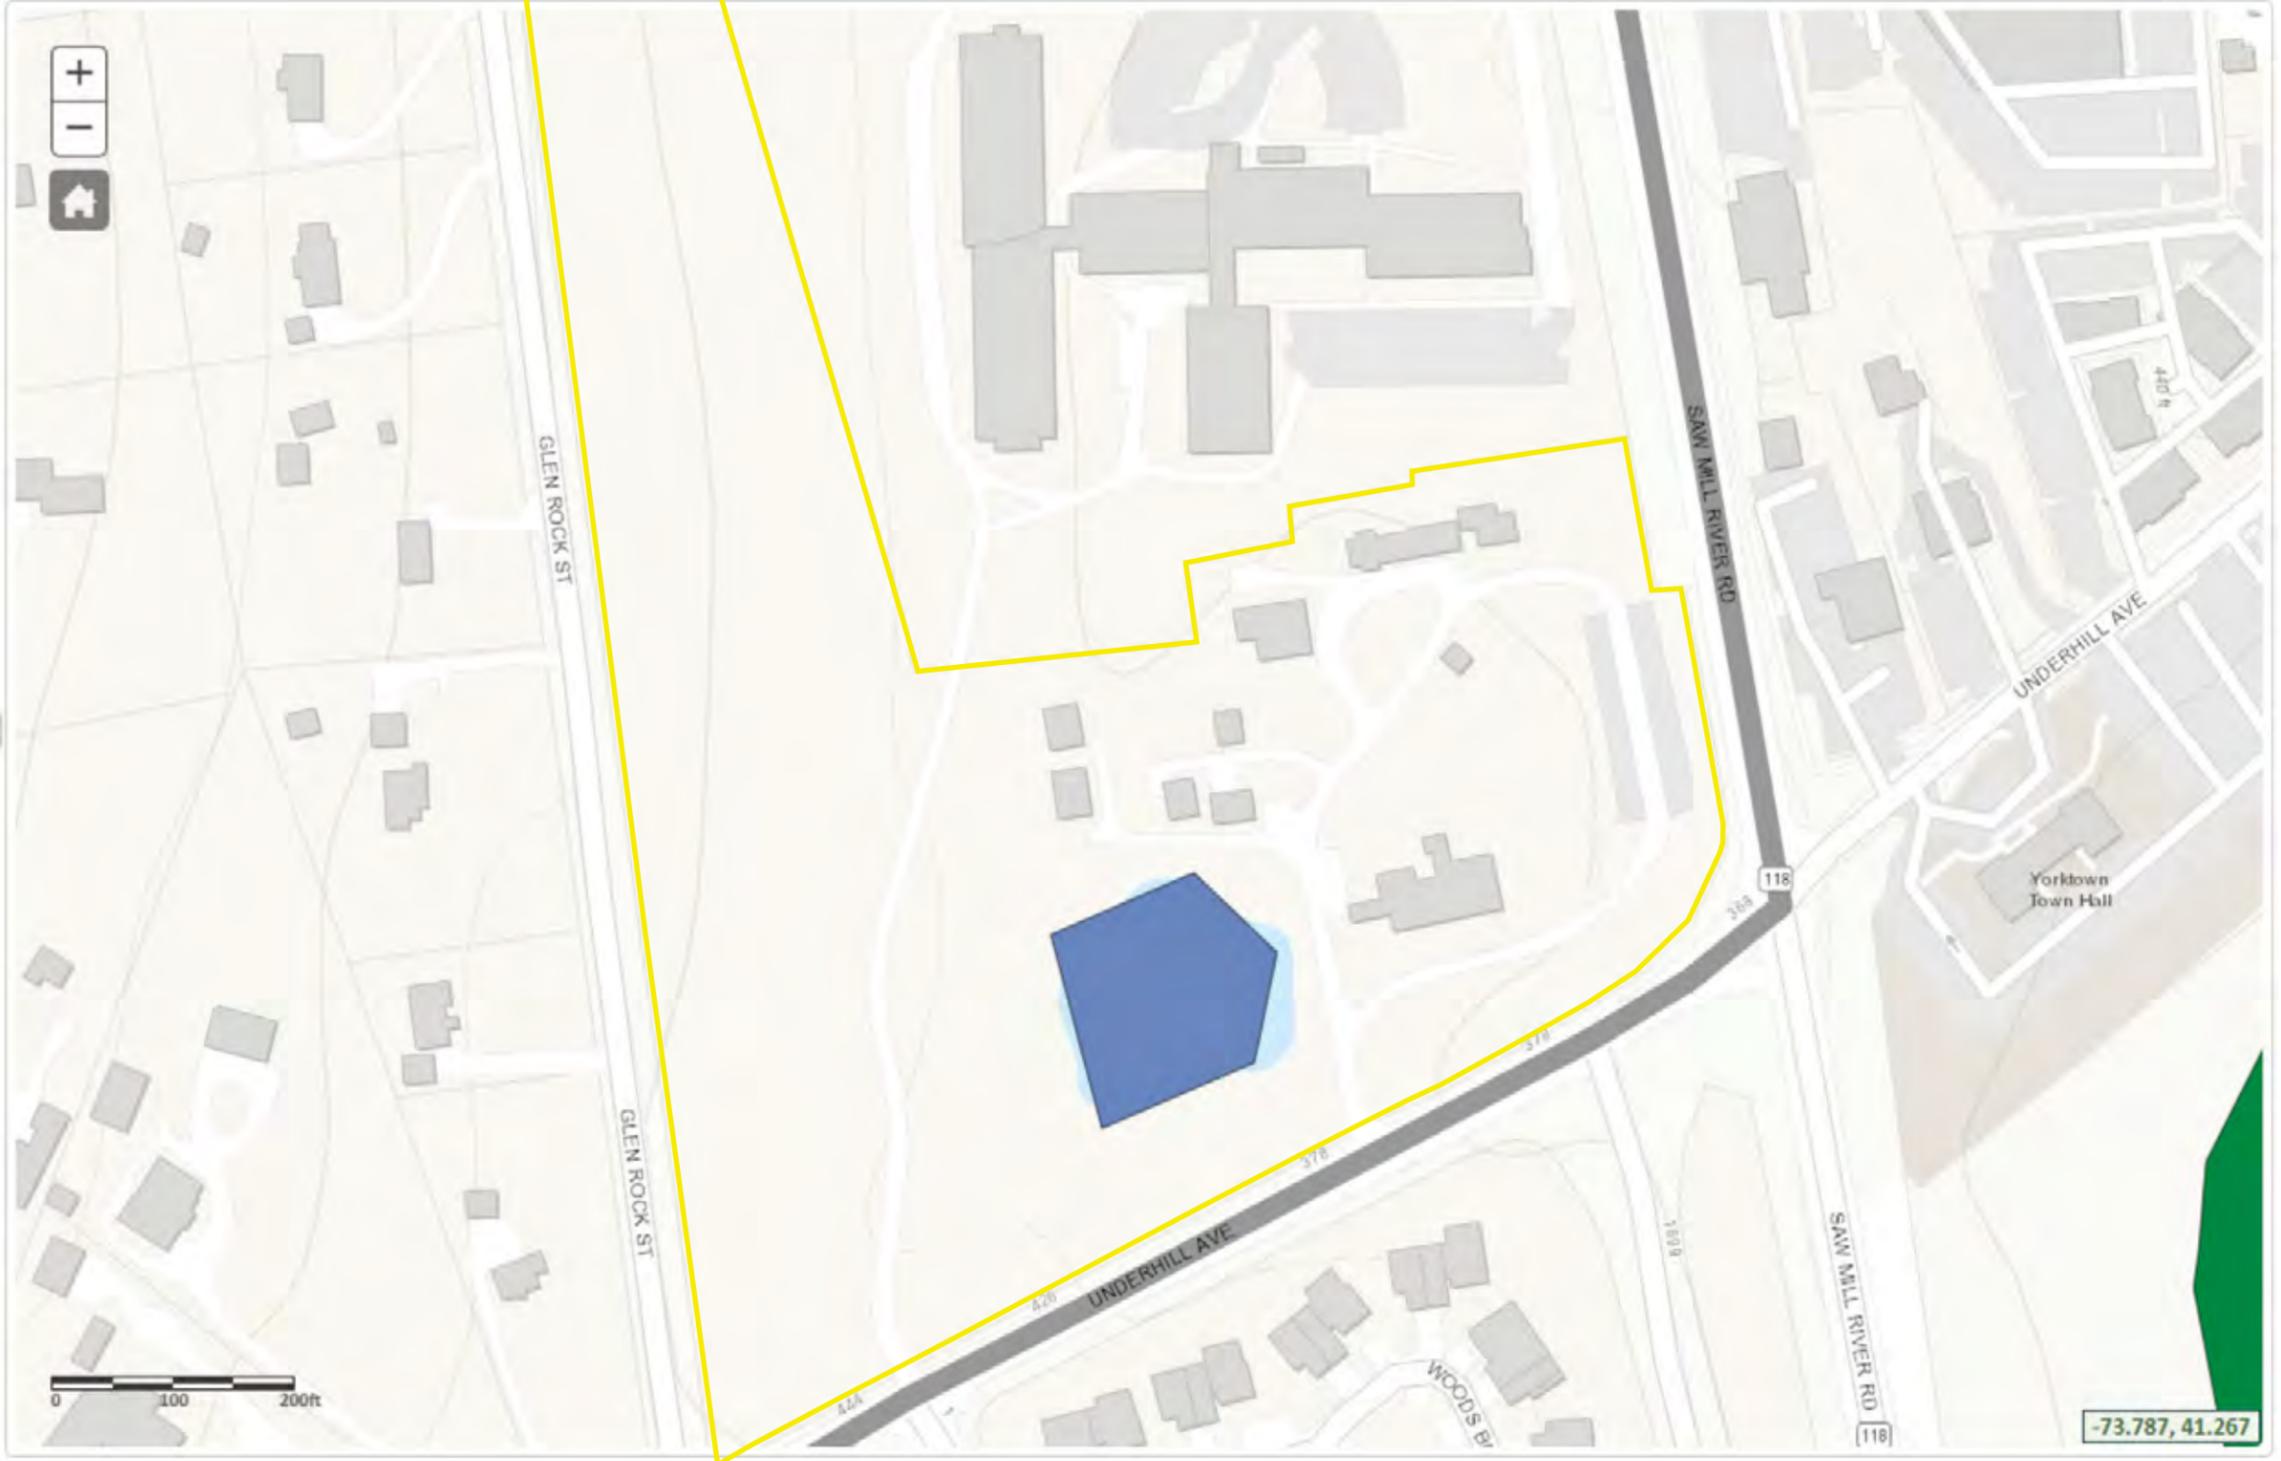
National Wetland Inventory Wetland Map
Underhill Farm
Underhill Avenue, Yorktown
Source: DEC Environmental Resource Mapper

No New York State-mapped wetlands exist on the site. The existing pond is mapped on the National Wetland Inventory as a "freshwater pond". During the site visits, three areas were identified that meet the delineation criteria of Chapter 178 of the Town of Yorktown Code. Representative photos of the site, historic aerial photos, the NRCS soils mapping and relevant information are attached.

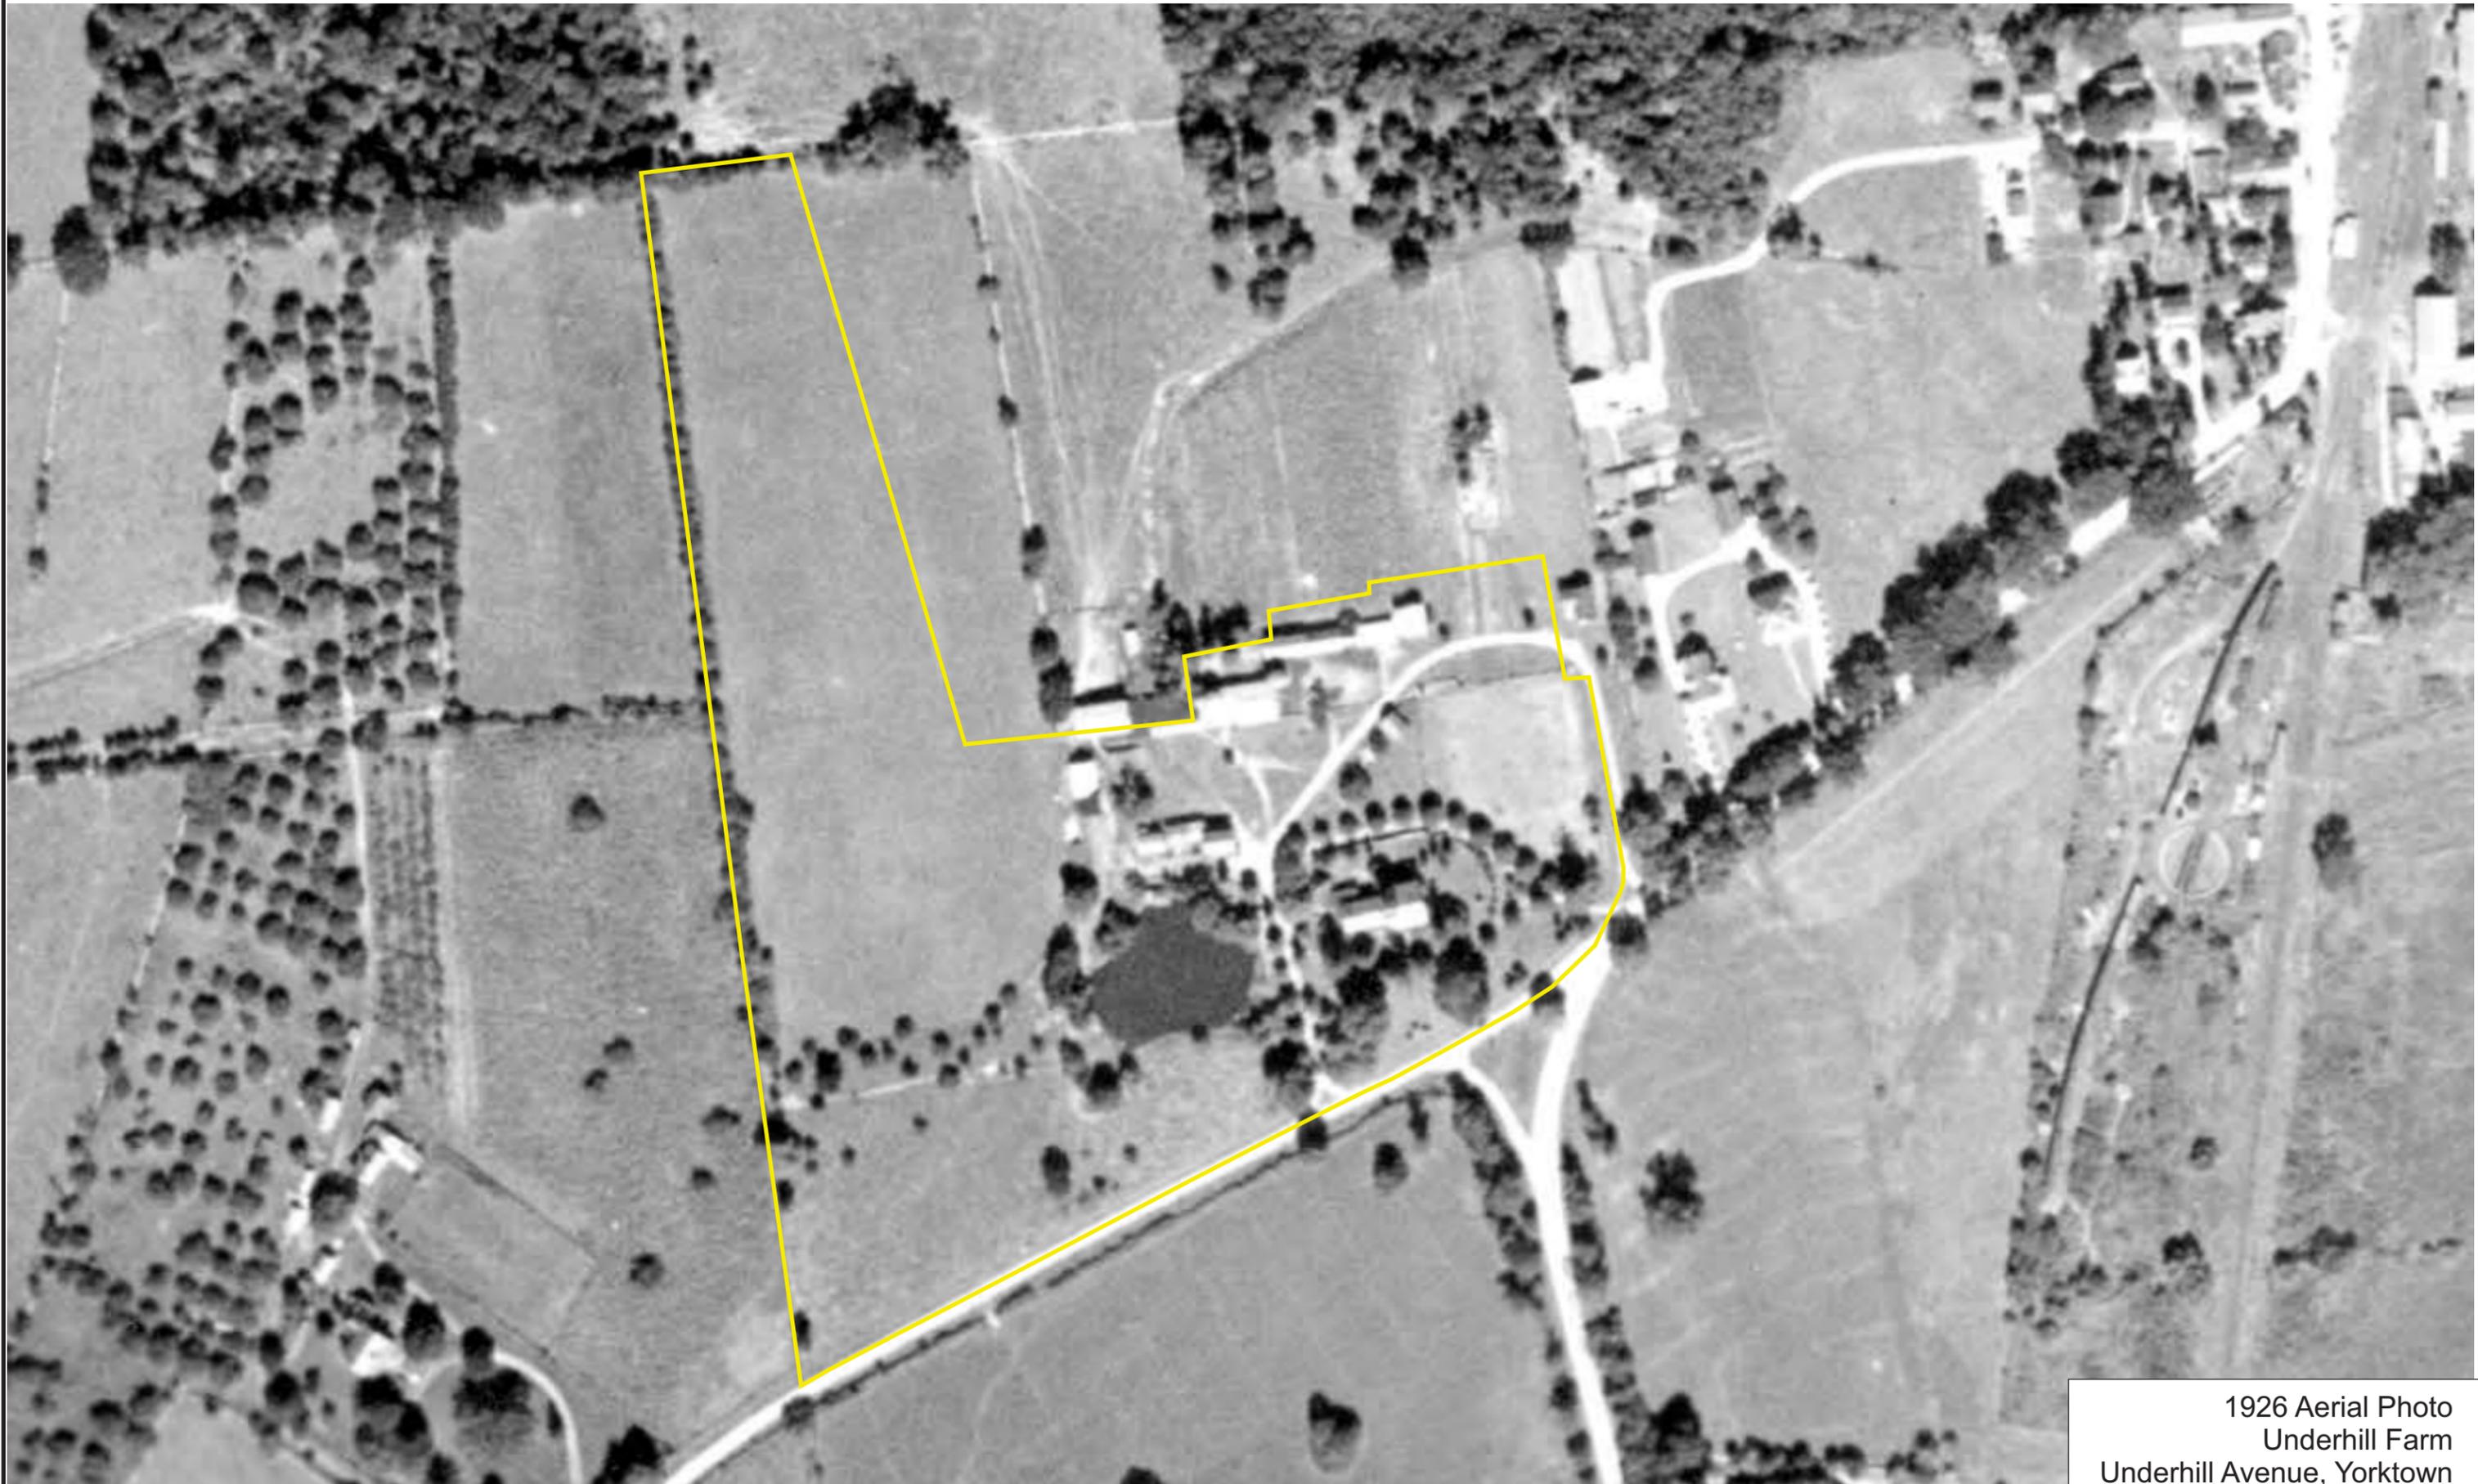
1926 Aerial Photo
Underhill Farm
Underhill Avenue, Yorktown
Source: Town of Yorktown

The watercourse flows into the existing pond on site. Known to exist since at least 1926 (see attached 1926 aerial photograph), the pond is relatively shallow and bordering on eutrophic. A significant part of the pond edge is bordered with stone. The pond outlet is a stone culvert on the north side, with a significant drop to a deep culvert underground to and through the Beaver Ridge

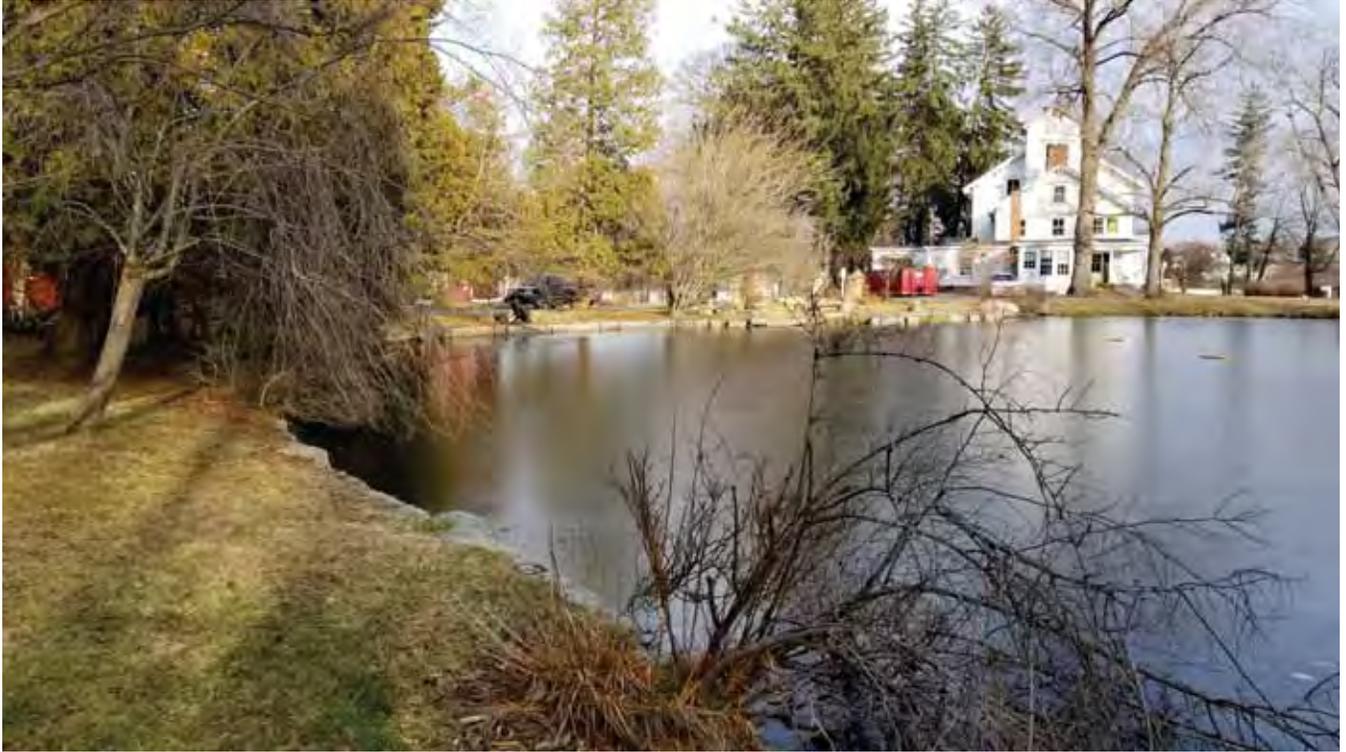
Photo 1 - Existing Pond Looking East

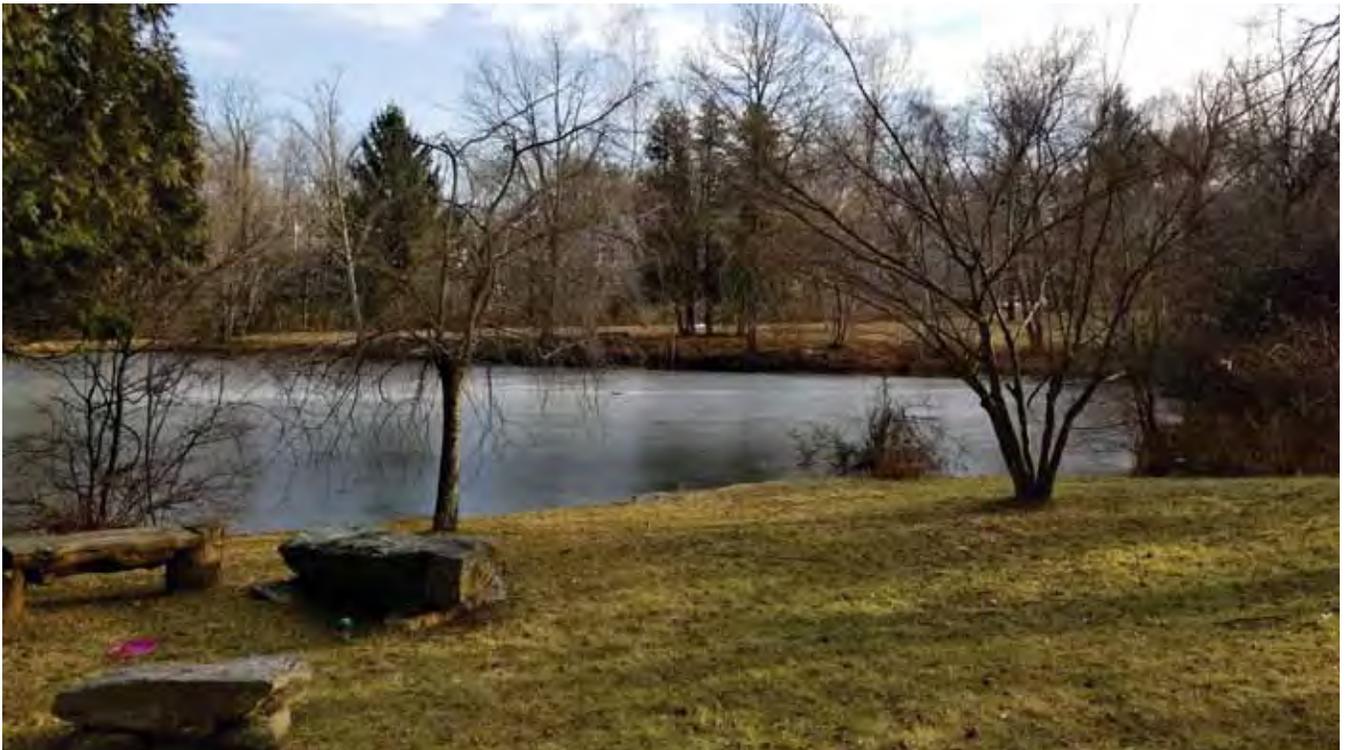
Photo 2 - Existing Pond Looking South

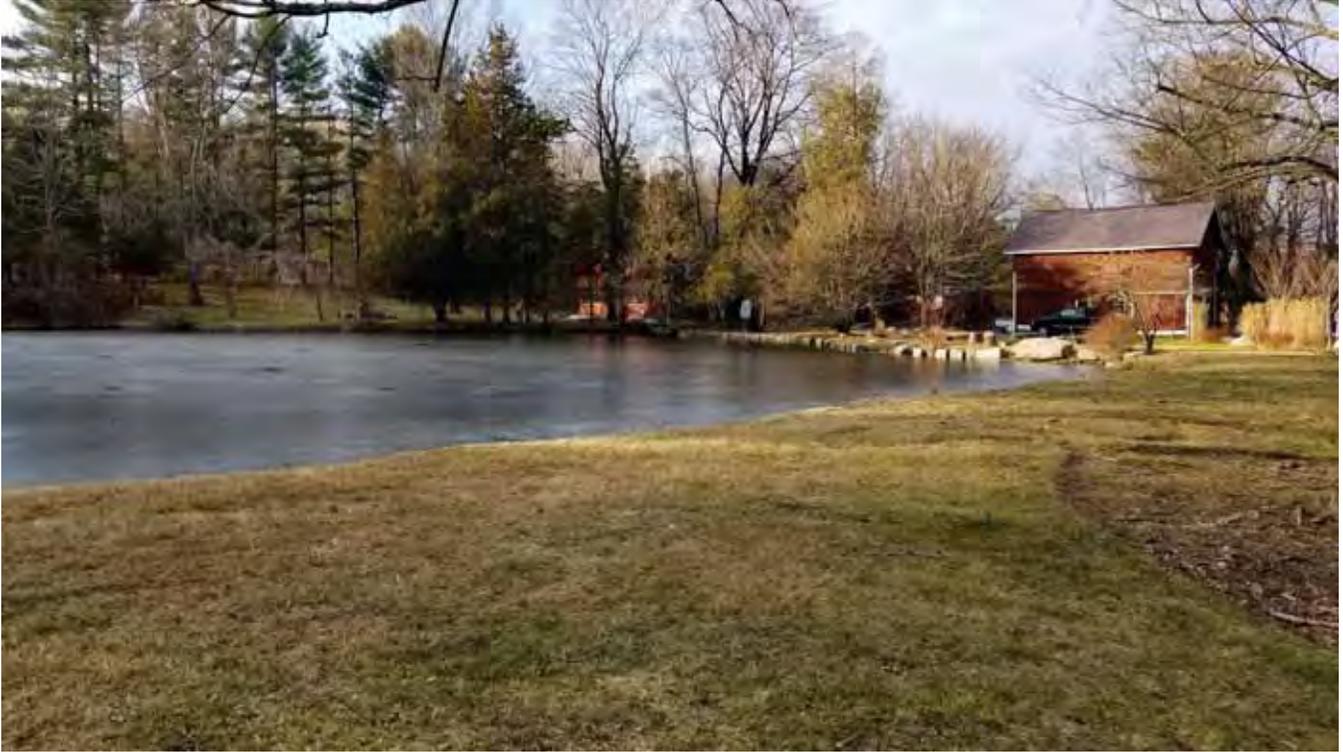
Photo 3 - Existing Pond Looking North

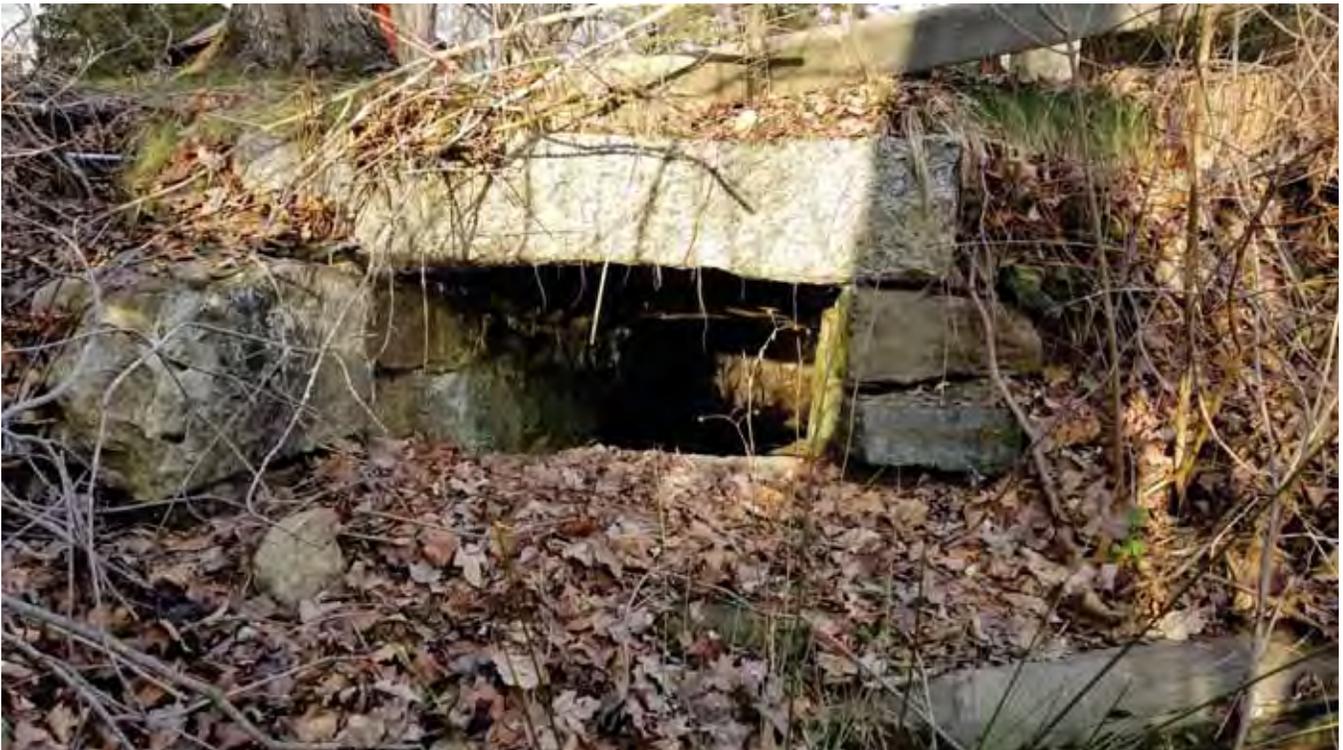
Photo 4 - Existing Pond Outlet

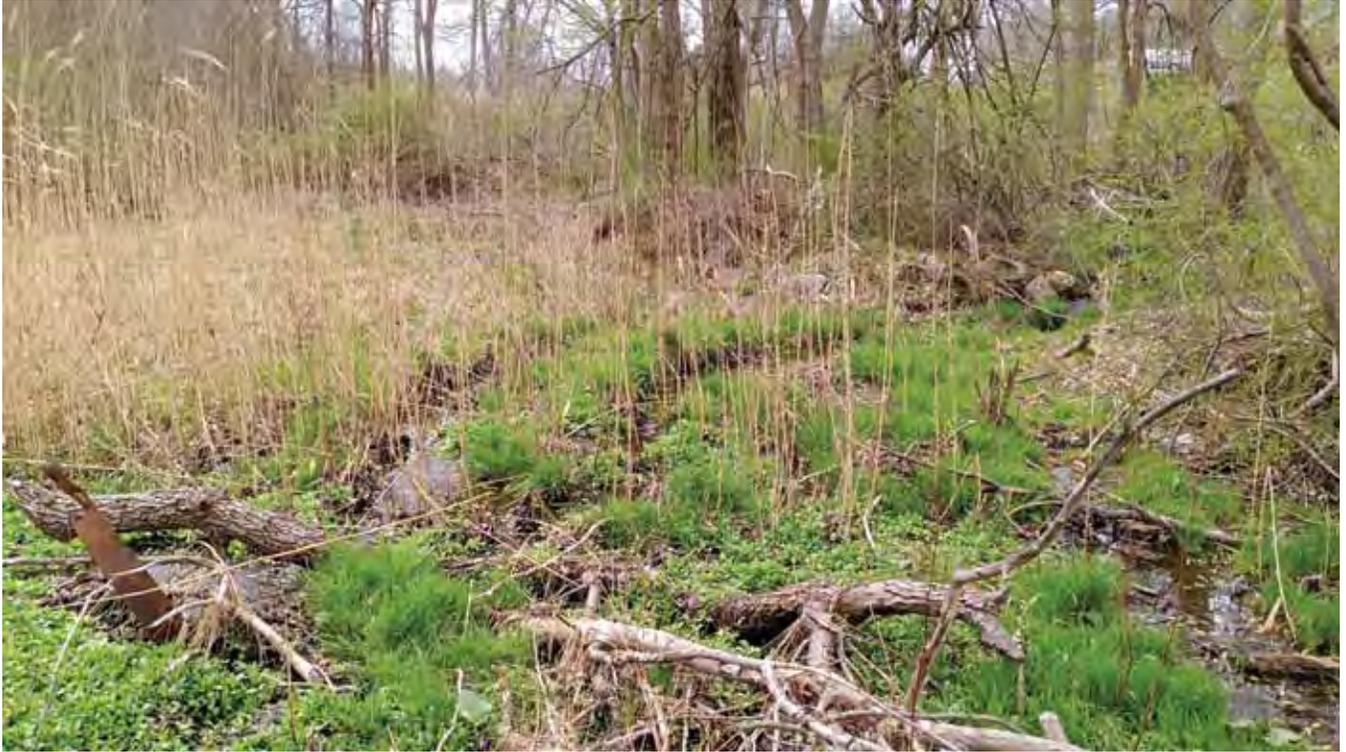
Photo 5 - Wetland A west of access road

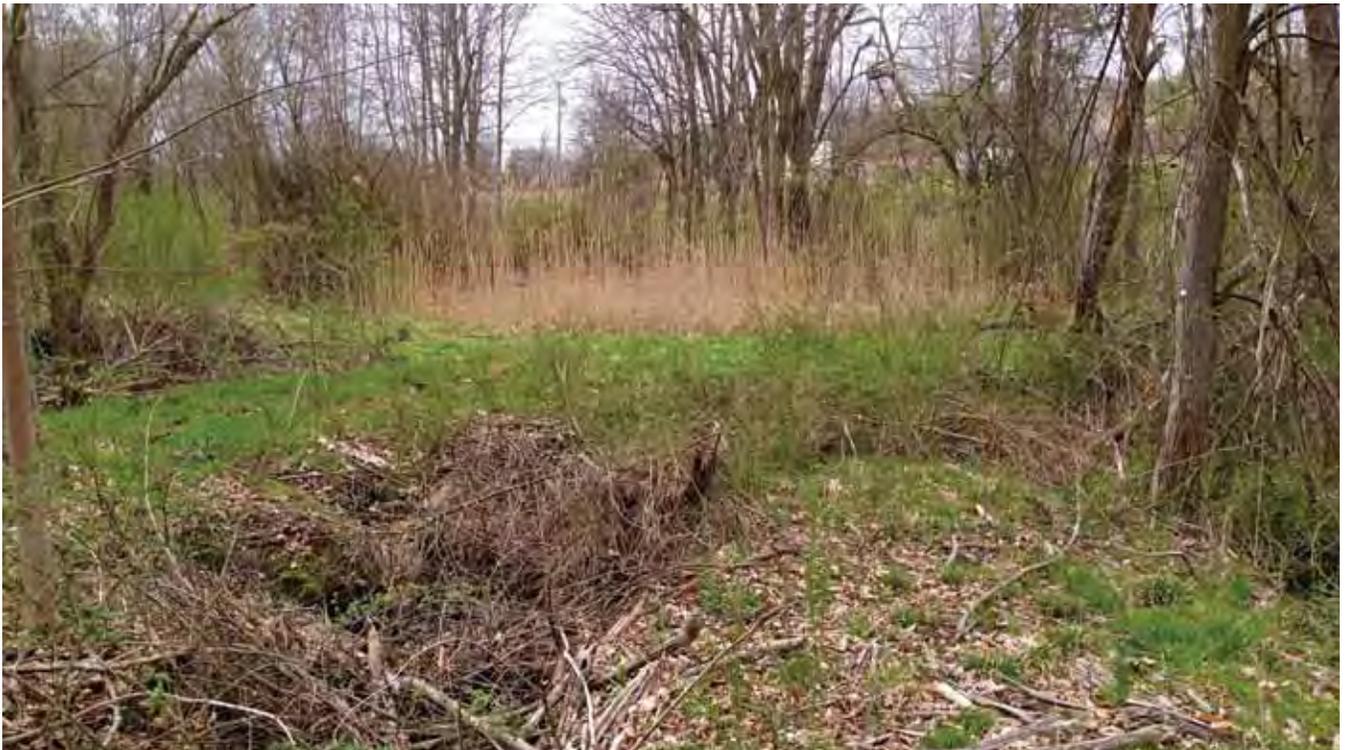
Photo 6 - Wetland A with outlet from clogged culvert in foreground,
Glen Rock Street in background

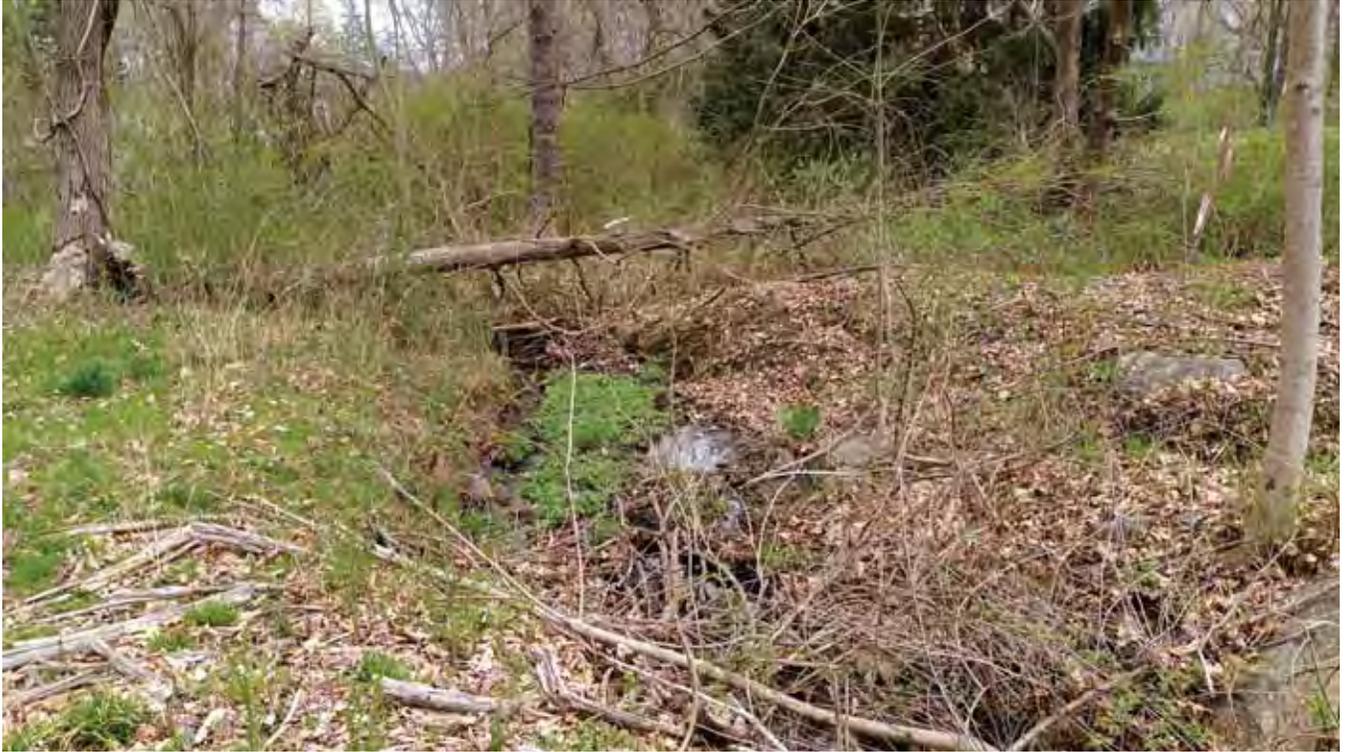
Photo 7 - Wetland A looking west towards pond

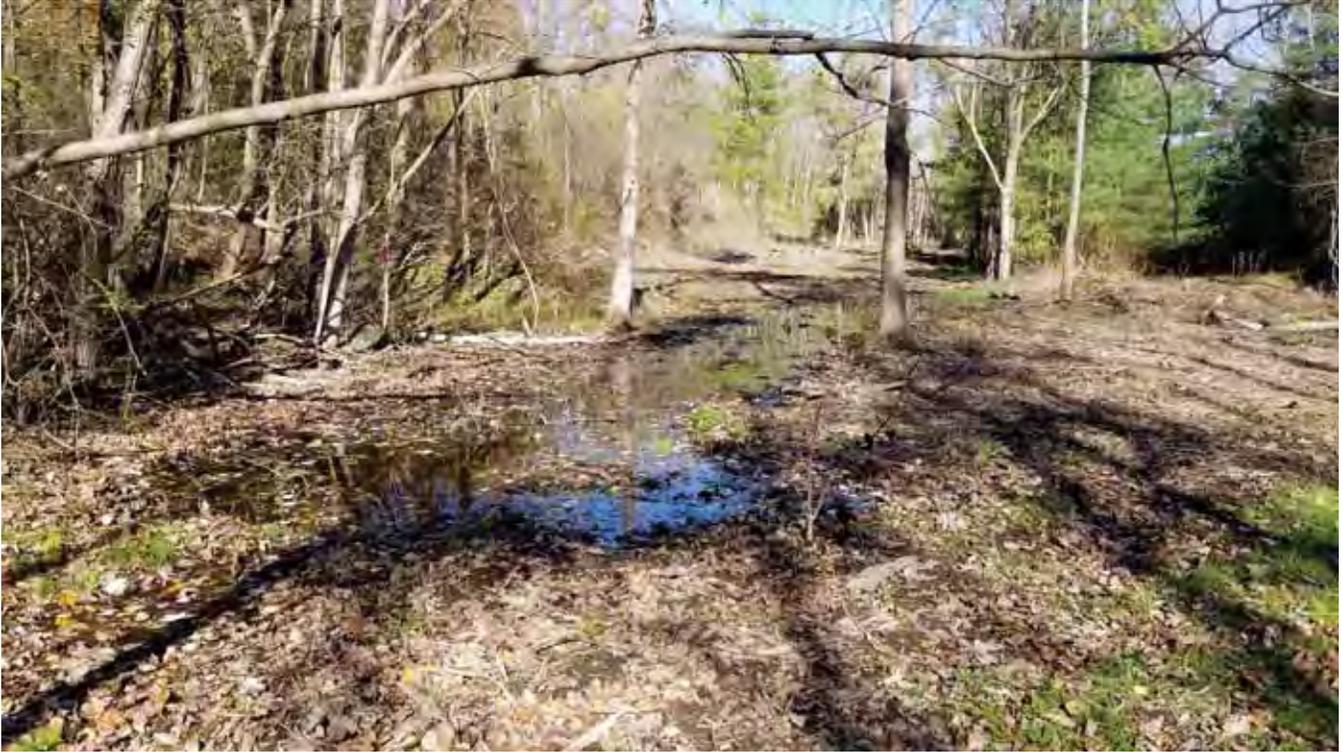
Photo 9 - Wetland C looking north

Wetlands B and C are two small pockets of saturated soils (initially delineated at about 2,000 square feet each) on the west side of the emergency access way (Photos 9 and 10). Historically, these wet areas first appear in aerial photographs in 1990 with the completion of the emergency access road from Underhill Avenue. When this access was constructed, soil was stripped and piles of fill were left on either side. Wetland B was likely a borrow pit where soil was extracted to level out the road. This combined with the lack of a culvert under the access created a damming effect that allows water to pool in Wetlands B and C for a significant portion of the growing season. A total of 14 flags were hung for wetlands B and C. Wetland vegetation is largely absent in both wetlands.

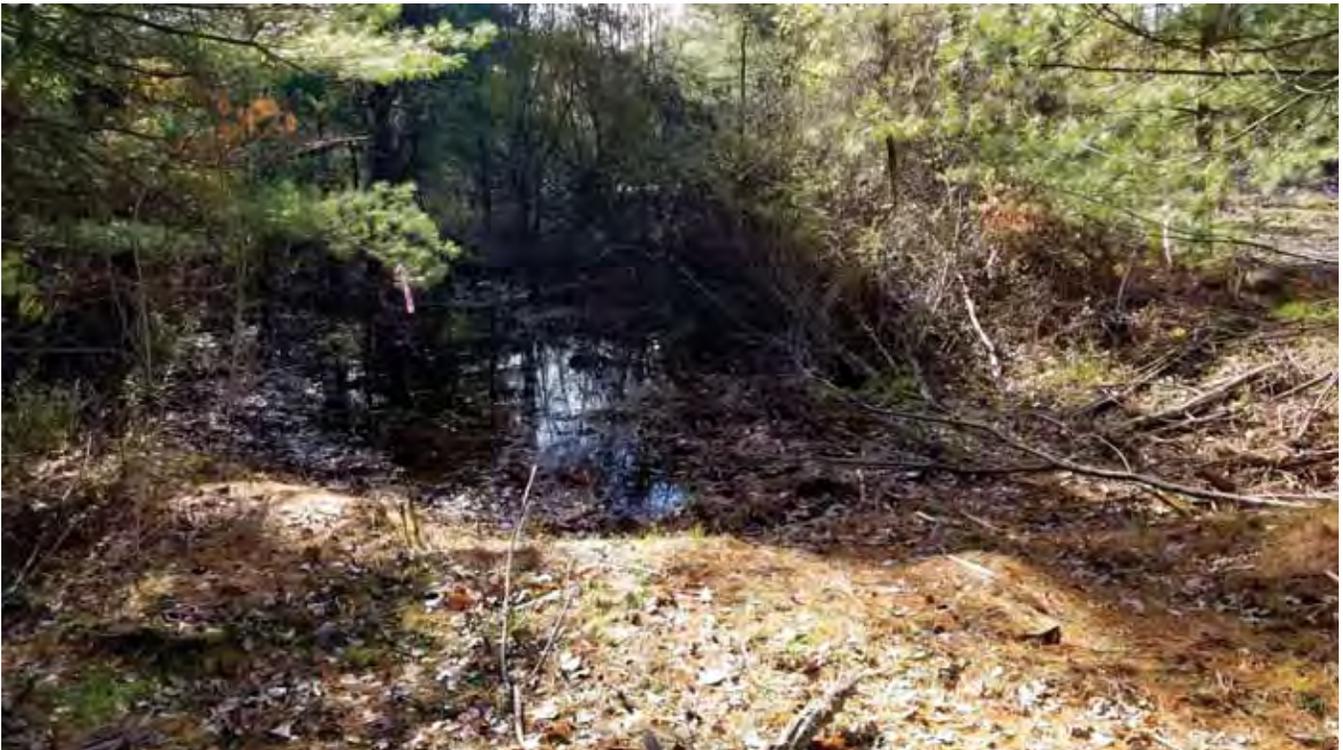
Photo 10 - Wetland B looking south

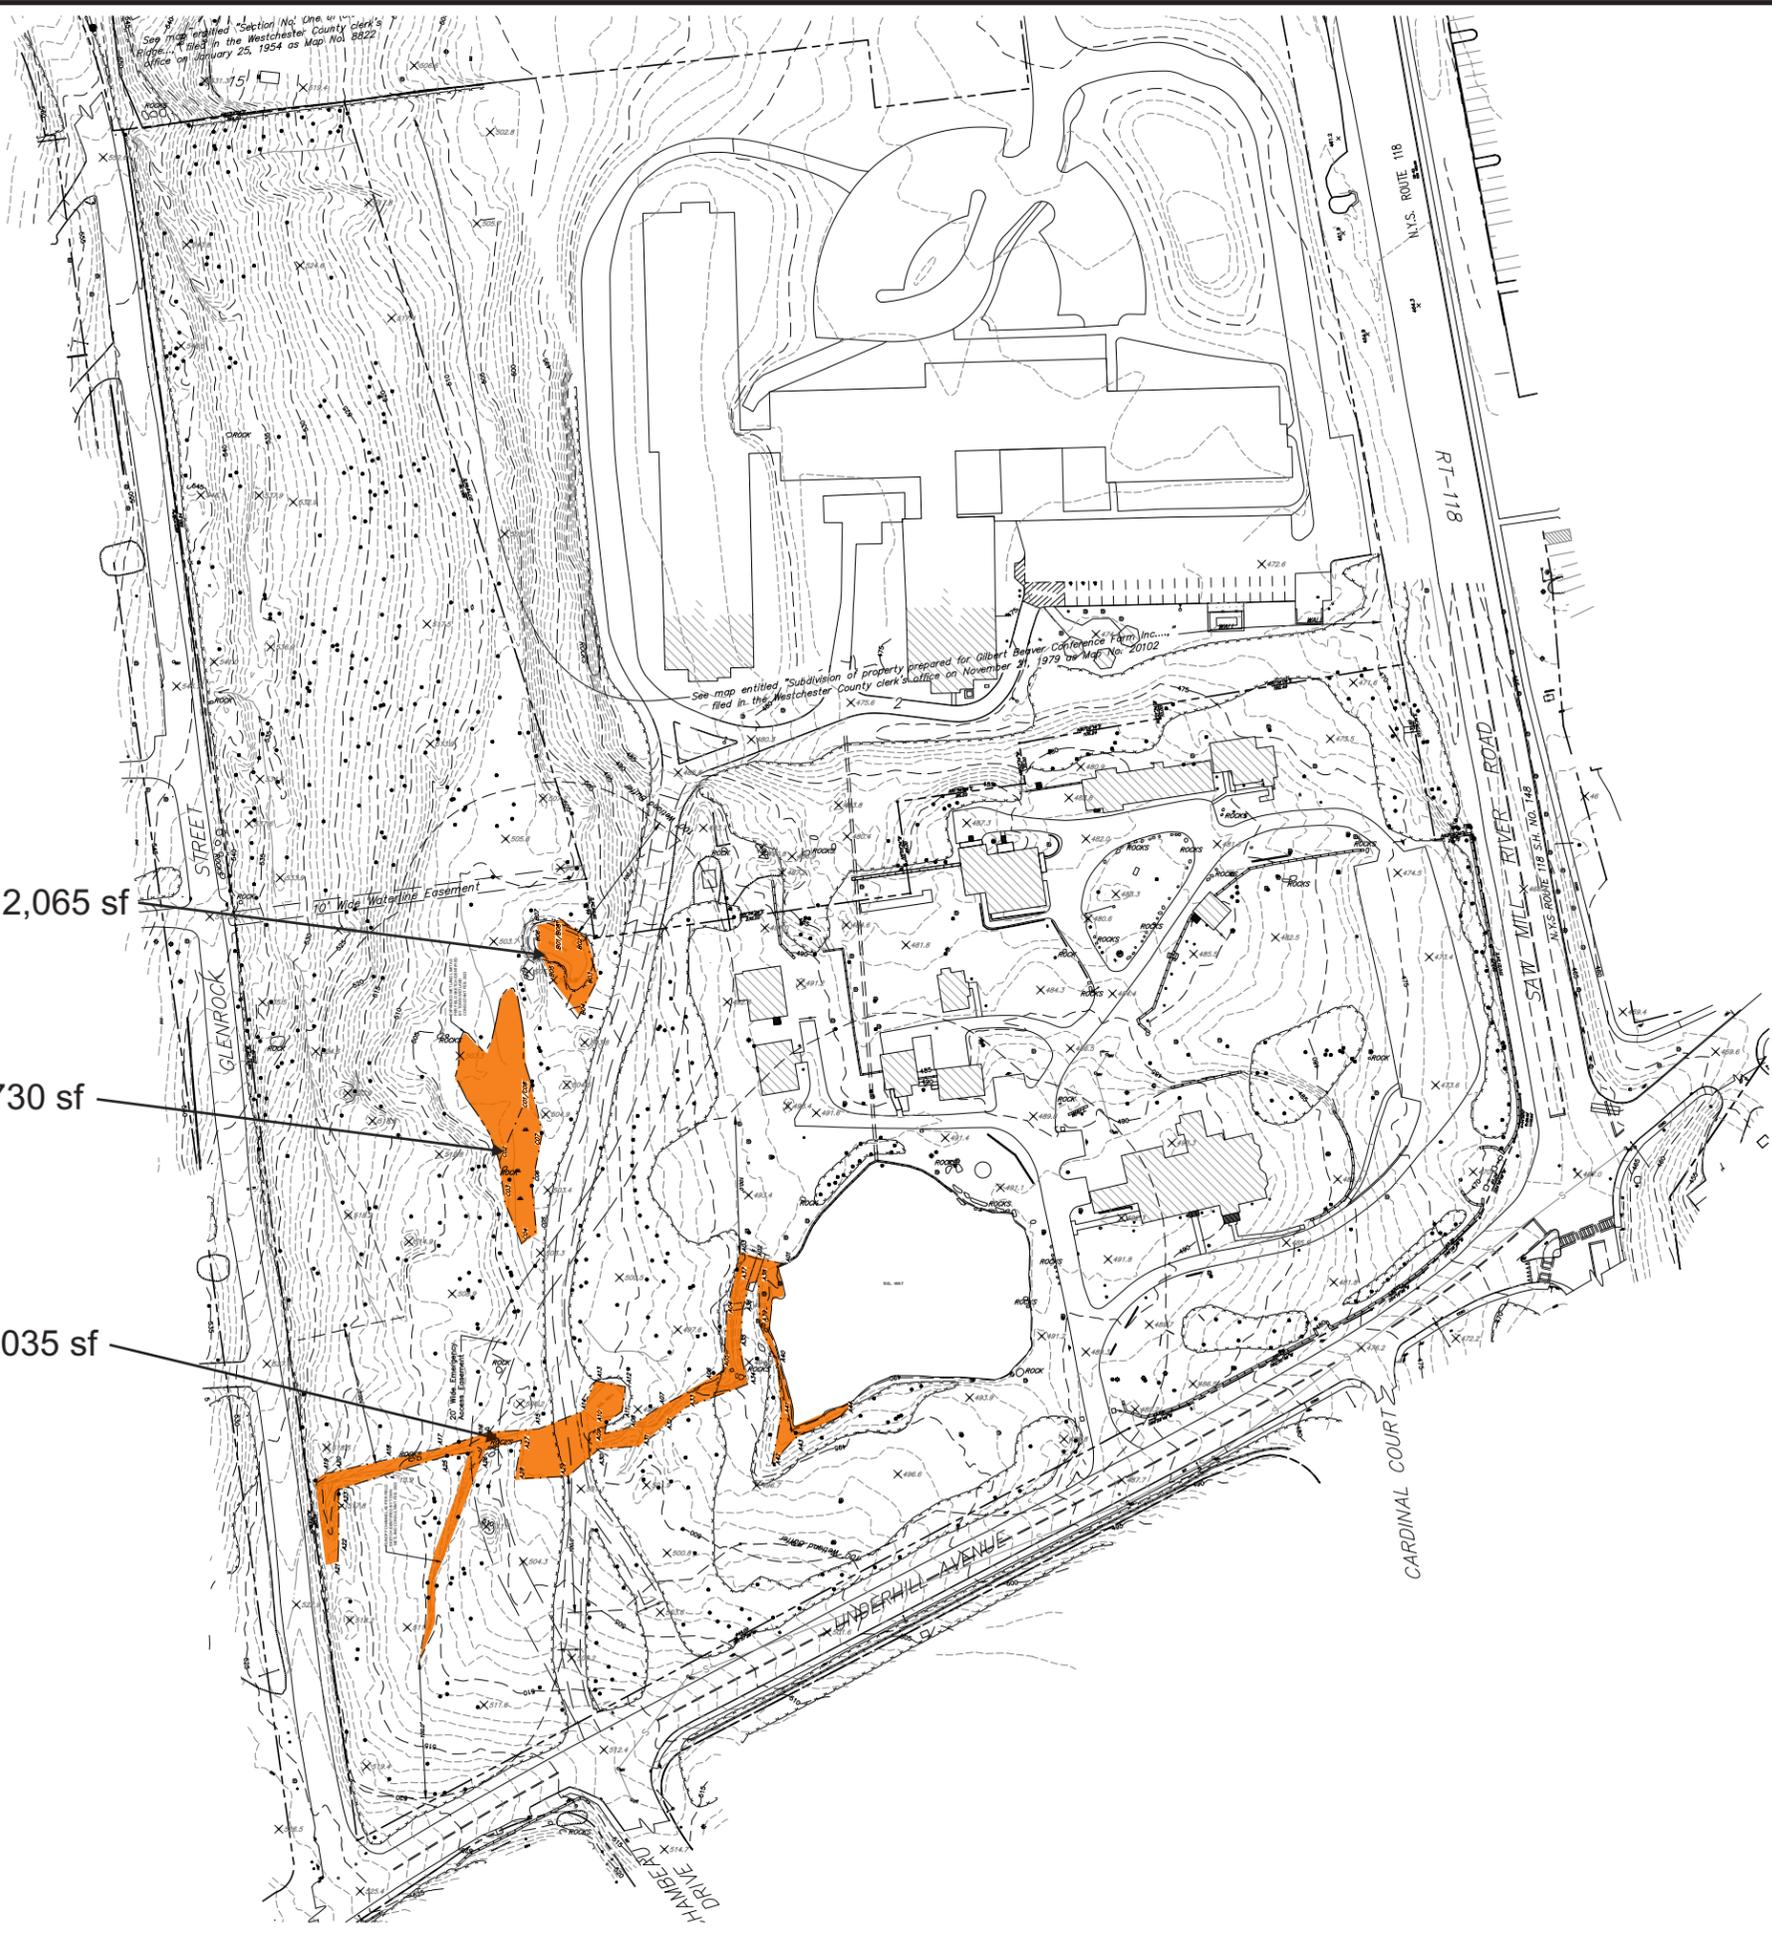
Wetland C - 5,730 sf

Wetland A - 10,035 sf

Wetland Existing Conditions Map
Underhill Farm
Underhill Avenue, Town of Yorktown
Source: Site Design Consultants
