Catskill Aqueduct Repair & Rehabi

Town of Yorktown Planning Board

Public Hearing

Re: Wetland Permit Applications

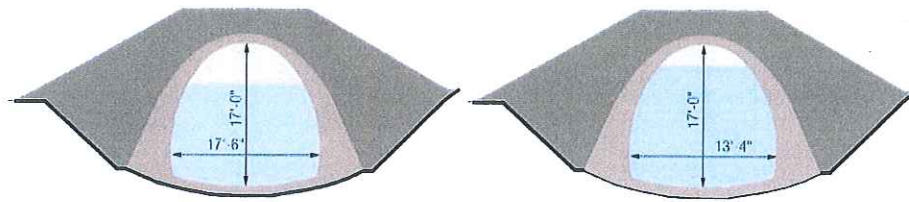
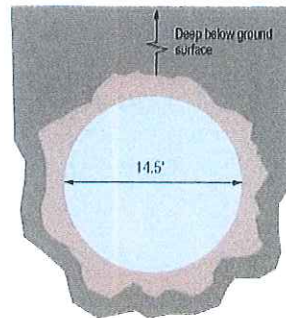
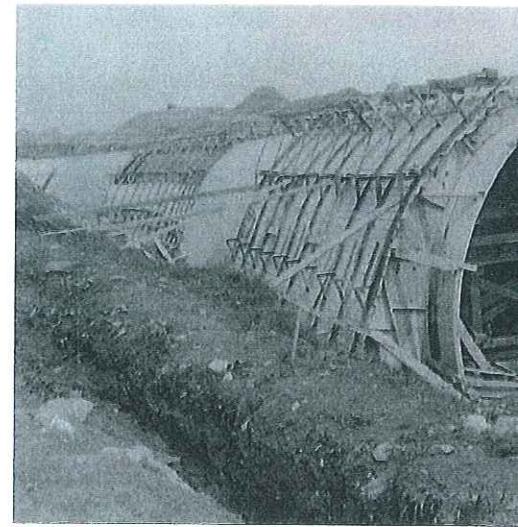
Figure 9.2-5: Types of Tunnel Segments along the Upper Catskill Aqueduct

Cut-and-Cover Tunnel

Grade Tunnel

Pressure Tunnel

Steel Pipe Siphon

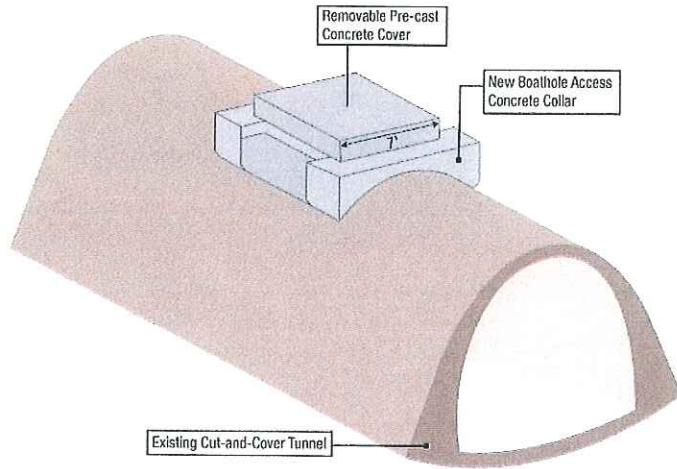
Figure 9.2-15: Boathole Installation

Figure 9.2-15: Boathole Installation

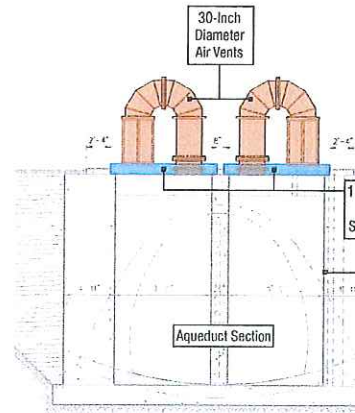
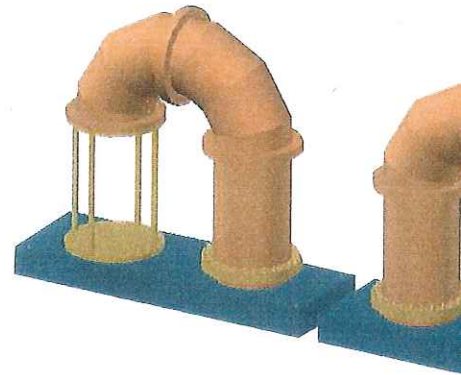
Figure 9.2-16: Air Vent Installation Example

Figure 9.2-16: Air Vent Installation Example

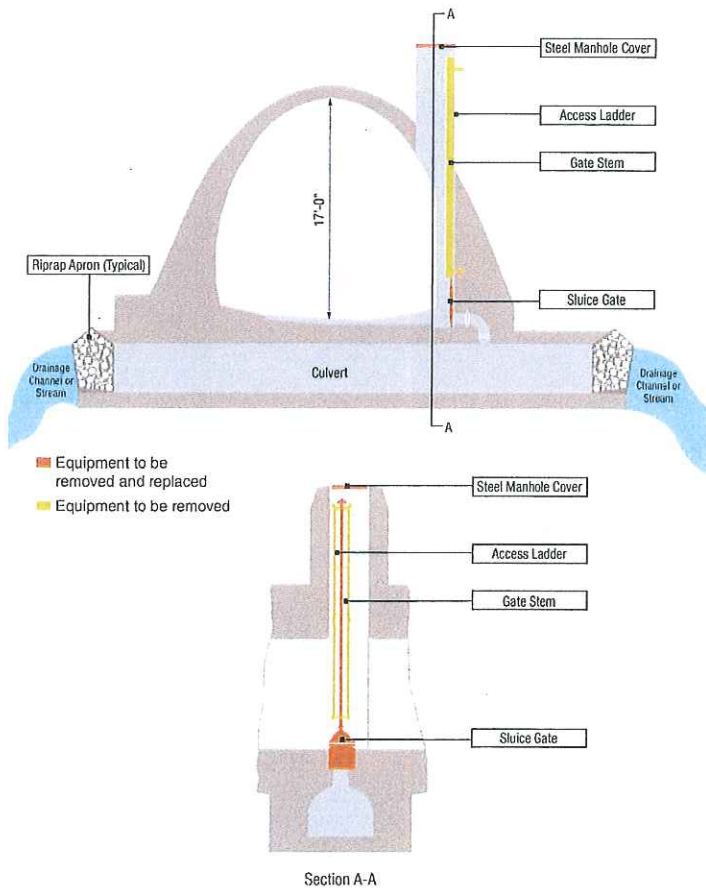
Figure 9.2-17: Culvert Drain Sluice Gate Repairs

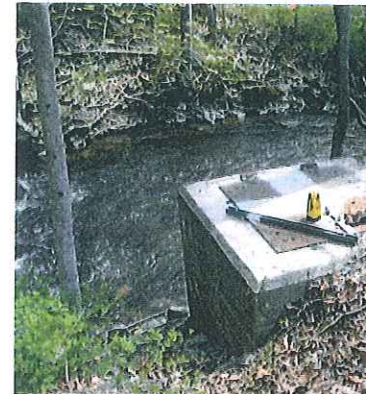
Photograph 1: Hunters Brook Steel Pipe Siphon east blow-off chamber.

Photograph 1: Hunters Brook Steel Pipe Siphon east blow-off chamber at
Hunter Brook.

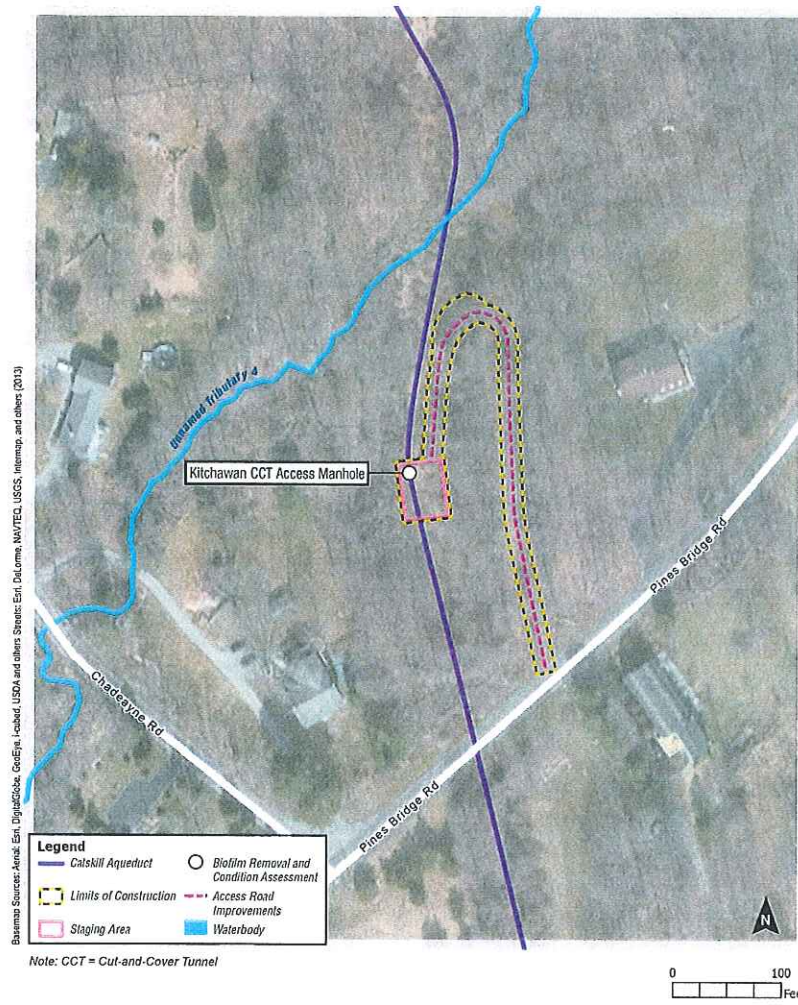
Figure 9.14-47: Site Plan – Pines Bridge Road Study Area

Figure 9.14-47: Site Plan – Pines Bridge Road Study Area

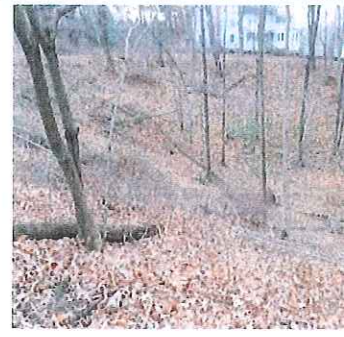
Photograph 1: Looking southwest towards Kitchawan CCT Access Photo taken from the berm of the aqueduct where off Pines Bridge Road is proposed.

Photograph 1: Looking southwest towards Kitchawan CCT Access Manhole. Photo taken from the berm of the aqueduct where the proposed access road off Pines Bridge Road is proposed.

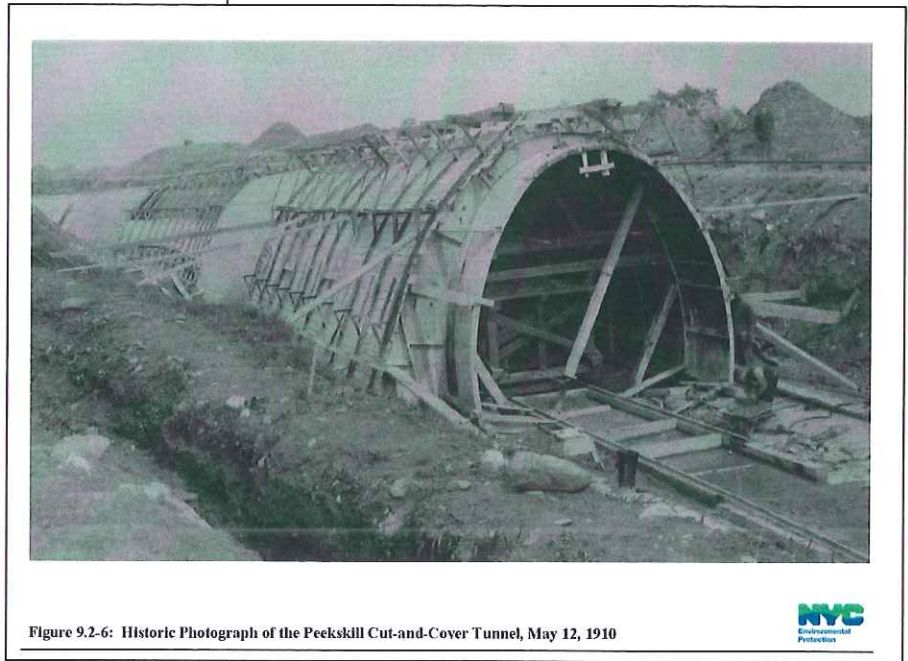
Figure 9.2-6: Historic Photograph of the Peekskill Cut-and-Cover Tunnel, May 12, 1910

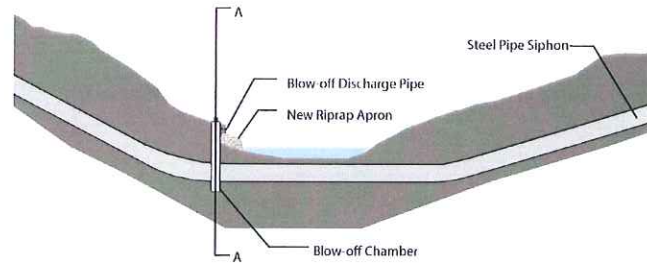
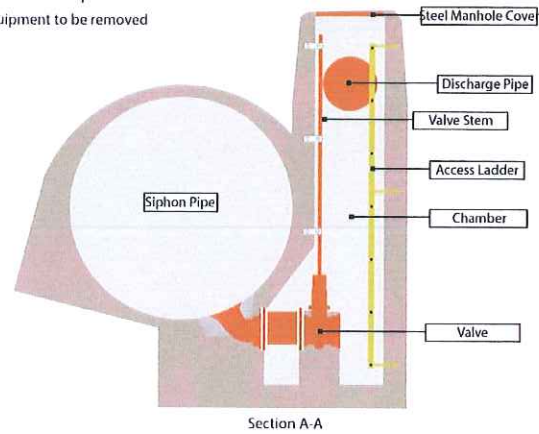
Figure 9.2-13: Siphon Drain Blow-off Valve Repairs – Under-stream

Typical Under-Stream Configuration

- Equipment to be removed and replaced
- Equipment to be removed

Section A-A

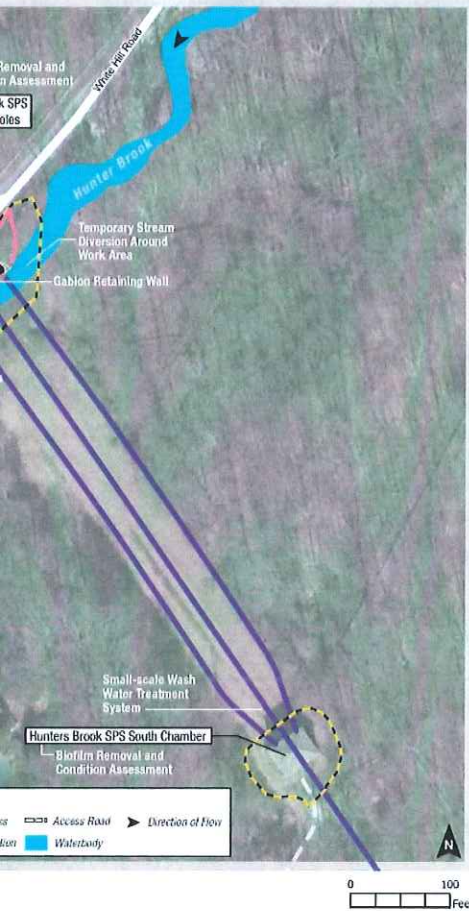
Hunters Brook SPS Blow-off Chambers and
Over – Jacob Road Study Area

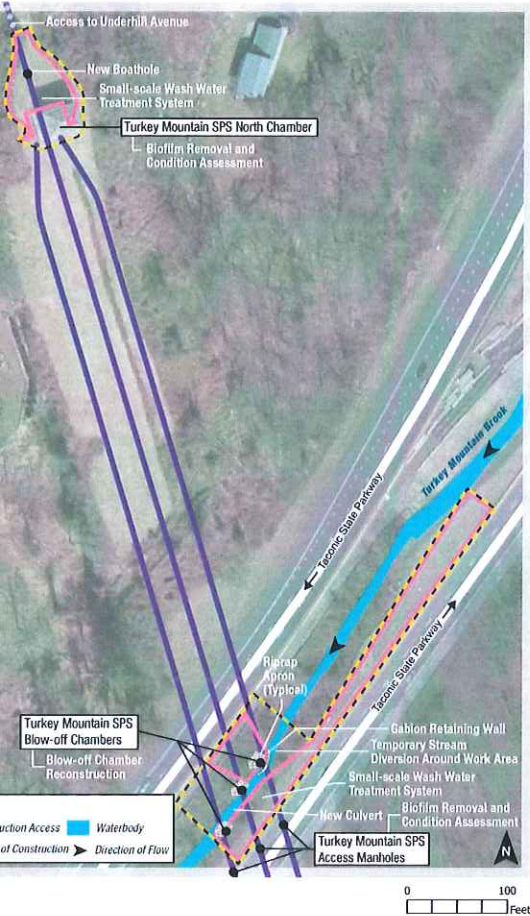
Plan for Turkey Mountain SPS North Chamber and Blow-off Chambers – Chapman Road Study Area
