**WETLAND DELINEATION REPORT  
CROTON OVERLOOK DEVELOPMENT  
TOWN OF YORKTOWN, WESTCHESTER COUNTY, NEW YORK**

**Prepared by:  
ENVIRONMENTAL COMPLIANCE SERVICES, INC.  
226 EAST MAIN STREET  
MIDDLETOWN, NEW YORK 10940**

**MAY 2011**

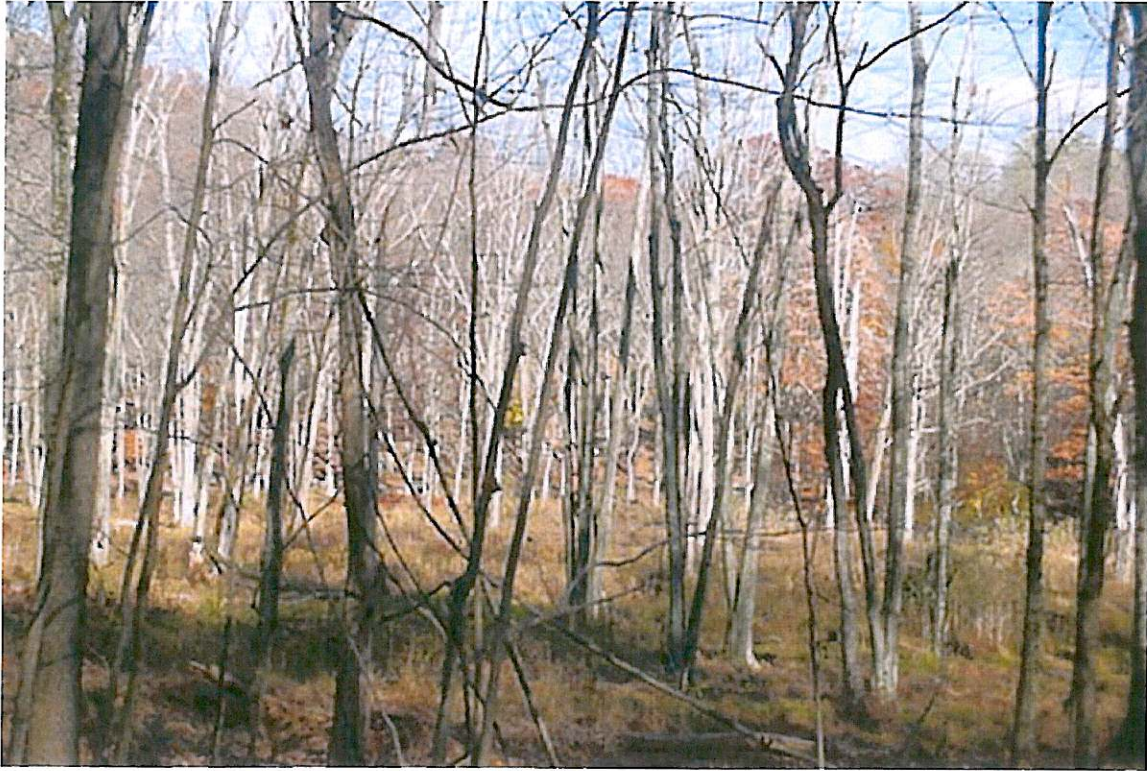
*Photo 1 - View of central portion of on-site Wetland A. Evidence of inundation and wetland vegetation in mid- and background.*

Based on the above information (including the enclosed resource information and photograph 1), two of the three wetland areas (Wetlands Areas A and C) delineated in the field by ECSI can be regarded as being Federal Jurisdictional wetlands. Essentially, wetland conditions observed in Wetlands A and C

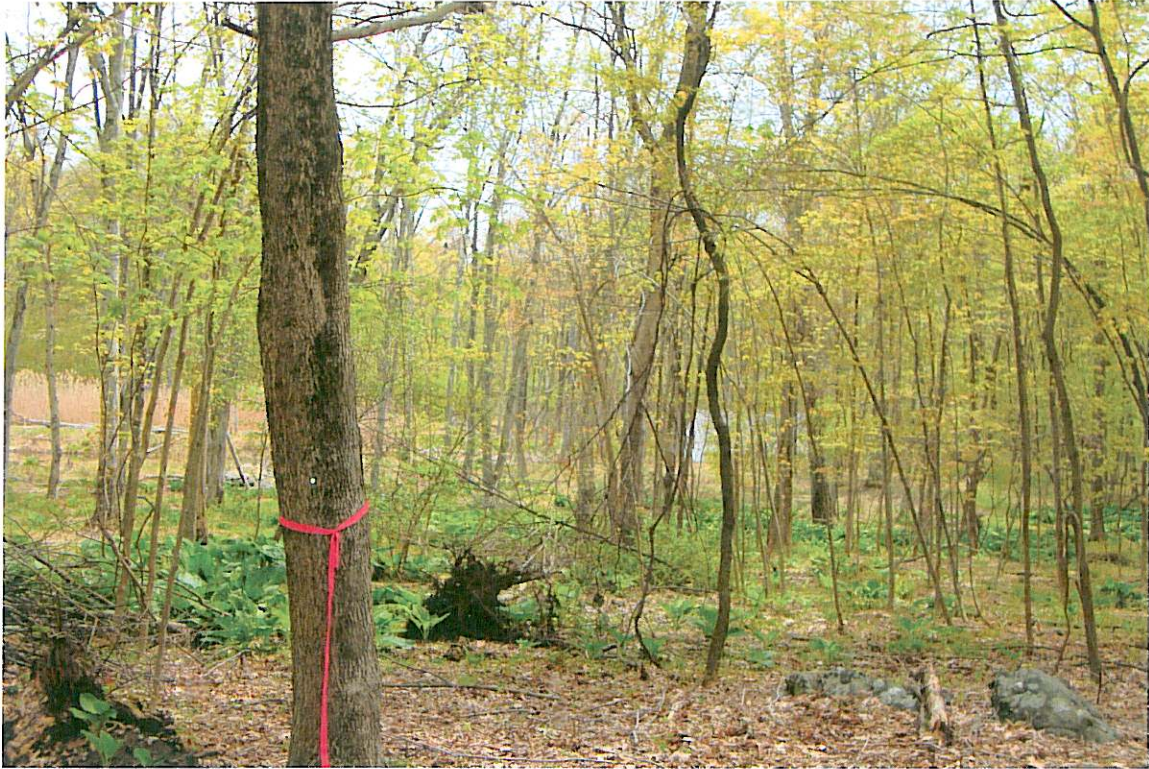
*Photo No. 1 - East view of wetland sample point in Wetland A.*

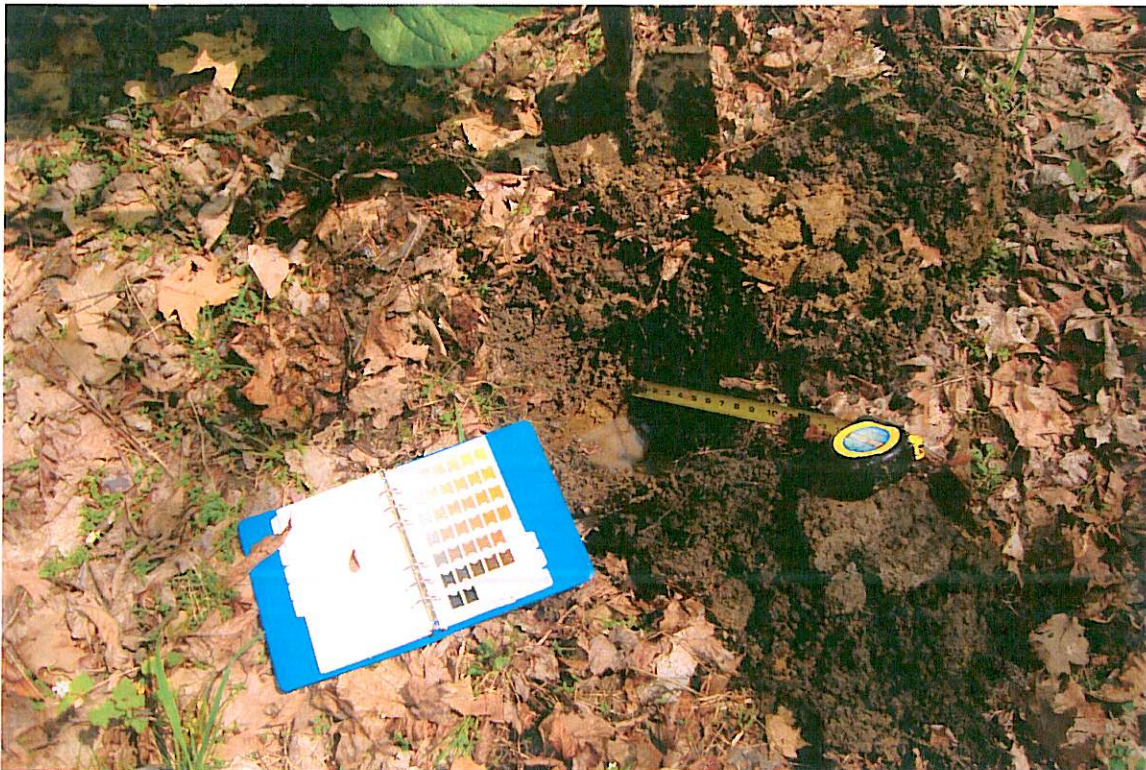
*Photo No. 2 - View of shovel dig within Wetland A; water table encountered within 12 inches of surface. Soil is saturated.*

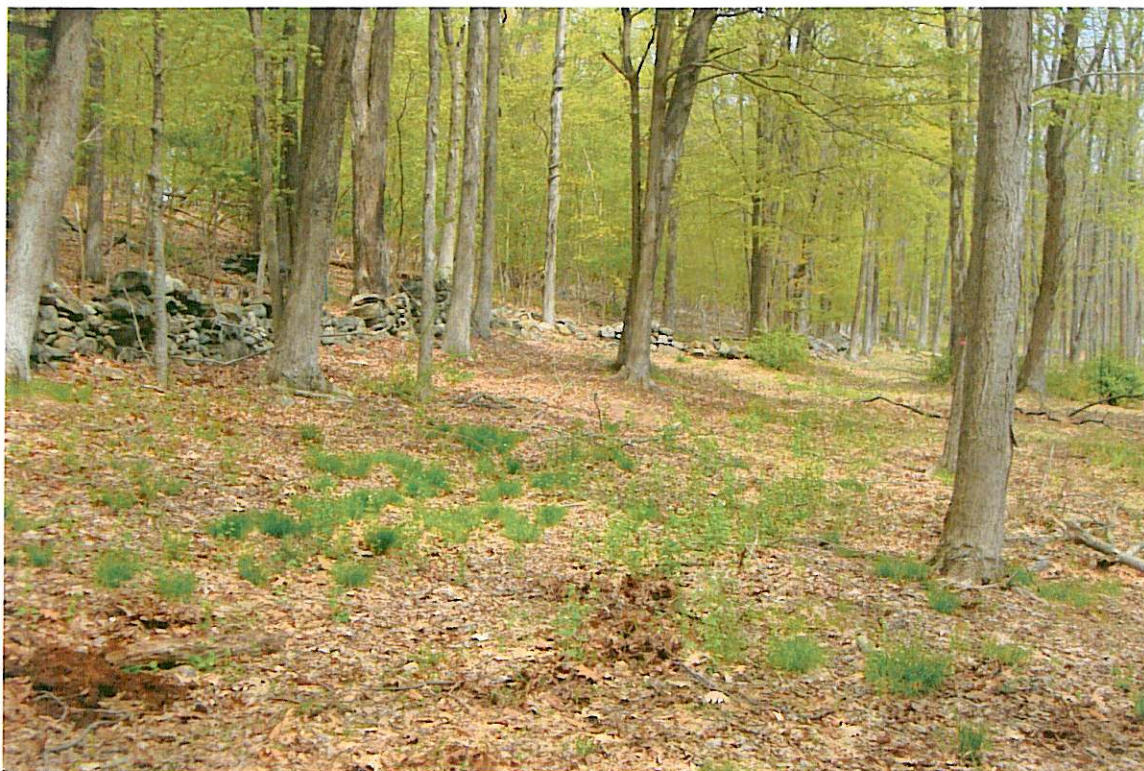
*Photo No. 3 - North view of upland sample point adjoining Wetland A boundary.*

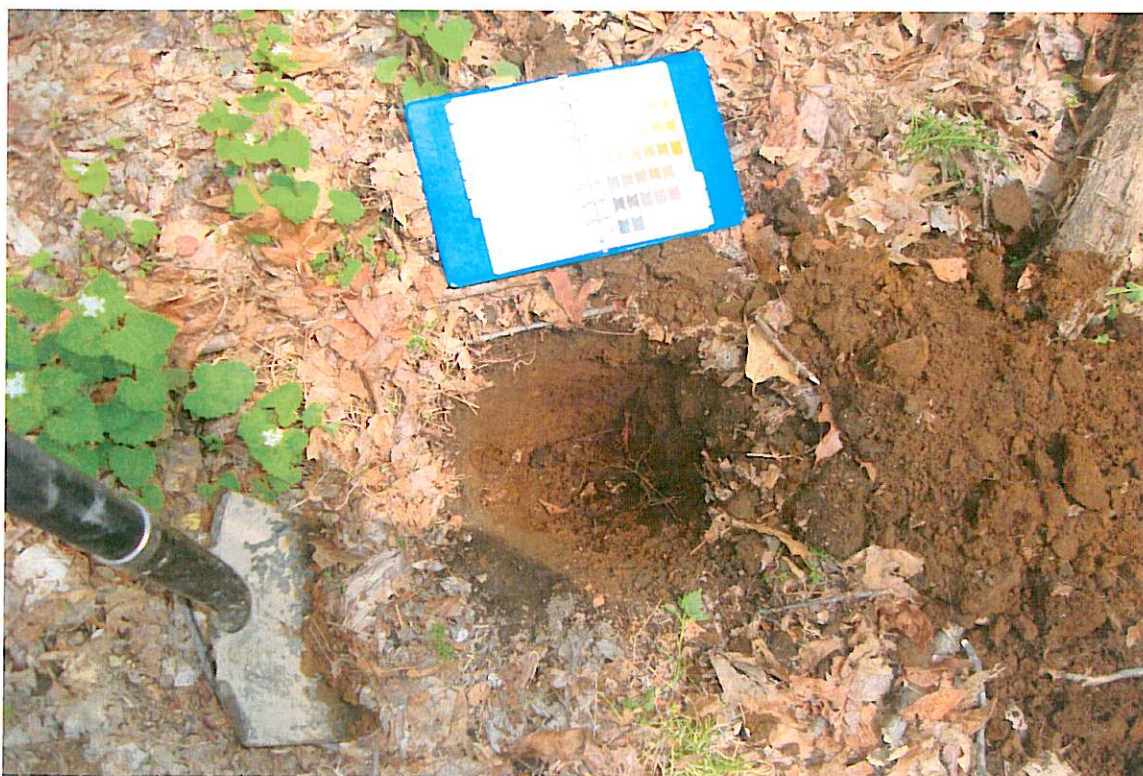
*Photo No. 4 - View of upland shovel dig adjacent to Wetland A; a brown to light-brown silty-sandy soil loam was observed.*

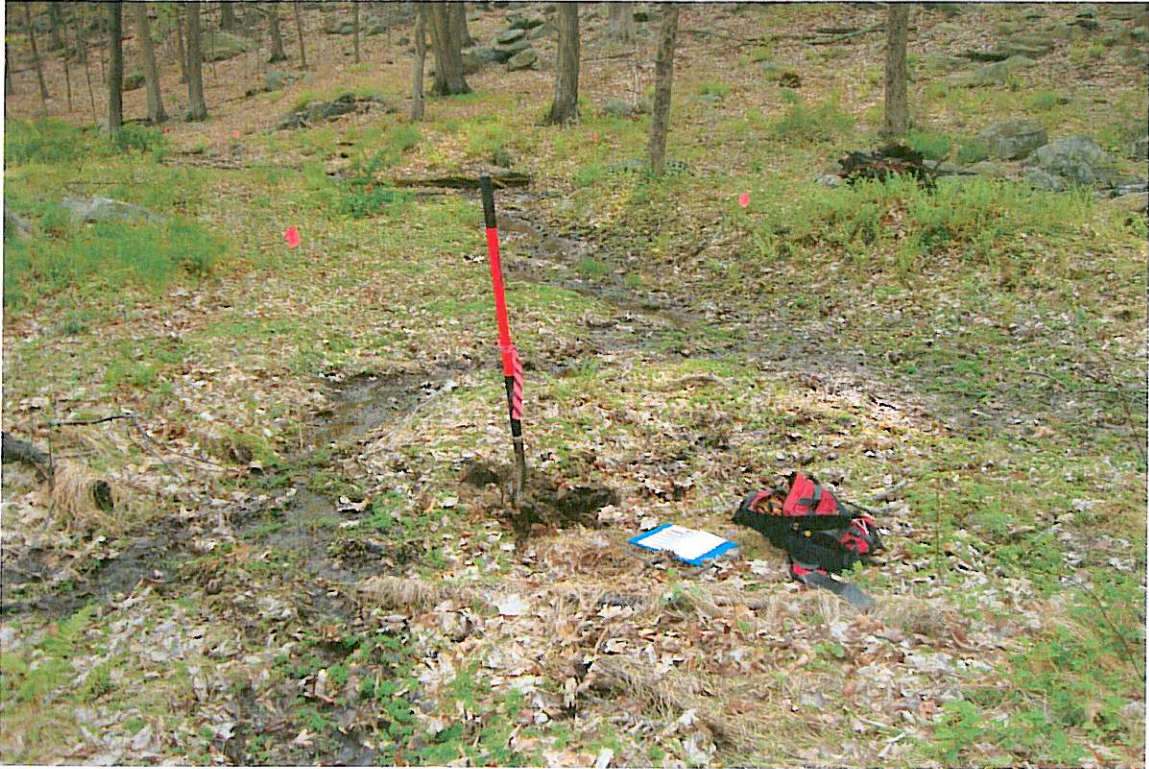
*Photo No. 5 - North view of Wetland sample point within Wetland B.*

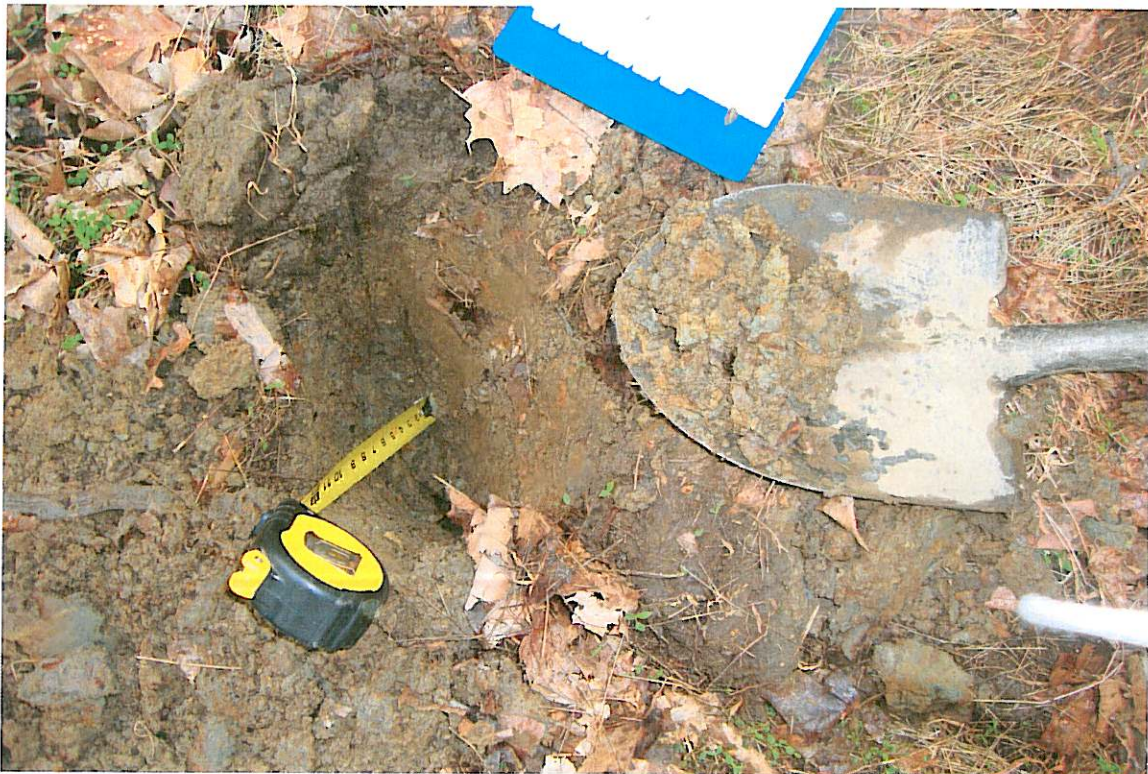
*Photo No. 6 - View of shovel dig within Wetland B; orange mottles depicted within moist soils as shown on shovel blade.*

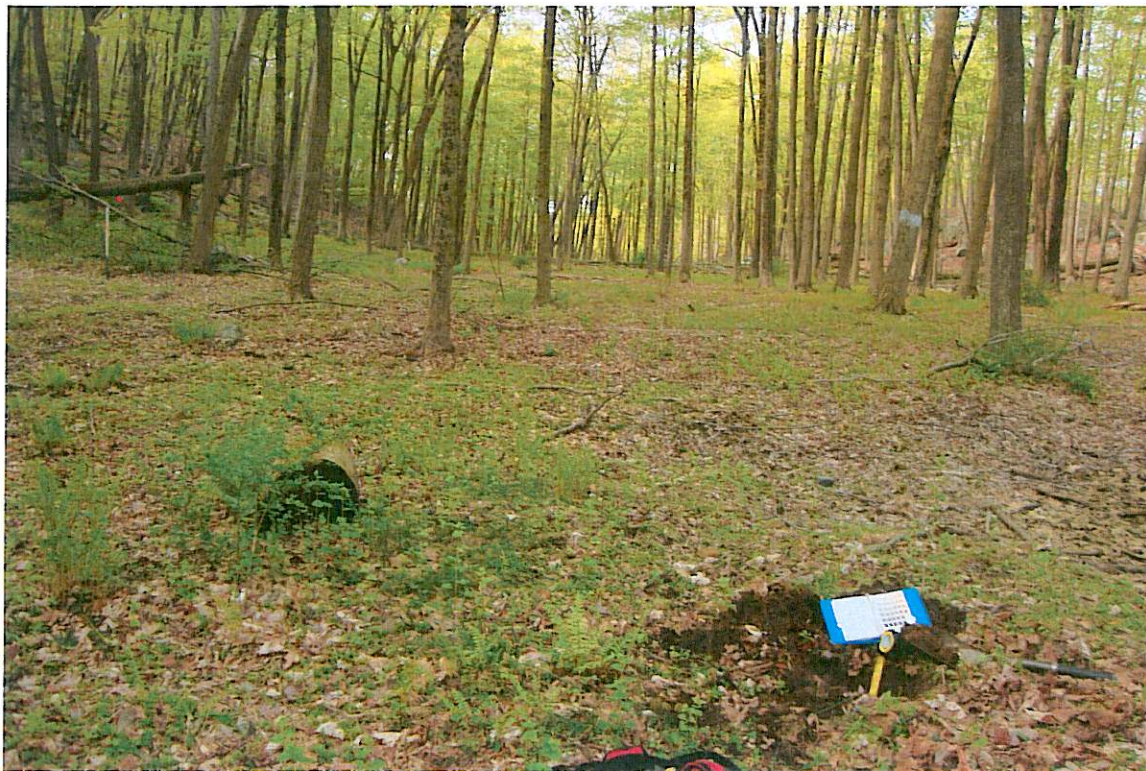
*Photo No. 7 - South view of upland sample point adjoining Wetland B.*

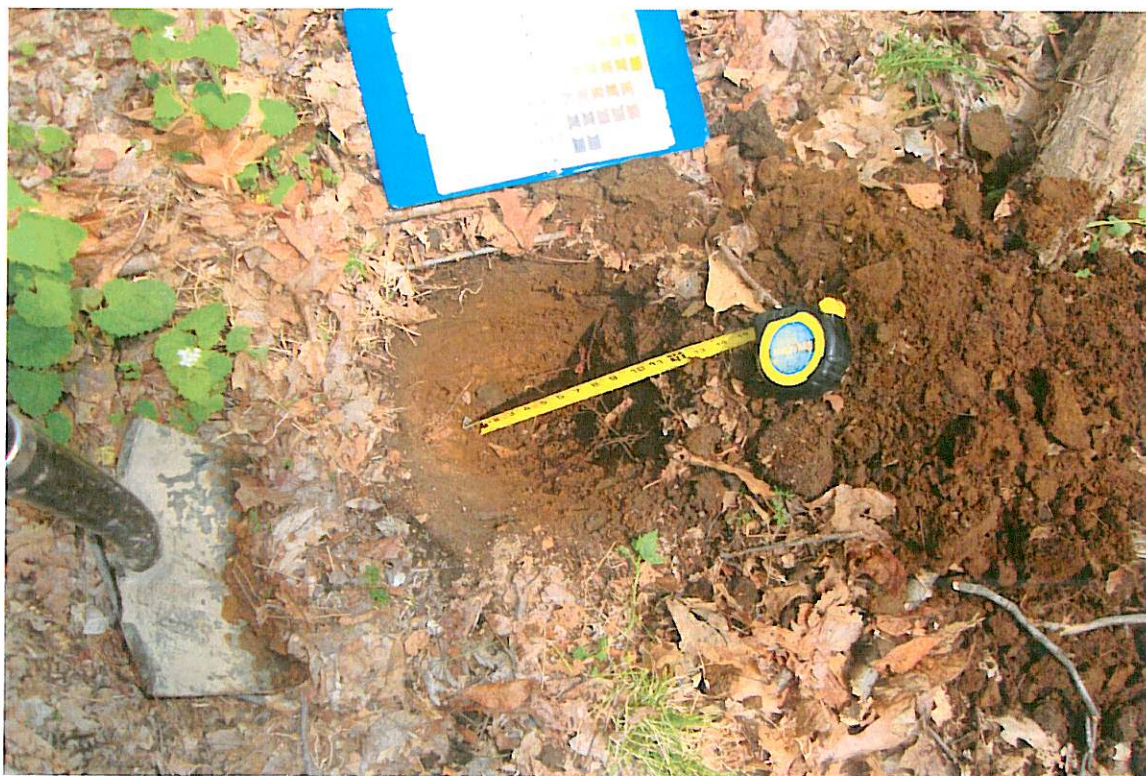
*Photo No. 8 - View of upland shovel dig adjacent to Wetland B; a brown to light-brown silty-sandy loam soils was observed.*
