**NEW YORK STATE DEPARTMENT OF  
ENVIRONMENTAL CONSERVATION/  
U.S. ARMY CORPS OF ENGINEERS  
JOINT APPLICATION FORM**

**New York City Department of Environmental Protection  
Bureau of Engineering Design and Construction  
Capital Project WM-30, in Westchester County, NY**

**Replacement of Baptist Church Road Bridge, Town of  
Yorktown, NY**

**BIN: 2-26243-0**

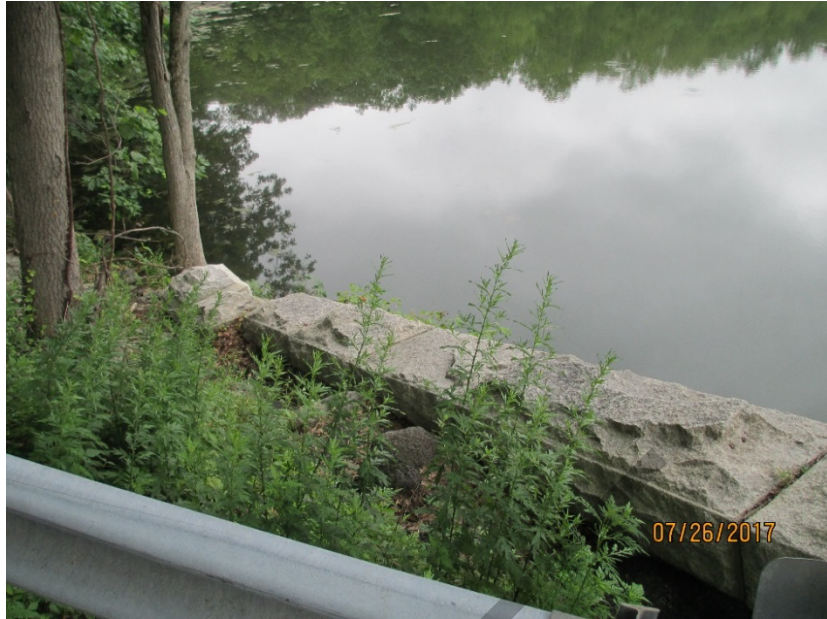
**Photo No. 1**

Location: End Abutment Wingwall

Subject: Note minor vegetation and erosion behind wingwall, granite capstones in good condition.

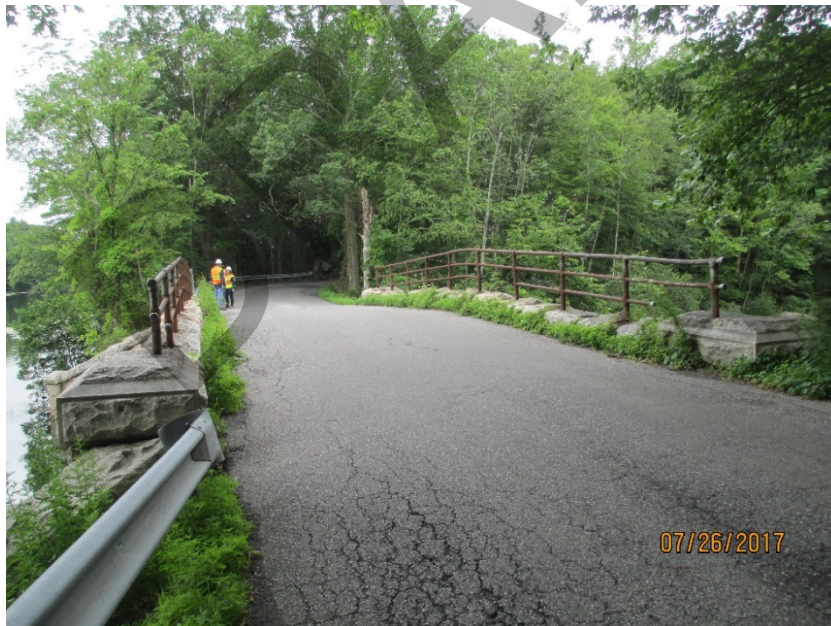
**Photo No. 2**

Location: End Approach

Subject: Note map cracking in pavement and vegetation along gutter line, no transition between bridge railing and approach railing.

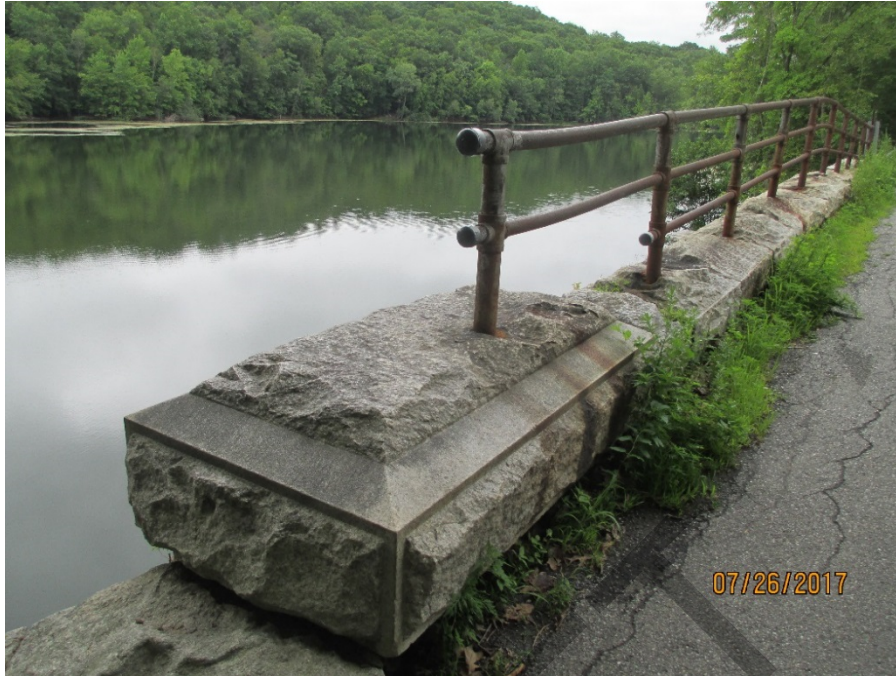
**Photo No. 3**

Location: South Fascia, Granite Capstone and Tubular Bridge Railing

Subject: Vegetation, cracked and settled pavement along gutter line and missing railing.

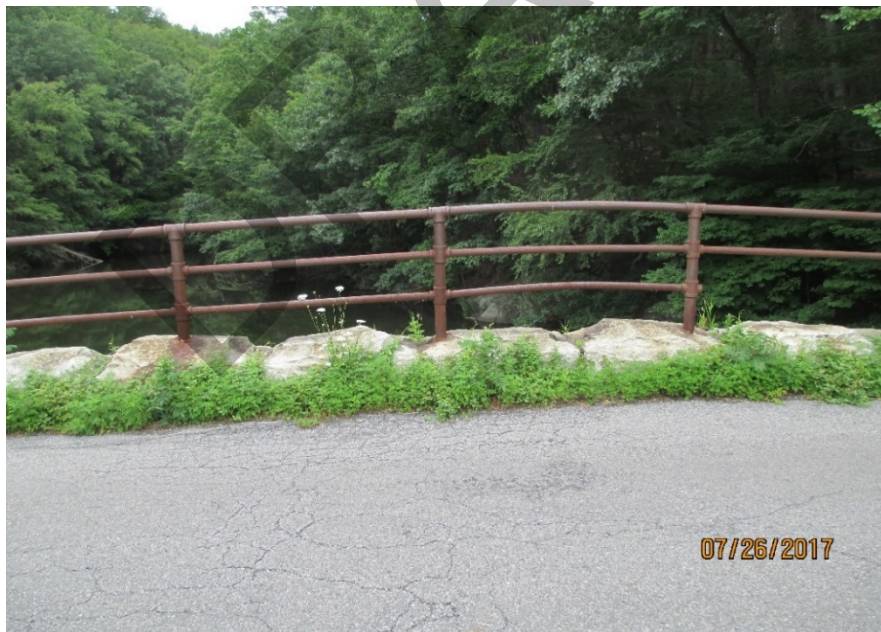
**Photo No. 4**

Location: Bridge Railing

Subject: Railing is heavily rusted. Excessive map cracking in pavement. Vegetation noted in gutter line.

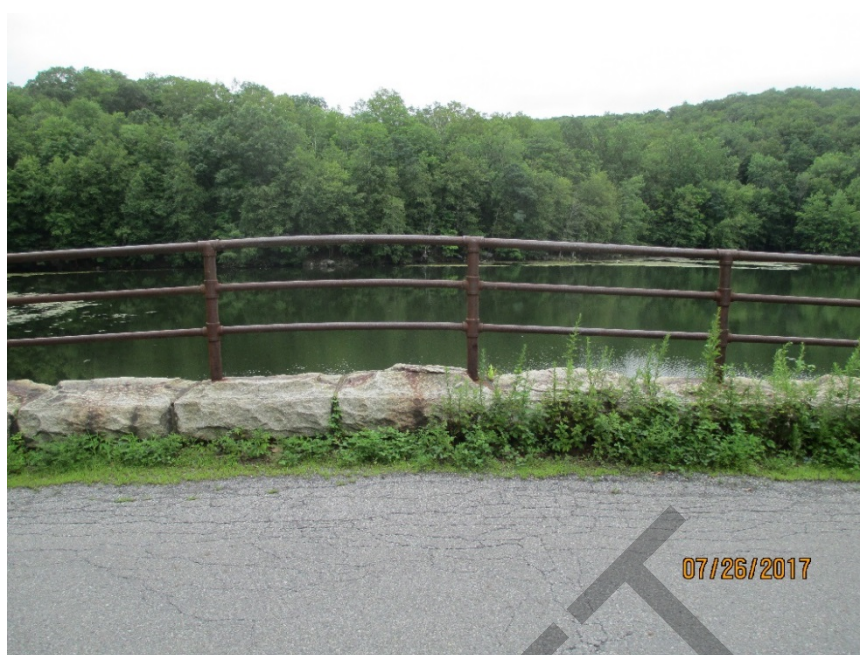
**Photo No. 5**

Location: Bridge Railing

Subject: Railing is heavily rusted. Excessive map cracking in pavement. Vegetation noted in the gutter line.

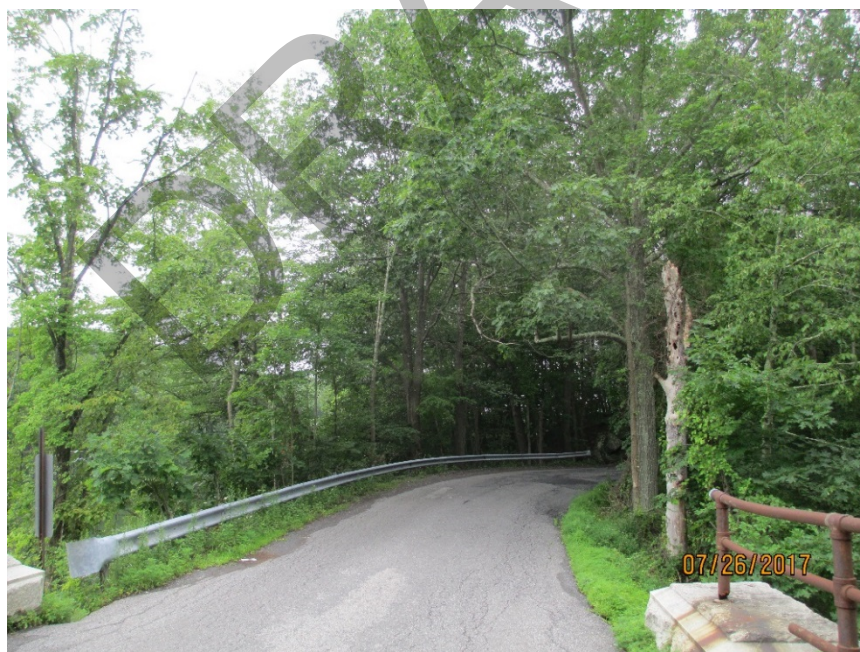
**Photo No. 6**

Location: Begin Approach

Subject: Heavy vegetation and trees hinder driver's horizontal sight line; missing bridge/railing transitions.

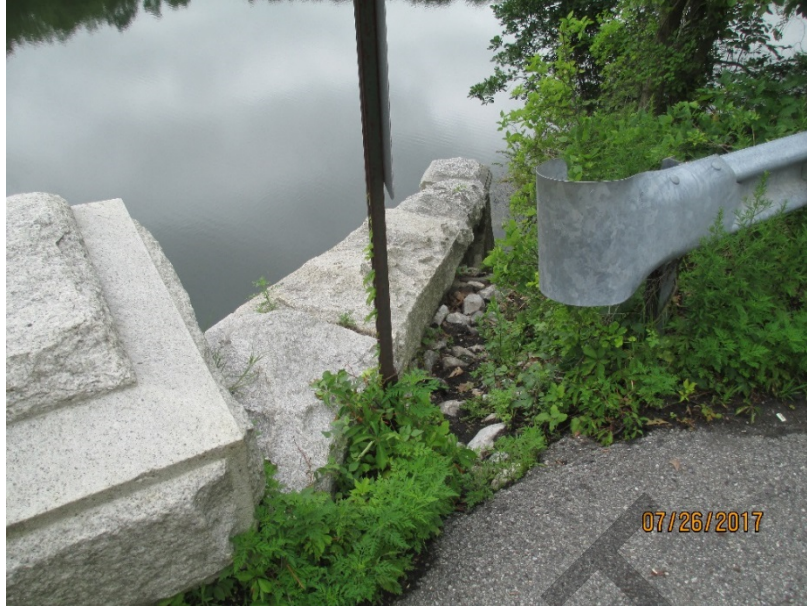
**Photo No. 7**

Location: Begin Abutment Wingwall

Subject: Wingwall exhibits excessive erosion behind wall. Granite coping is in good condition, note missing railing transition elements.

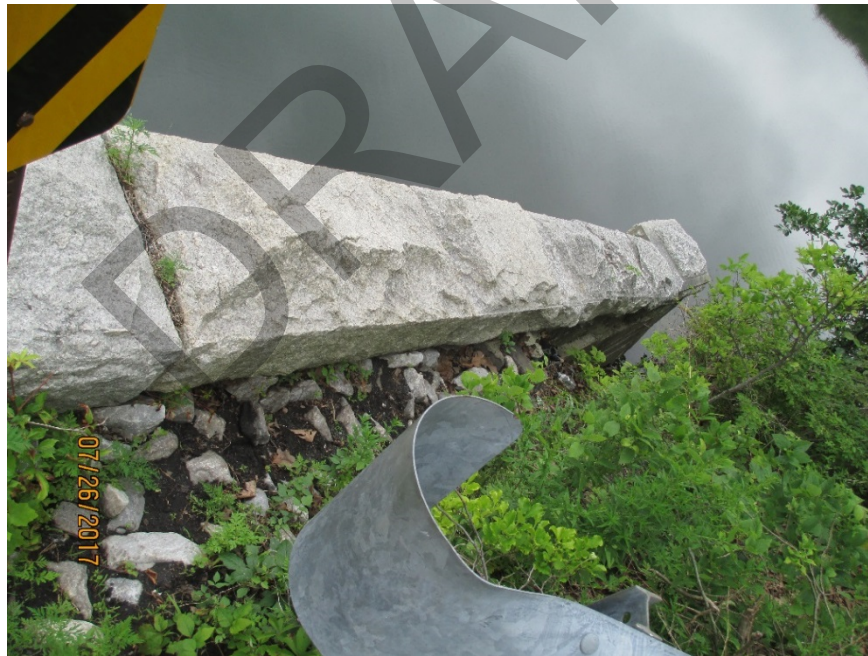
**Photo No. 8**

Location: Begin Abutment Wingwall

Subject: Wingwall exhibits excessive erosion behind wall. Granite coping is in good condition, note missing railing transition elements.

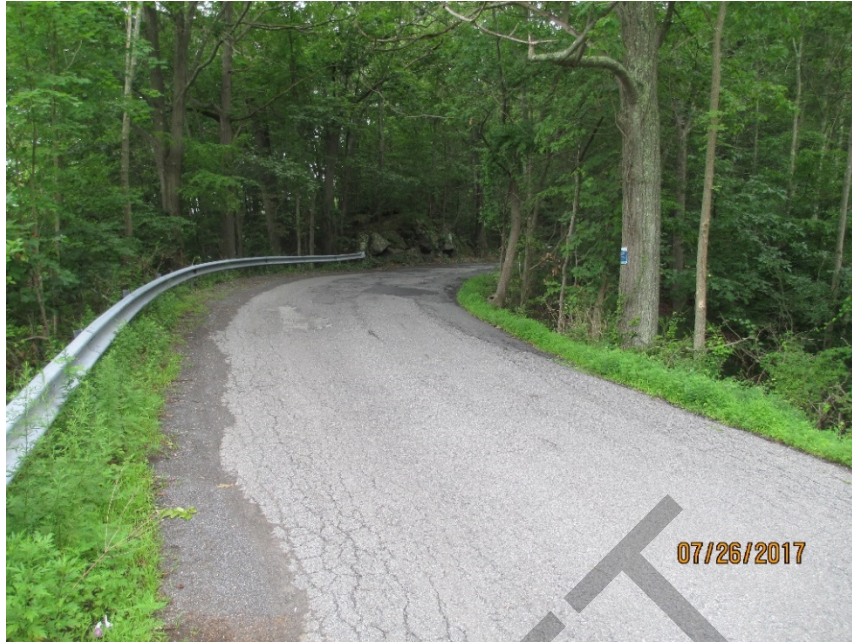
**Photo No. 9**

Location: Baptist Church Roadway near begin approach

Subject: Roadway exhibits vegetation in travel lane, map cracking and roadway settlement repairs.

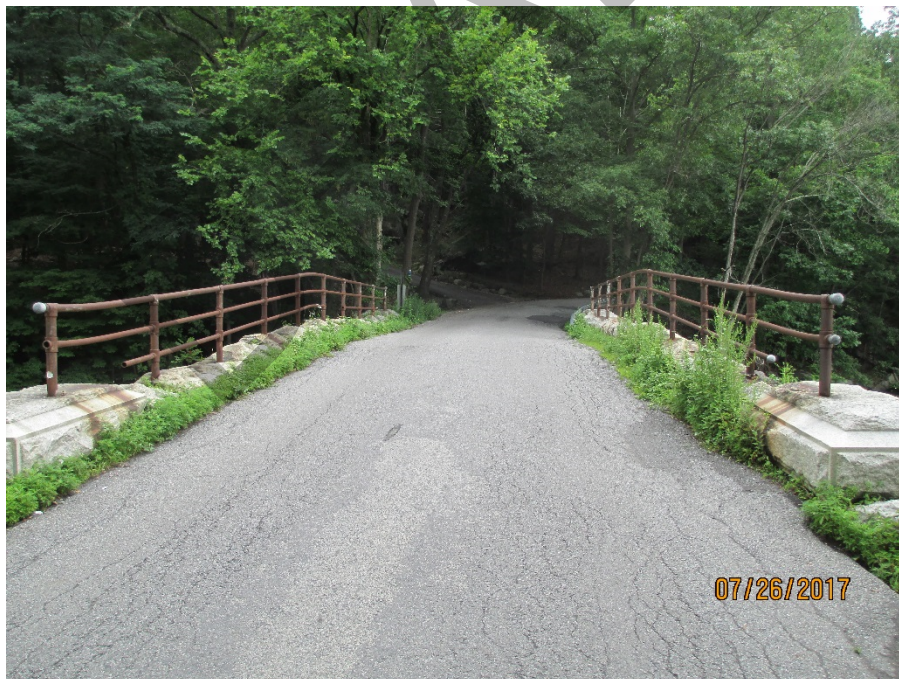
**Photo No. 10**

Location: Baptist Church Road Bridge

Subject: Roadway exhibits vegetation, heavy map cracking and pavement settlement.

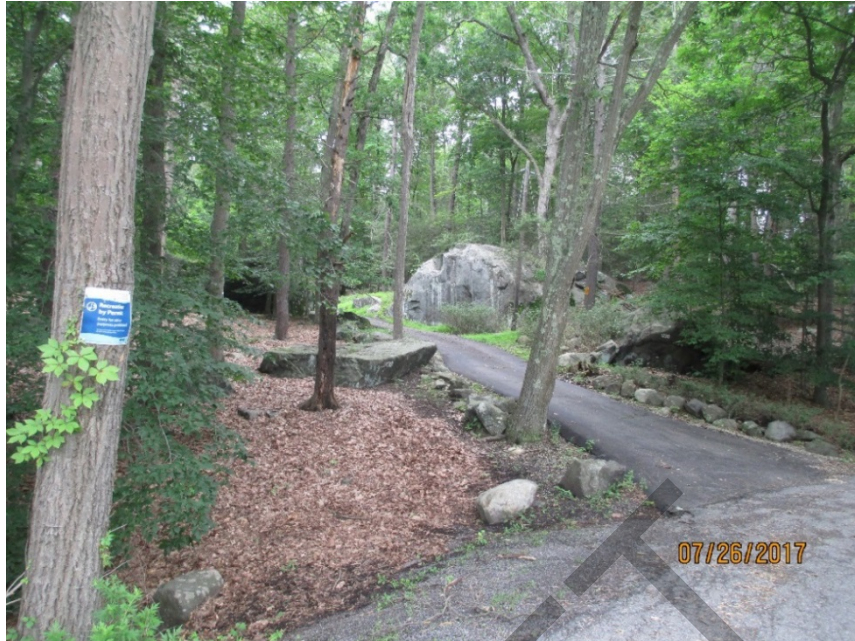
**Photo No. 11**

Location: Baptist Church Road – Driveway near Baptist Church Road Bridge

Subject: Driveway appears to be in good condition. Note overhead utility over driveway, note it is not an affect to construction.

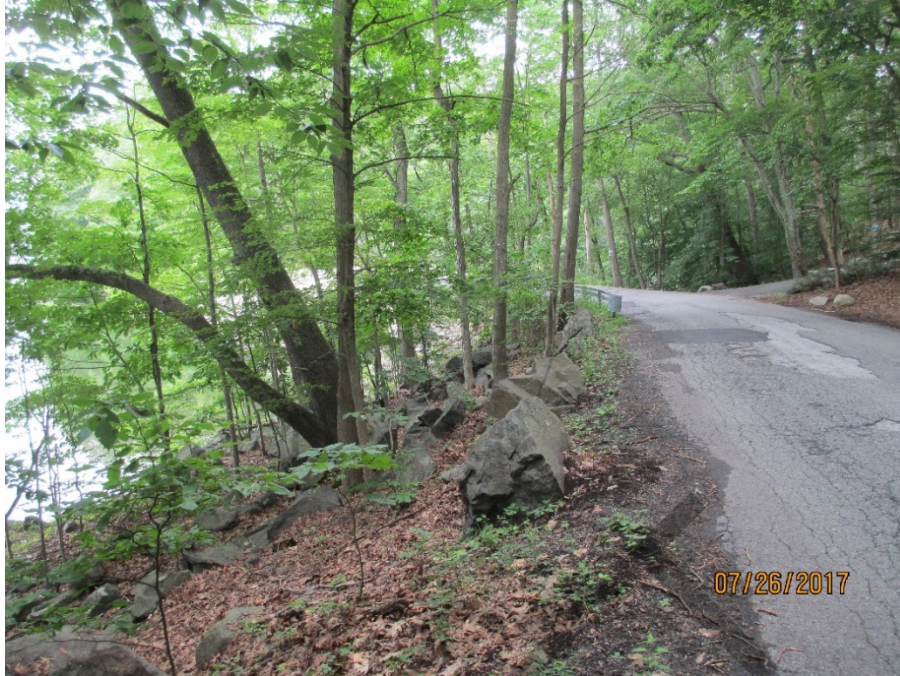
**Photo No. 13**

Location: Baptist Church Road – Roadway leading to End Approach

Subject: Approach slope appears to be stable.

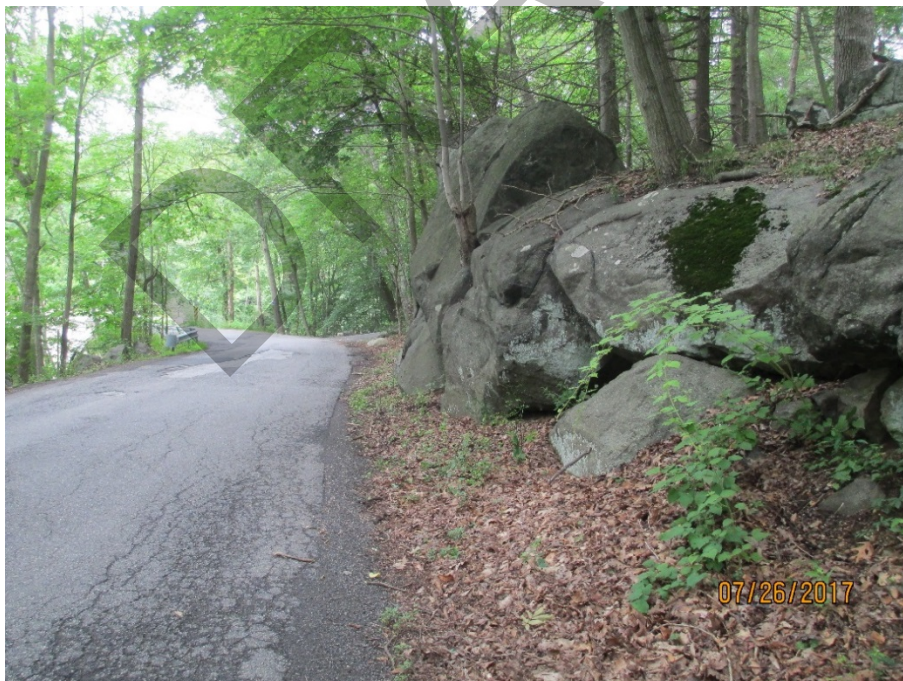
**Photo No. 14**

Location: Baptist Church Road – Roadway leading to End Approach, north of driveway

Subject: Rock outcropping just north of driveway and end approach.

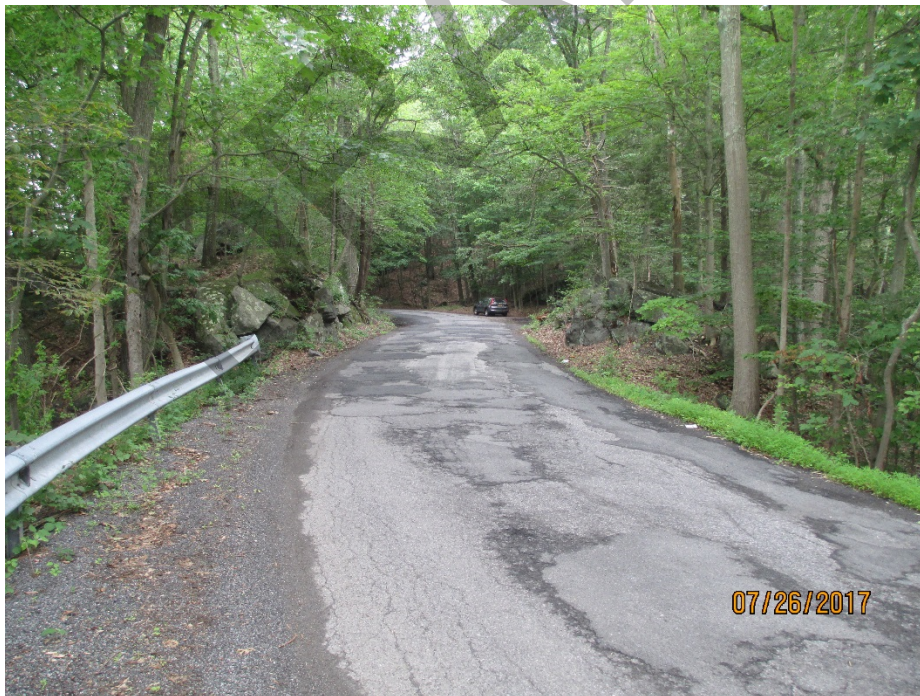
**Photo No. 16**

Location: Baptist Church Road – Roadway before Begin Approach

Subject: General view of Baptist Church Road, condition of approach roadway is fair.

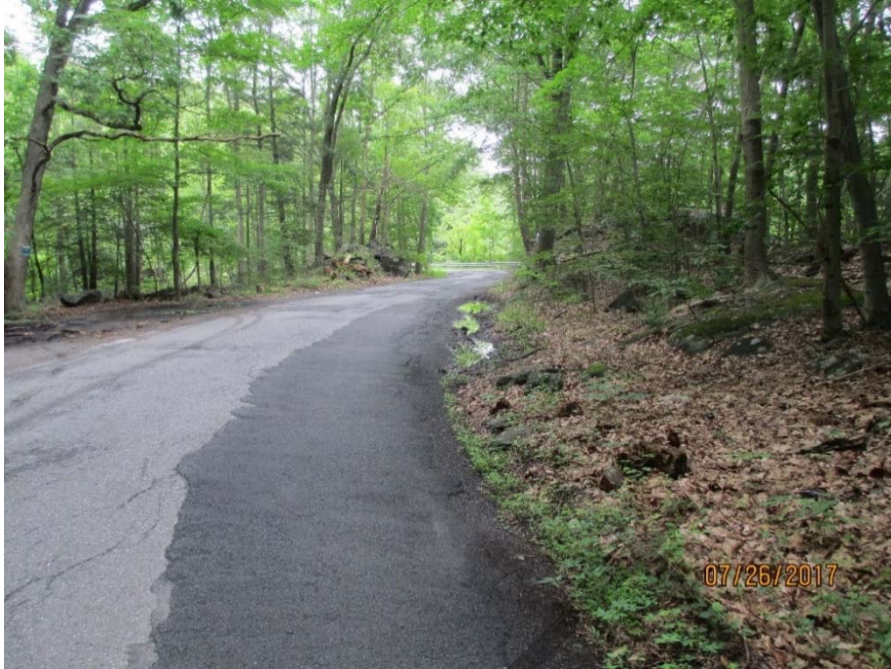
**Photo No. 19**

Location: Baptist Church Road – Roadway leading to Begin Approach

Subject: Ponding of water and cracked/repared roadways visible.

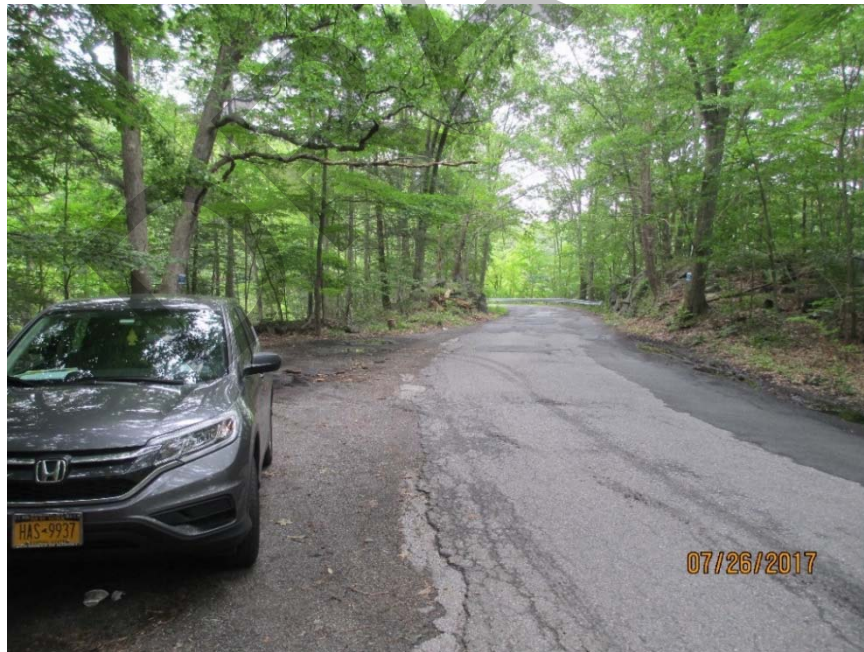
**Photo No. 20**

Location: Baptist Church Road – Roadway leading to Begin Approach

Subject: Ponding of water and cracked roadways visible. Heavy vegetation prohibits a clear line of horizontal sight.
