**FULL ENVIRONMENTAL ASSESSMENT FORM  
(PARTS 1 & 2)**

**FIELD HOME ACTIVE-ADULT  
COMMUNITY DEVELOPMENT**

**2300 CATHERINE STREET  
TOWN OF YORKTOWN, WESTCHESTER COUNTY, NEW YORK**

**DATED: FEBRUARY 16, 2024**

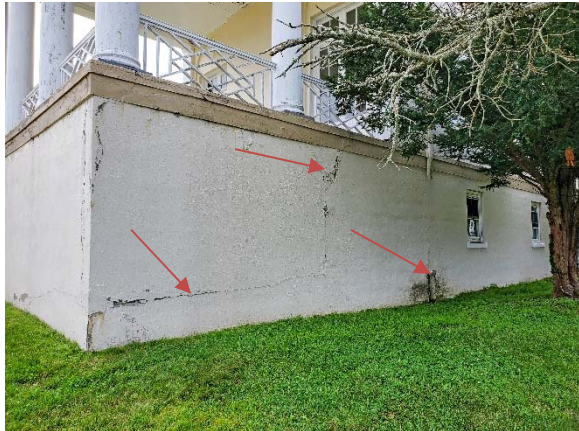
West Pavilion: vertical & horizontal cracks in basement wall & at porch floor/table; missing portion of downspout (right)

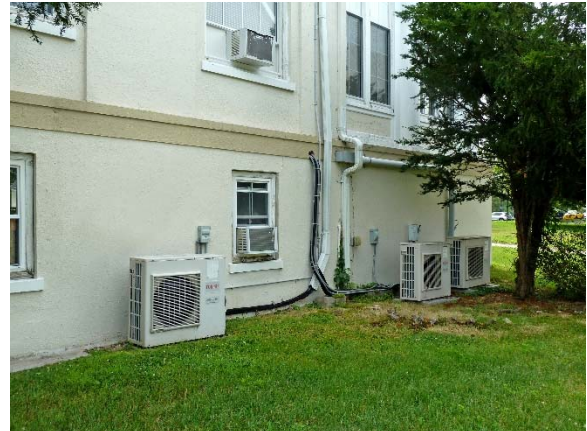
In-window air conditioning units; multiple split system condensing units with conduit overlapped by downspout

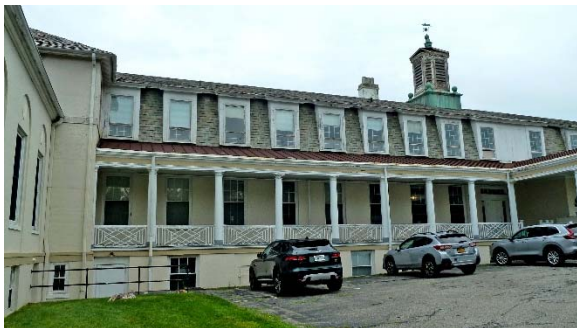
Central Addition (1897): porch in fair condition with likely original standing seam roof, replacement balusters, parking

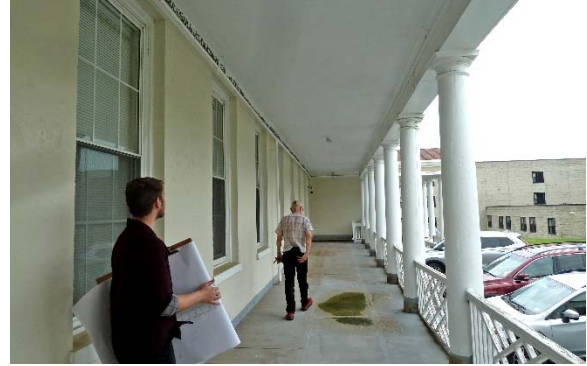
South porch: replacement balusters, coated floor and Tuscan column bottoms; bird deterrent visible above windows

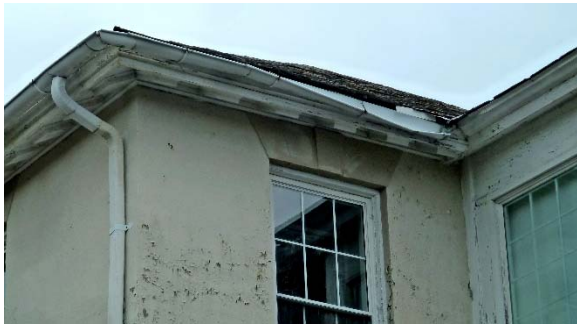
East wall of 1924 Addition: deformed gutter allowing stormwater overflow down wall; peeling paint

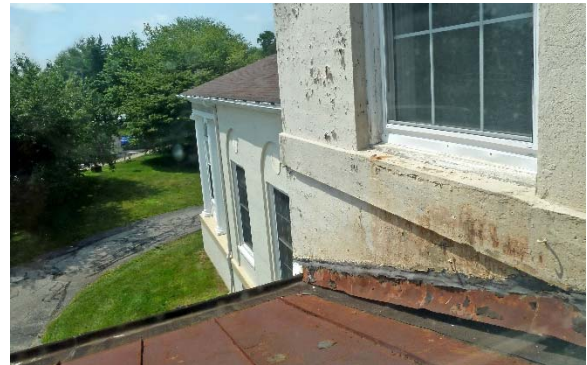
East wall of 1924 Addition: peeling paint and visible staining on concrete walls; original porch roof and flashing with repairs

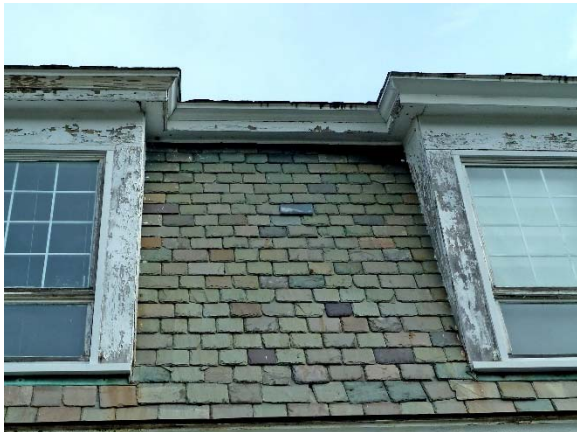
Chapel, south elevation: Slate gambrel roof in fair condition with some slates slipping or displaced; peeling dormer trim

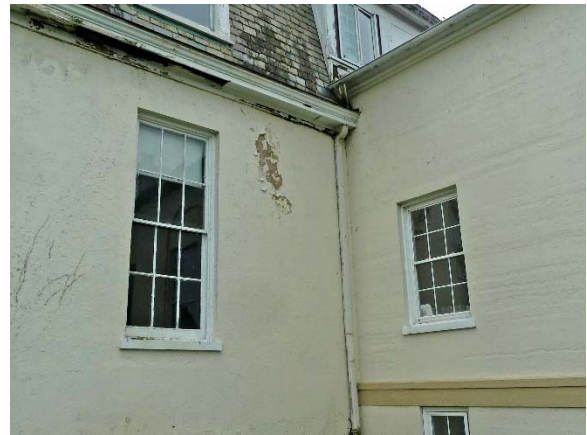
Chapel, north elevation: roof soffit very deteriorated and open; peeling paint on wall; downspout at corner with pavilion

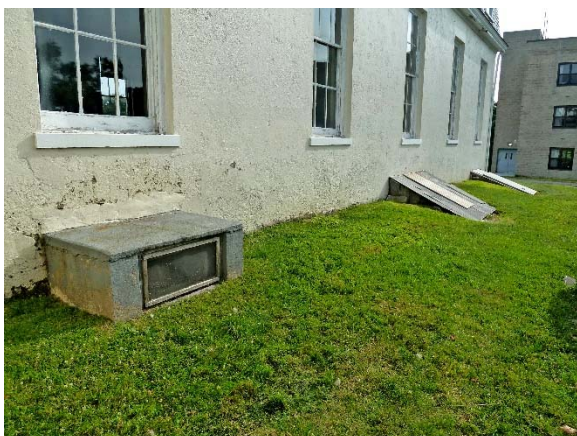
Chapel, south elevation: peeling paint and repairs at lower walls; access point to basement level

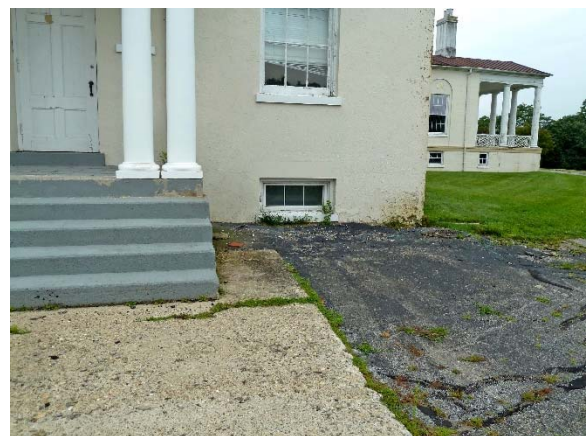
Chapel, east elevation: peeling paint along northeast corner of building & concrete stair; macadam driveway with repairs

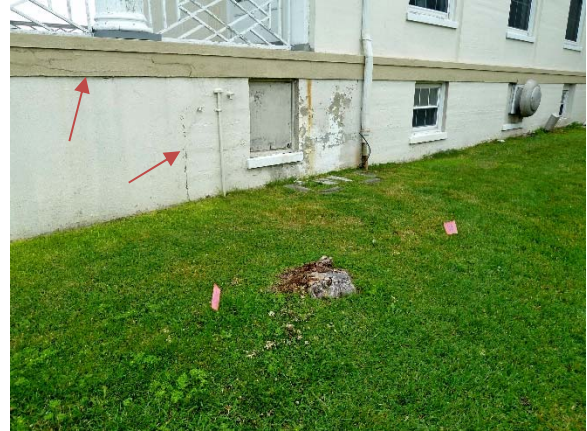
East Pavilion, west wall: cracks at basement level where interior spaces begin & at water table/edge; peeling paint

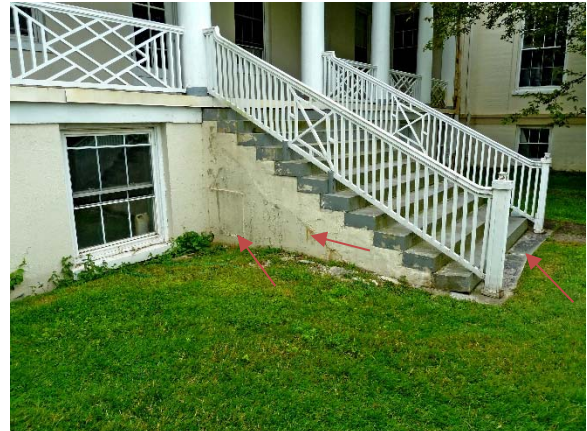
North porch stairs: visible structural cracks on side wall(s); displaced & rotated lowest two stairs/treads; peeling paint

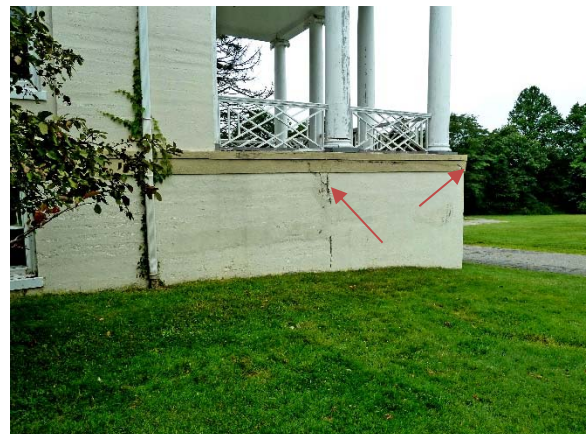
East façade of West Pavilion: vertical cracks at basement level; broken edge of porch floor; Ionic column separating

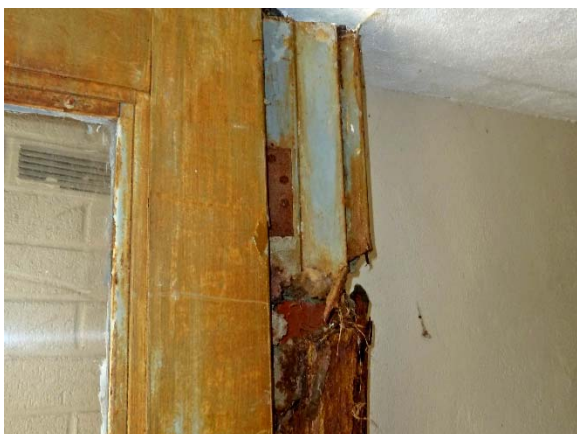
Exterior basement door, at West Elevation: steel frame severely rusted & disconnected with bird nest inside

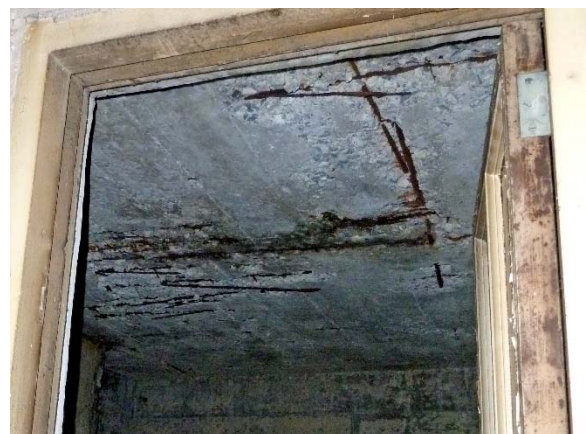
Underside of West first floor entry portico: concrete slab with multiple rebar visible & rusty near the deteriorated surface

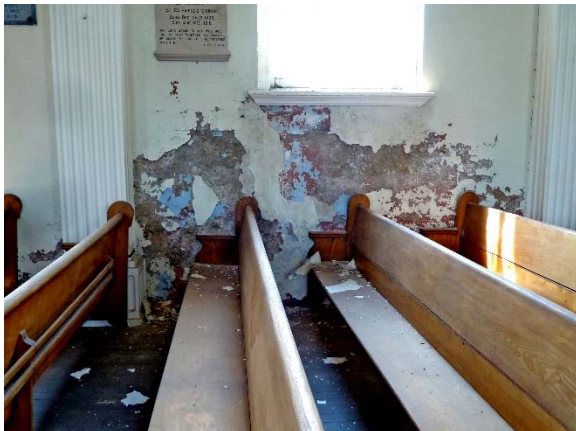
Chapel, south wall: severely deteriorated finishes below window sills, allowing view of previous paint layers & bare concrete

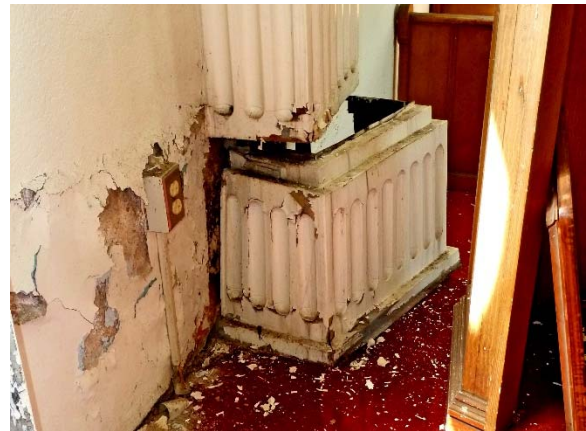
Chapel, south wall by sanctuary: sheet metal pilaster/tie cover disconnected; peeling paint on exterior wall and cover

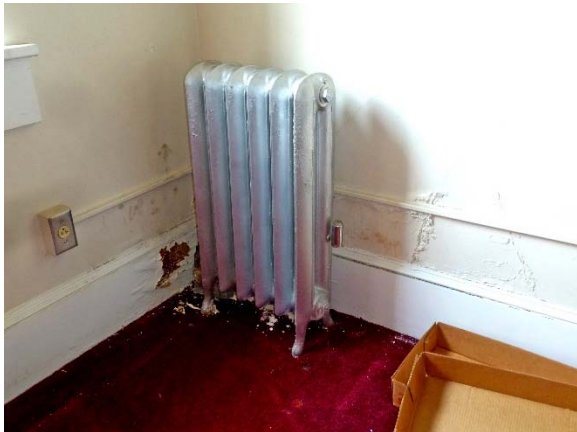
Peeling & bubbling wall and baseboard finishes around steam radiator suggests ineffective or failing controls

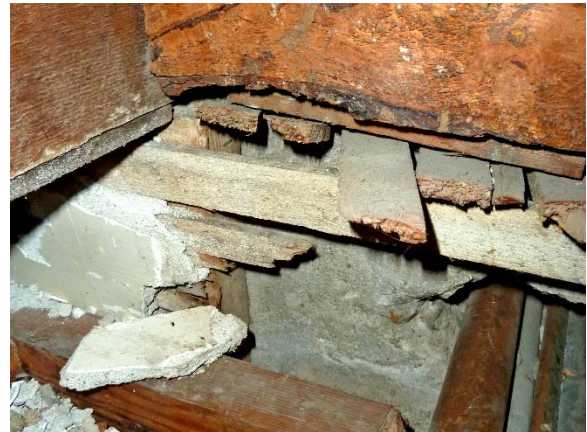
Kitchenette: floor probe exposes plaster walls above a dropped ceiling, and concrete wall penetration
