# PRE-DEMOLITION HAZARDOUS BUILDING MATERIALS SURVEY

Town of Yorktown  
Catherine Street Pump Station  
Garden Lane and Old Crompond Road  
Yorktown, New York 10598

November 28, 2018

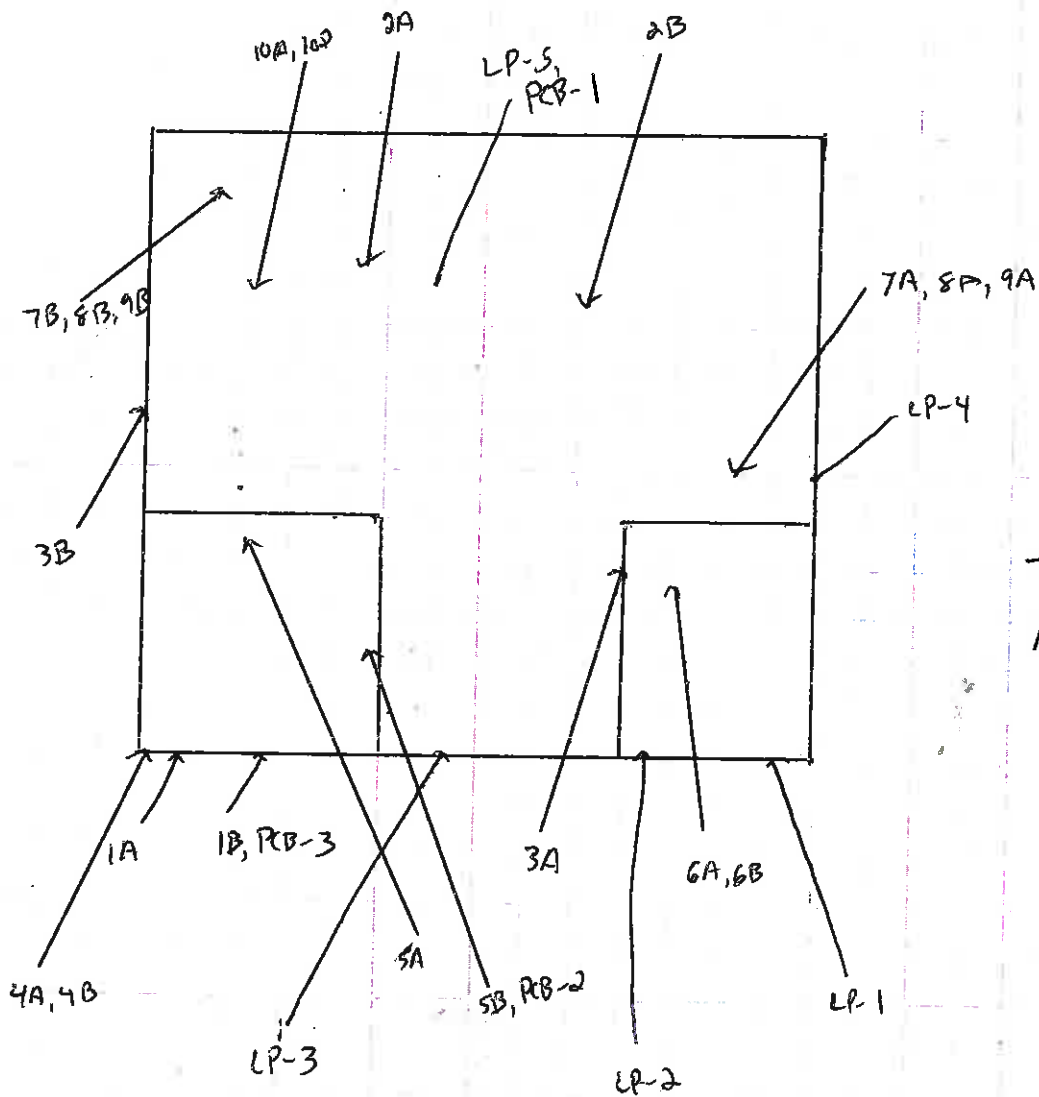
Sample Location Diagram  
Figure 1

Arcadis identified eleven (11) HAs, of which, twenty (20) suspect ACM bulk samples were collected and submitted for laboratory analysis. A listing of the identified HAs, including each HA material description, location, condition, asbestos content, and estimated quantity, are presented in Table 1. Approximate sampling locations are shown on Figure 1.

Five (5) paint chip samples were collected and submitted for laboratory analysis. Lead in paint was detected in four (4) samples analyzed at concentrations ranging from 0.011% by weight to 4.3% by weight. Details regarding material description, location, substrate, condition, and reporting limit of each paint chip sampled are presented in Table 2. Approximate sampling locations are shown on Figure 1.

Three (3) bulk samples were collected and submitted for laboratory analysis. PCBs were detected in one (1) sample at a concentration of 16.3 mg/Kg. Details regarding the material description, location, reporting limit and results of each material sampled are presented in Table 3. Approximate sampling locations are shown on Figure 1.
